*W***INTER HAVEN**  
*The Chain of Lakes City*

# Annual Lakes Report

Presented by the Lakes Advisory  
Committee

CITY OF WINTER HAVEN  
Public Works Department  
Natural Resources Division

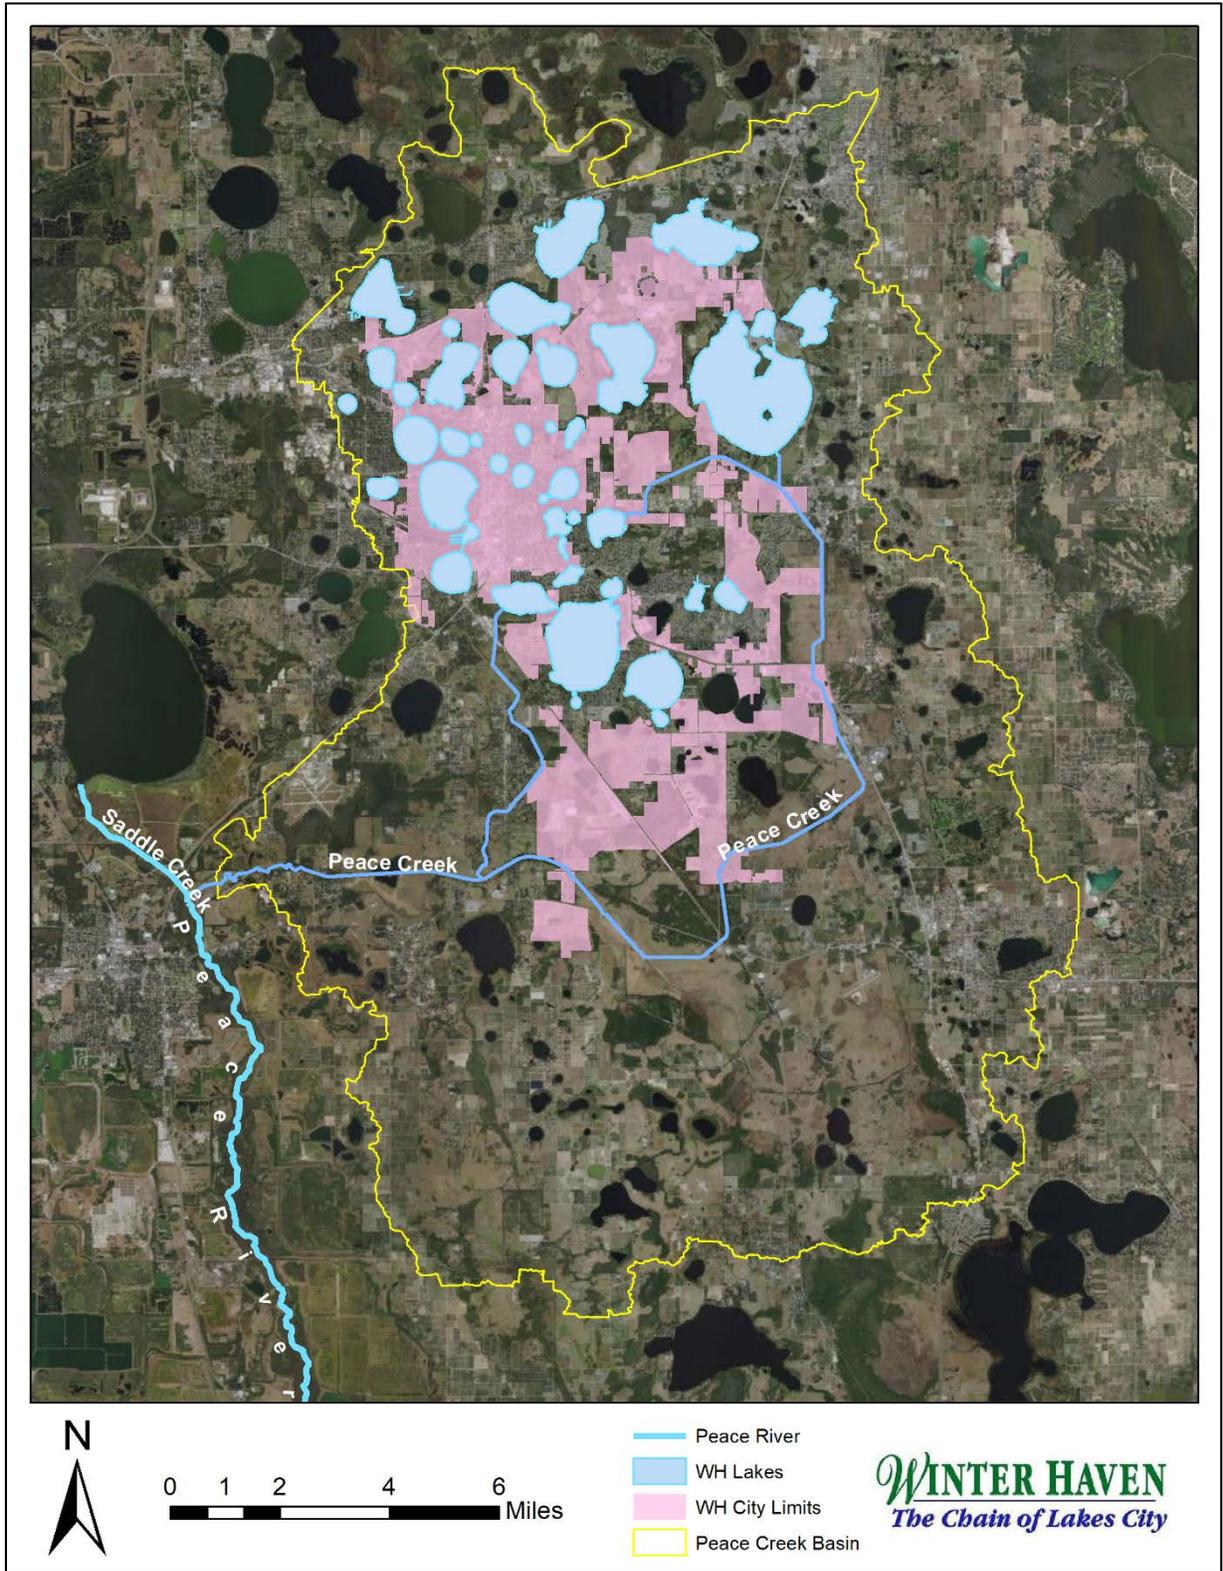
Figure 1-2. Map of the Peace Creek sub-basin, City of Winter Haven limits, contributing lakes and flow-ways.

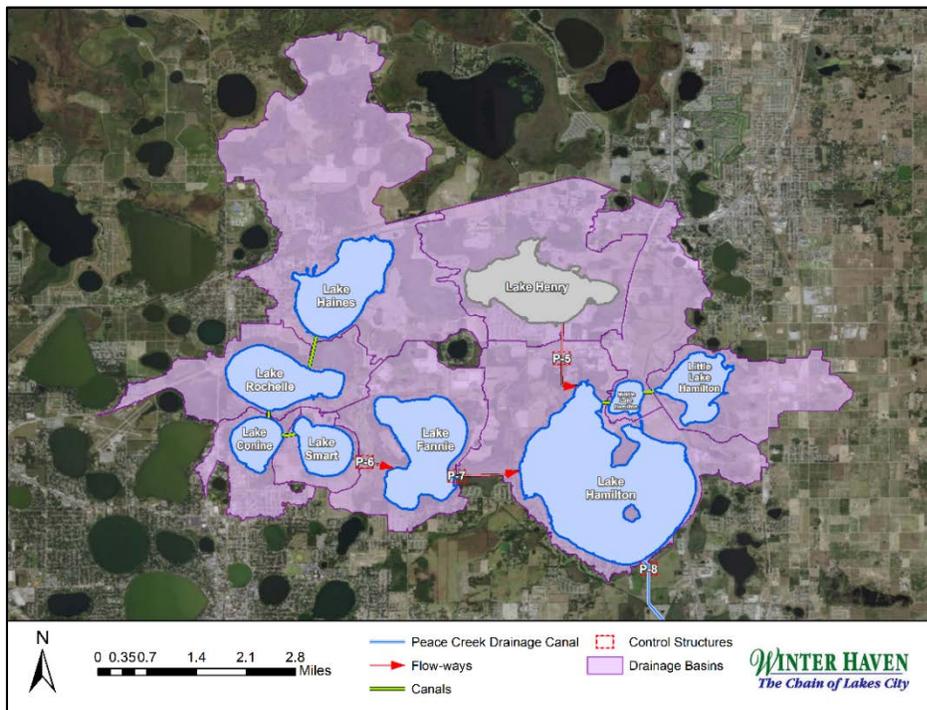
Figure 1-3. Map of North Chain of Lakes, Flow Pathways & Drainage Basins

The Southwest Florida Water Management District (SWFWMD) manages the surface level of the Northern Chain of Lakes via a series of active water control structures. For the purposes of water conservation and flood control, the SWFWMD sets maximum desired levels at each of these structures—discharging water to the Peace Creek Canal when surface levels exceed the upper limits [1]. In this system, water flows from West to East toward the terminal discharge point at Lake Hamilton (Figure 1-3). Lakes Conine, Haines, Rochelle, and Smart are all held roughly equal via a series of navigable canals. The P-6 water control structure, located downstream of Lake Smart, maintains the desired surface level for these four lakes. From Smart, water discharges to Lake Fannie which is controlled by the P-7 structure. Discharge from Lake Fannie flows to the Hamilton Chain (Lakes Hamilton, Little Hamilton, & Middle Hamilton) where the P-8 control structure maintains water in these three lakes before discharging to the Peace Creek Canal. In addition to these 8 waterbodies, Lake Henry discharges to Hamilton via the P-5 structure. However, because Lake Henry lacks public access and a means of water quality data collection, it has been excluded from this study.

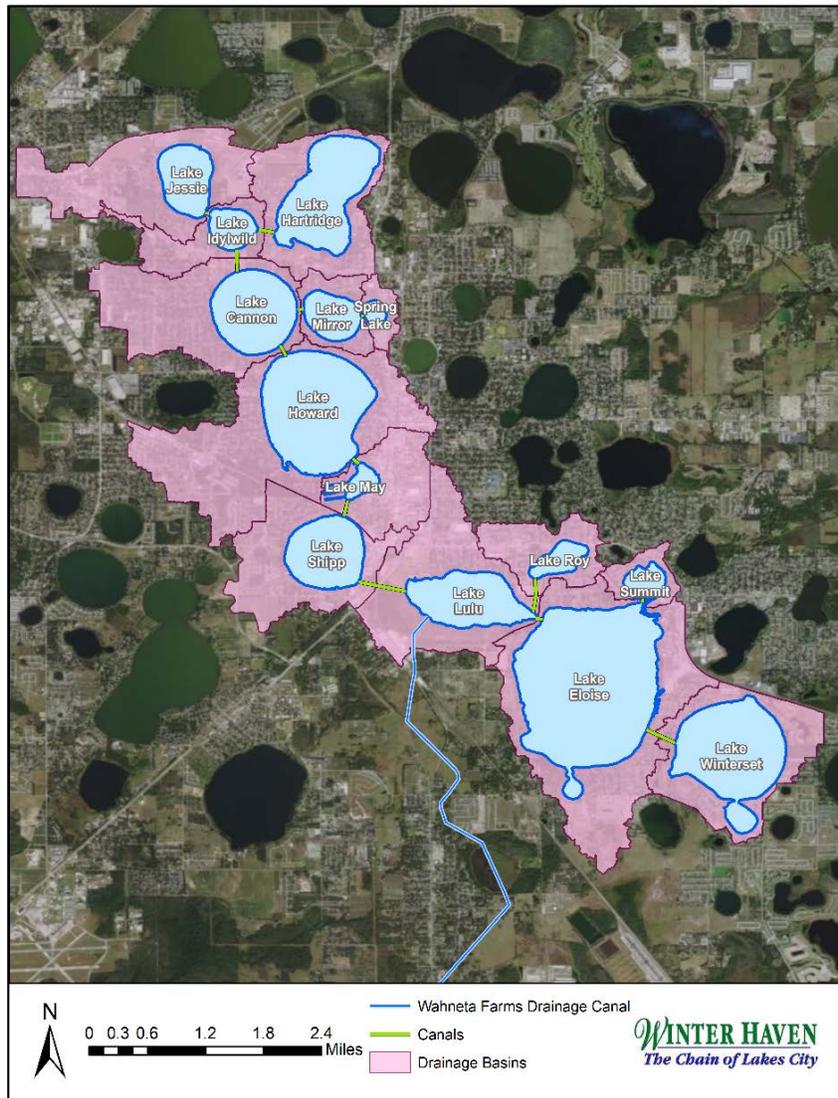
Figure 1-4. Map of South Chain of Lakes, Flow Pathways & Drainage Basins

The entirety of the Southern Chain is connected via a series of navigable canals. Many of these canals were constructed in the early 1900's, in part as a means to transport citrus through the region [2]. A passive control structure located on the southern shore of Lake Lulu and managed by the Lake Region Lakes Management District (LRLMD), maintains the surface level of this entire chain. From this structure, the Southern Chain discharges to the Wahneta Farms Drainage Canal; travelling south until it joins with the final stretch of the Peace Creek near the City of Bartow (Figure 1-4).

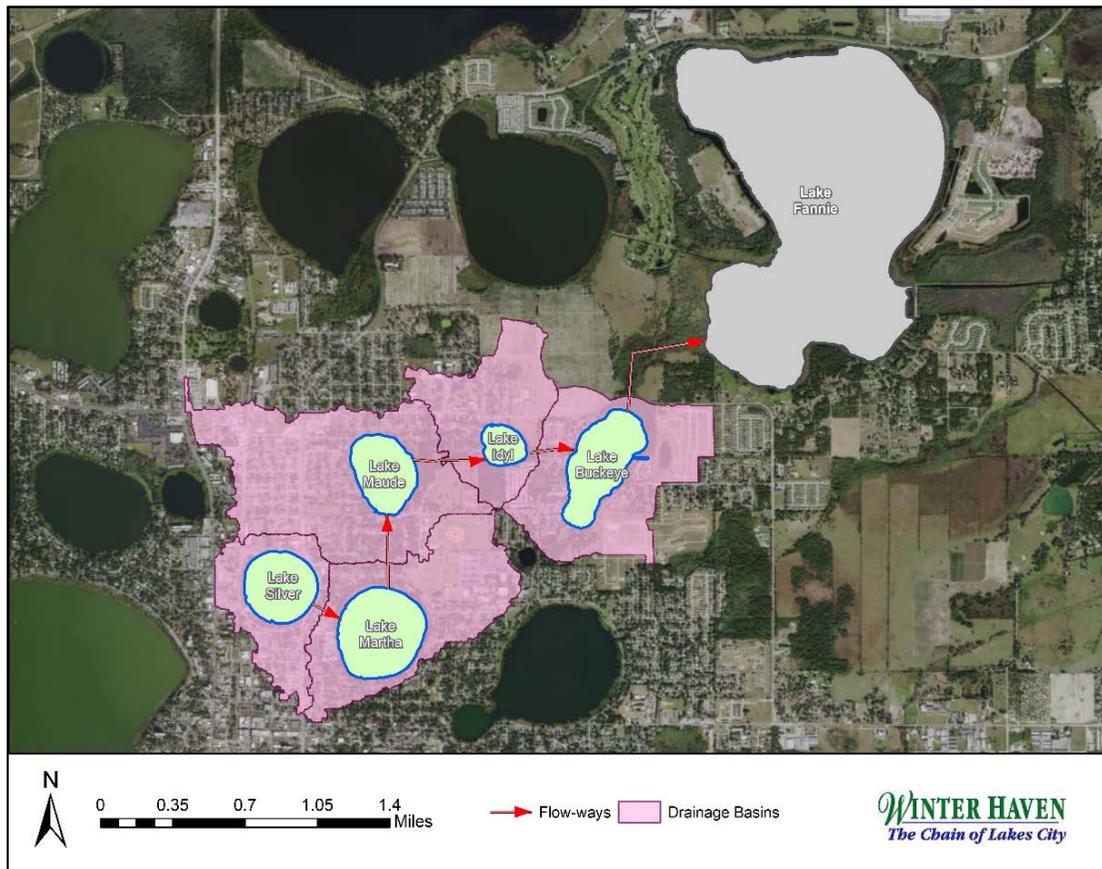
Figure 1-5. Map of North Central Lakes, Flow Pathways & Drainage Basins

Beginning in the heart of downtown Winter Haven, water flows from Lake Silver to Martha, Maude, Idyl, and Buckeye, respectively (Figure 1-5). The ditches and pipes that connect these lakes also act as passive water control structures maintained by the LRLMD. At the downstream end of this lake group, overflow from Lake Buckeye discharges north to Lake Fannie through a natural wetland area.

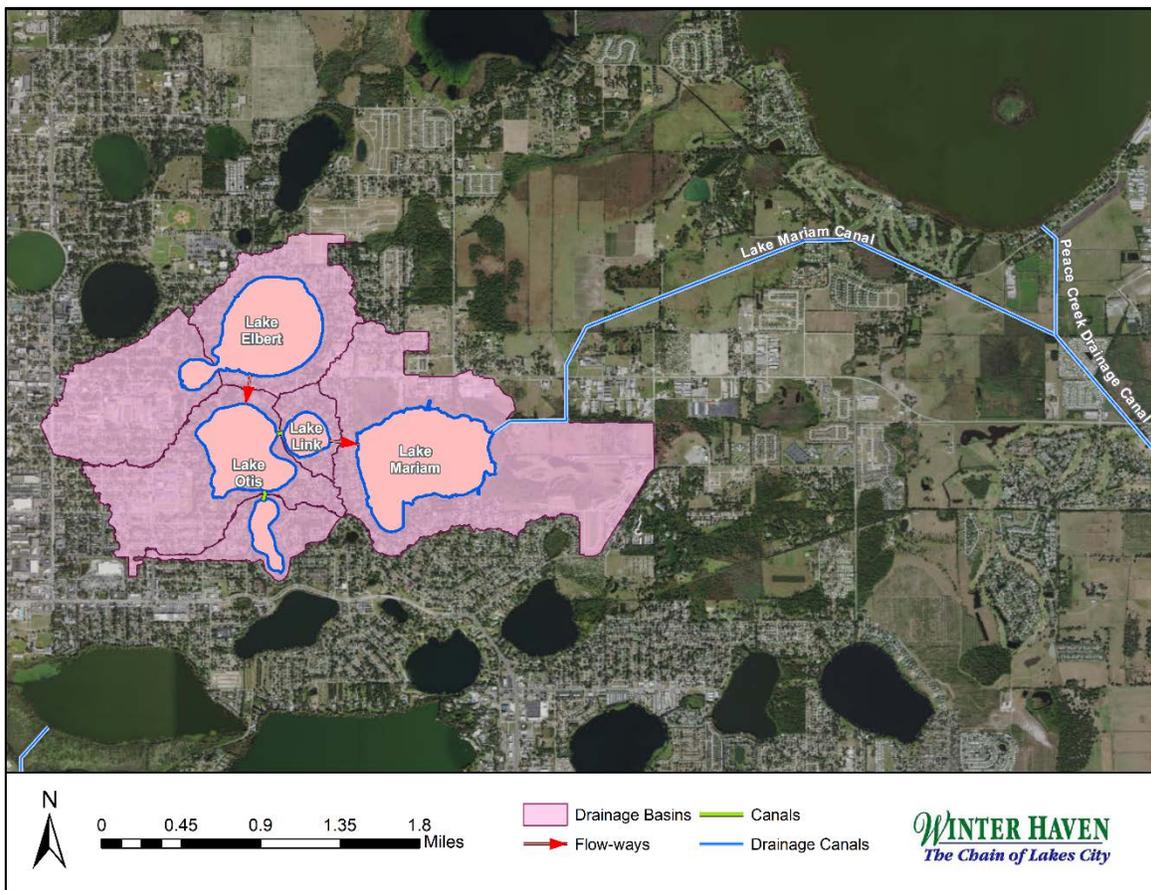
Figure 1-6. Map of South Central Lakes, Flow Pathways & Drainage Basins

Starting at Lake Elbert, water flows through an underground pipe to Lakes Otis and Link which are connected via a navigable canal. From Link, surface water is conveyed via another pipe to Lake Mariam which discharges to a small ditch that travels east until it meets with the Peace Creek Canal (Figure 1-6). Again, weirs control the maximum desired surface level of these lakes for the purposes of flood prevention and water conservation.

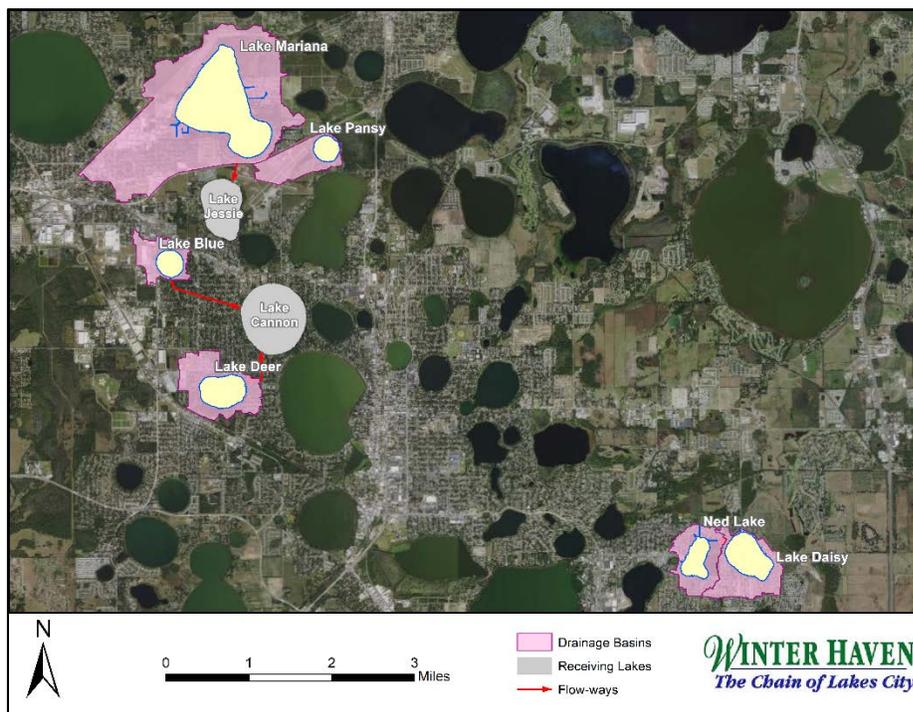
Figure 1-7. Map of Outlying Lakes, Flow Pathways & Drainage Basins

The lakes in this group are mostly separate systems that flow into other area waterbodies (Figure 1-7). Lakes Blue and Deer, located west of downtown Winter Haven, both discharge to the Southern Chain of Lakes (Lake Cannon) via underground stormwater pipes managed by Polk County. Located in the City of Auburndale, Lake Mariana was selected due to its contribution to the Southern Chain through a ditch and pipe system as well, which discharges into Lake Jessie. Lake Pansy doesn't appear to possess any man-made conveyances to other lakes. However, there is evidence to suggest that Lakes Pansy and Rochelle share a surface water connection via the wetland area between them. Because Pansy lacks a dedicated control structure, the surface level required for

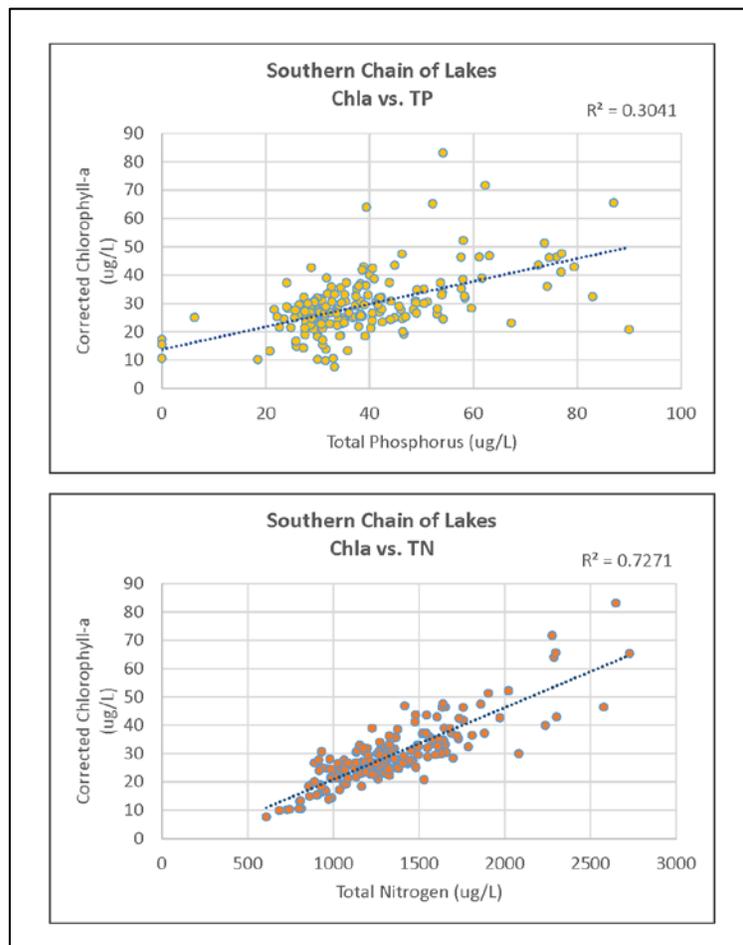
Figure 1-8. Linear Regression of Chlorophyll-a vs. Total Phosphorus & Total Nitrogen

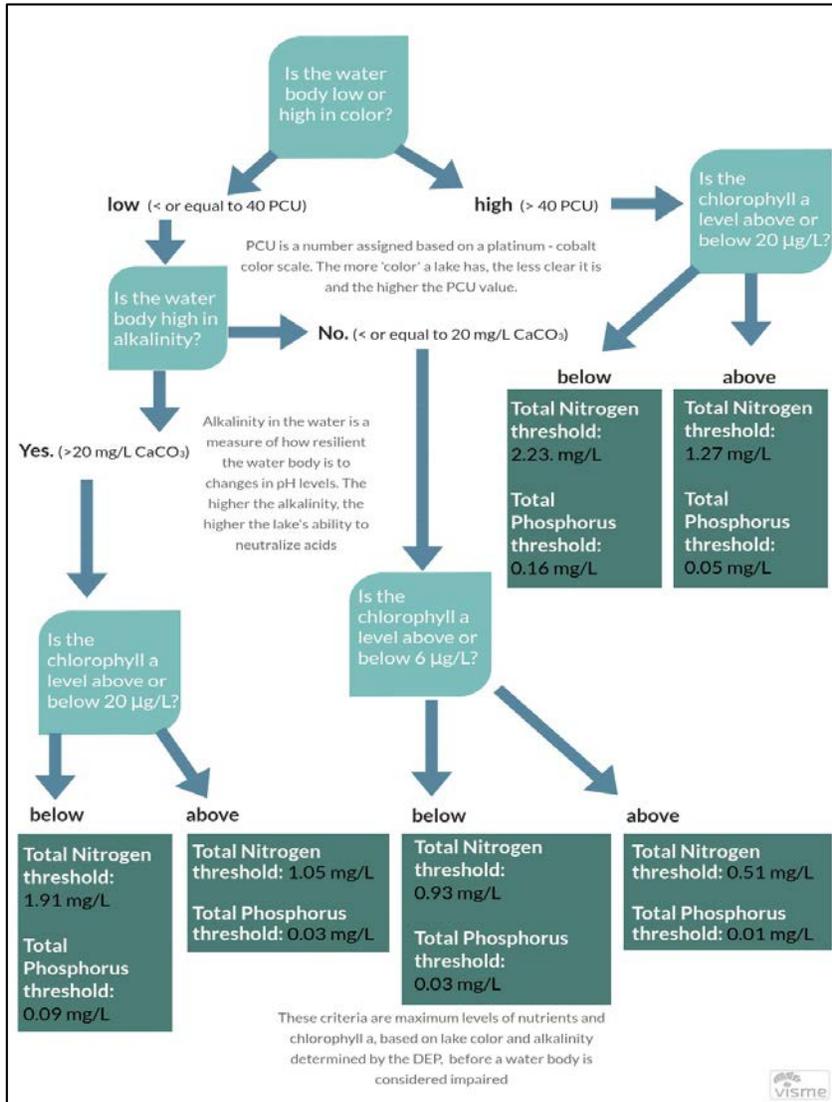
Figure 1-9. NNC Impairment Determination Flowchart

impairment limit for that year. If there is no Chla exceedance, AGM TN & TP concentrations are subject to the maximum limit. In order to assess long-term water quality trends, 7.5 years of AGM concentrations are evaluated. If the Chla, TN, or TP threshold is exceeded more than once in any consecutive 3 year period, then the waterbody is placed on the verified impaired list. By this process, a lake can be considered impaired for nutrients in response to exceedances by Chla, TN, and/or TP.

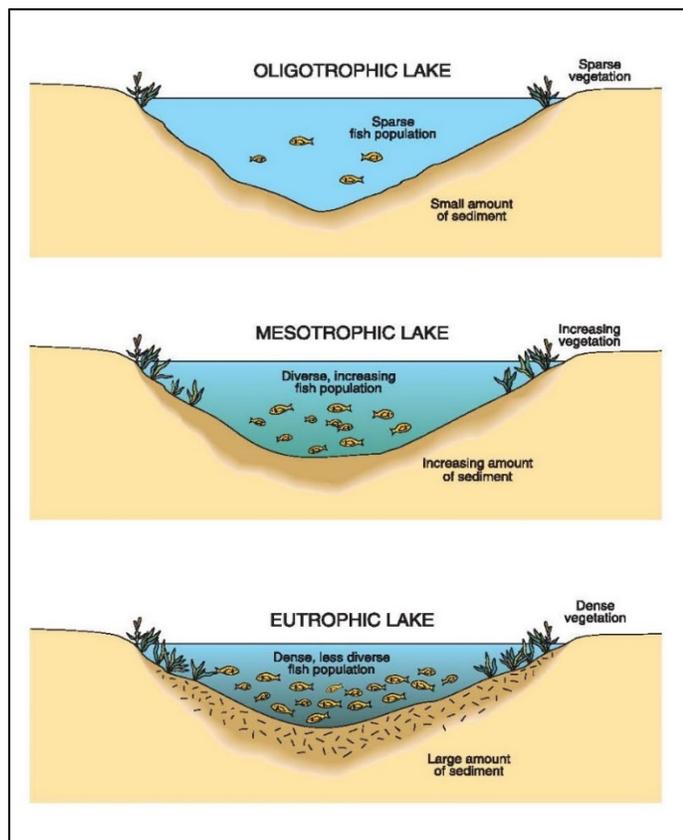
Figure 1-10. Diagram of Lake Trophic States [6].

Trophic state was mentioned previously as a concept describing a waterbody's level of primary productivity. Productivity is a term that relates to the amount of plants, algae, and wildlife a waterbody can support. Trophic status is broken down into several classes (Figure 1-10) [6]:

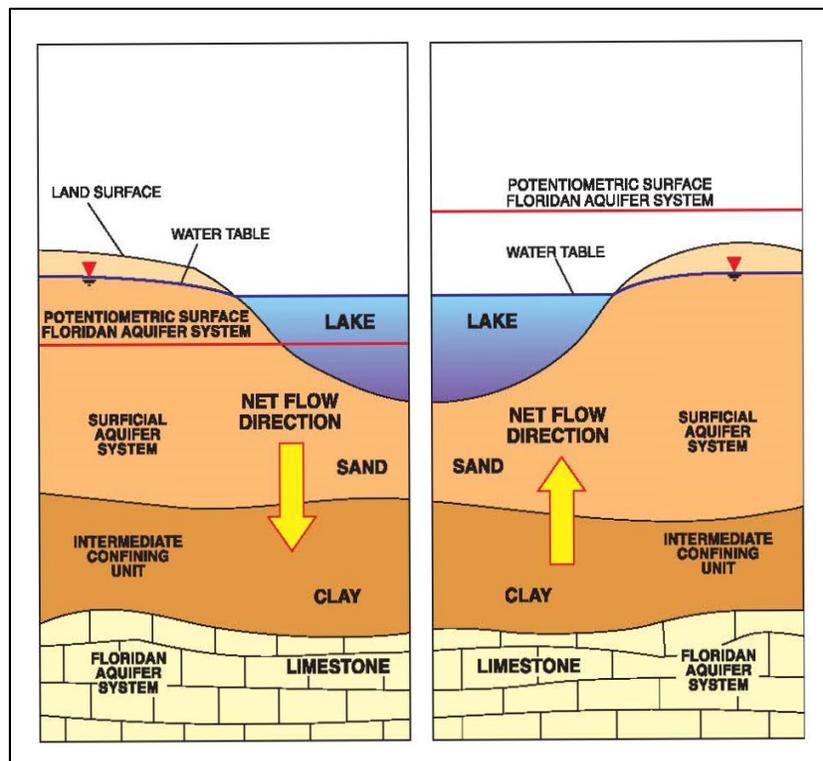
Figure 1-11. Diagram of Groundwater Interactions

The Upper Floridan Aquifer is the sole municipal water source for the City of Winter Haven. As one of the fastest growing metropolitan regions in the Country [10], the potential hydrologic impacts of water use must be considered not only for the ecological outlook of our lakes, but also for the future of our drinking water supply. The primary hydrologic strategies for this area include promoting rapid recharge of the Upper Floridan and the long-term storage, treatment, and slow infiltration of surface waters in areas where fast recharge isn't feasible.

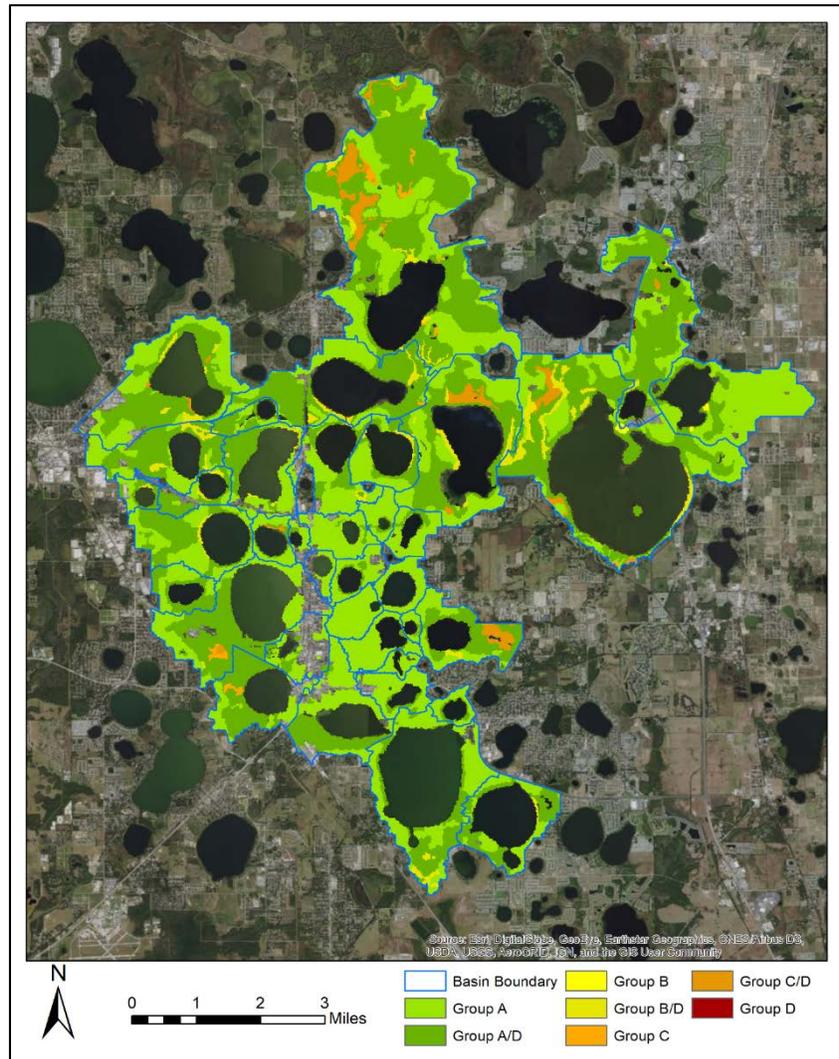
Figure 1-12. Hydrologic Soil Groups of the Winter Haven Lakes

The proportion of each soil group making up a given lake drainage basin can indicate the pre-development infiltration potential in that basin. This information can also be used to determine adequate locations for BMPs that promote groundwater recharge or treatment of stormwater. The majority of the Winter Haven area consists of Class A or A/D soils, however notice that the proportion of A/D soils increases further from the downtown area (Figure 1-12). It can be inferred that stormwater infiltration BMPs will be more effective in the City center with surface water storage/treatment being relegated to the less well-drained lower elevations at the periphery of the downtown area.

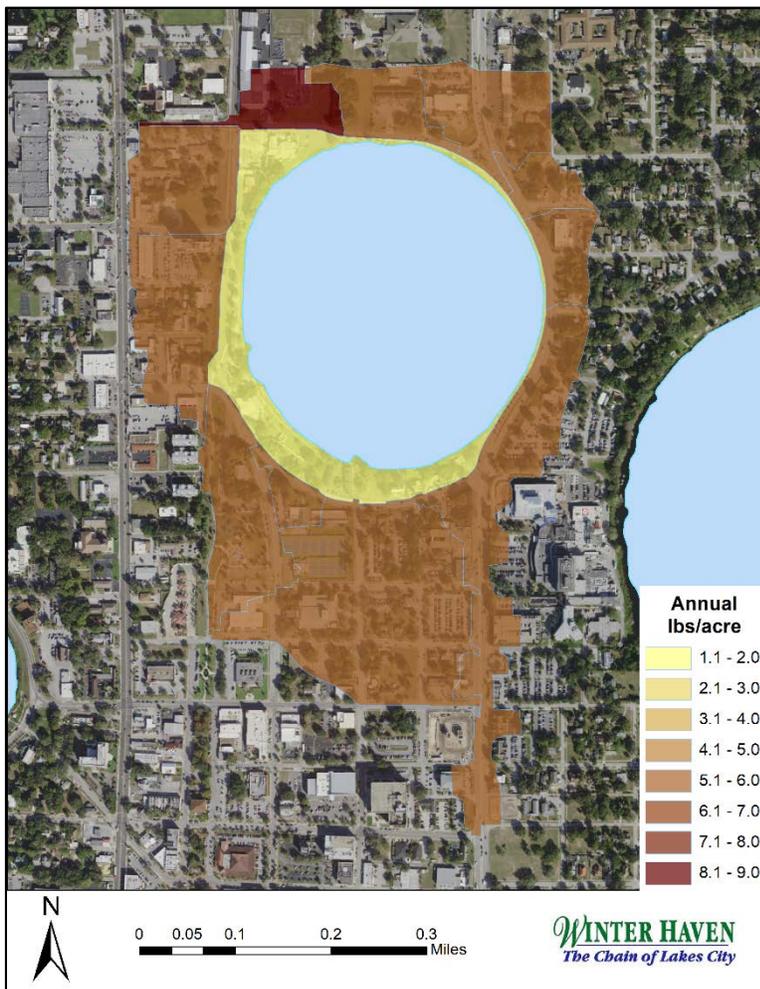
Figure 1-13. Annual Total Nitrogen Loads to Lake Silver in lbs/acre

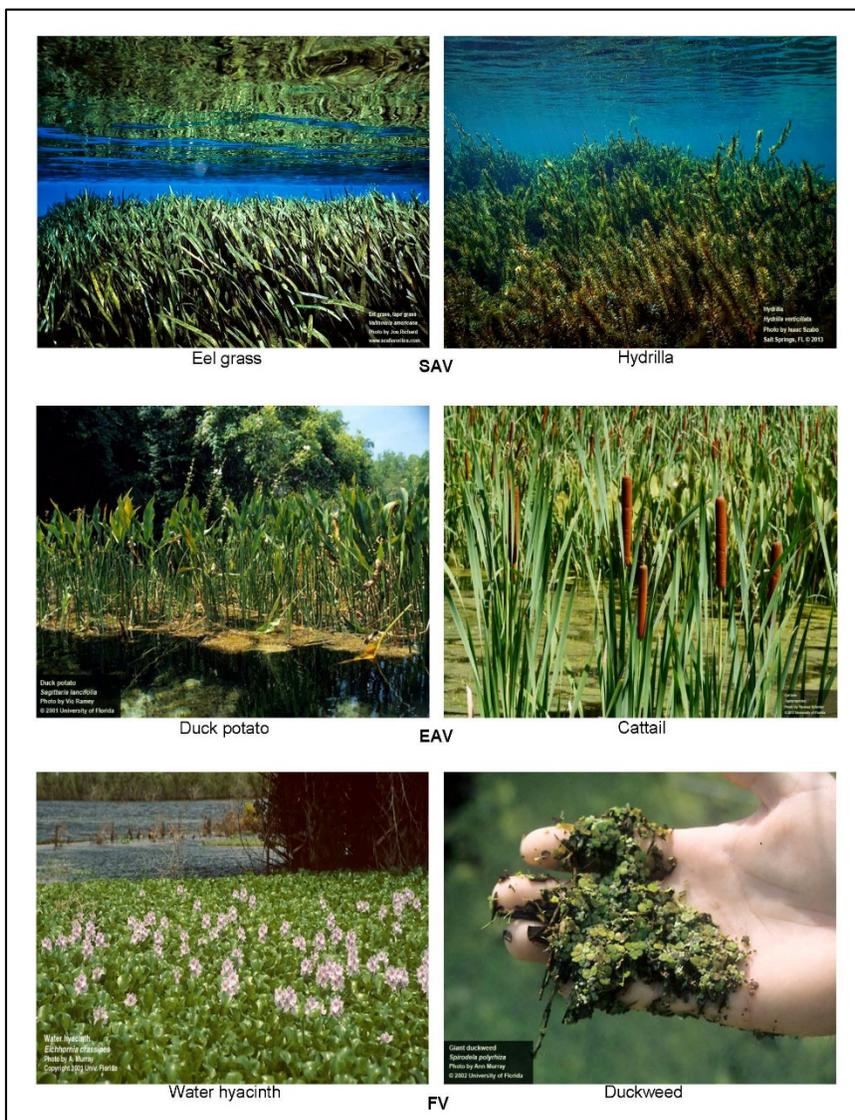
Figure 1-14. Examples of Aquatic Vegetation Categories

Of the different types of primary producers in aquatic environments, both microscopic algae and macrophytes (large aquatic plants) fill a similar ecological role as an oxygen-producing food source for primary consumers. A healthy balance of each is necessary for a functioning, diverse aquatic community. However, macrophytes provide additional ecological benefits such as their role as habitat for aquatic fauna. Based on their various fundamental growth strategies, aquatic macrophytes are separated into three categories: submerged aquatic vegetation (SAV), emergent aquatic vegetation (EAV), and free-floating vegetation (FV) (Figure 1-14).

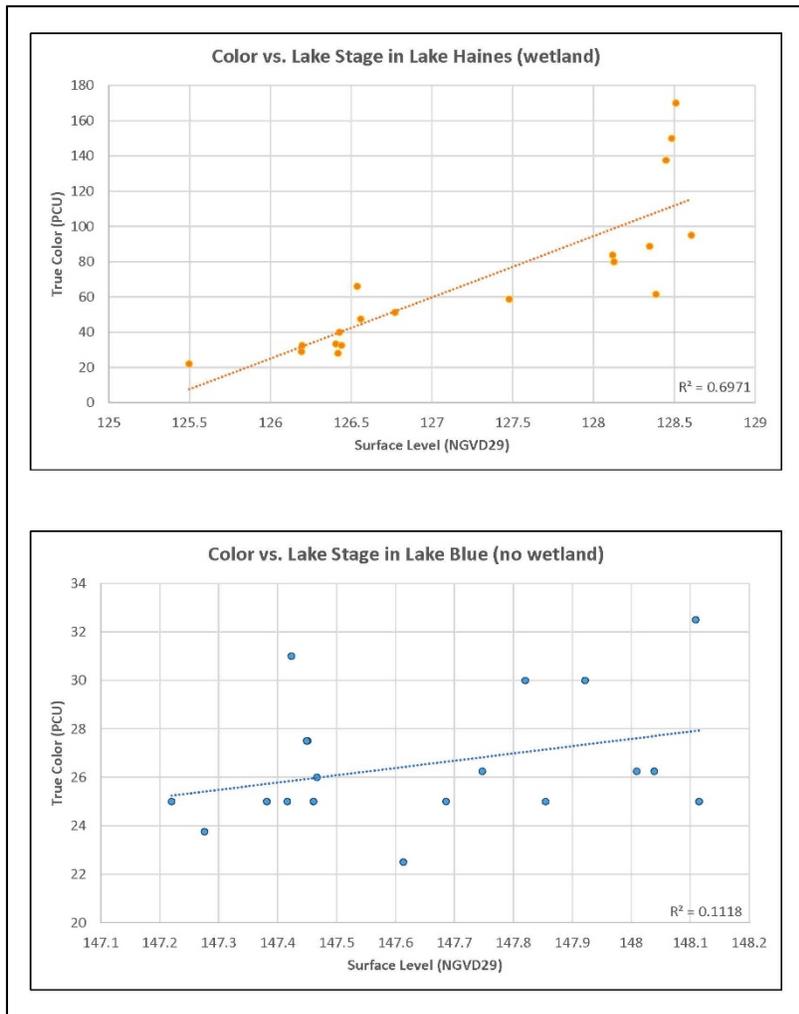
Figure 1-15. Correlation between Wetlands and True Color in Lake Haines & Lake Blue

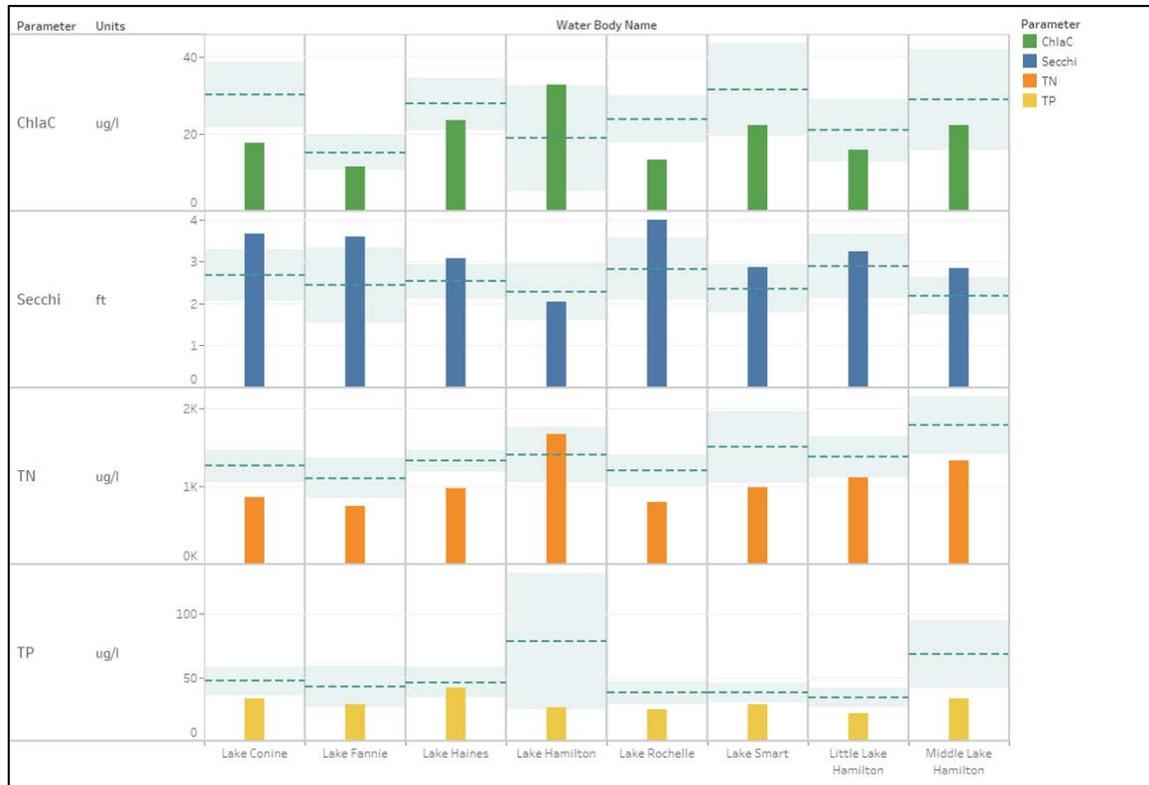
Figure 2-1. 2019 AGM Chla, TN, TP, & Secchi depth values for the North Chain of Lakes; dotted line represents long-term mean and the shaded area refers to the standard deviation range.

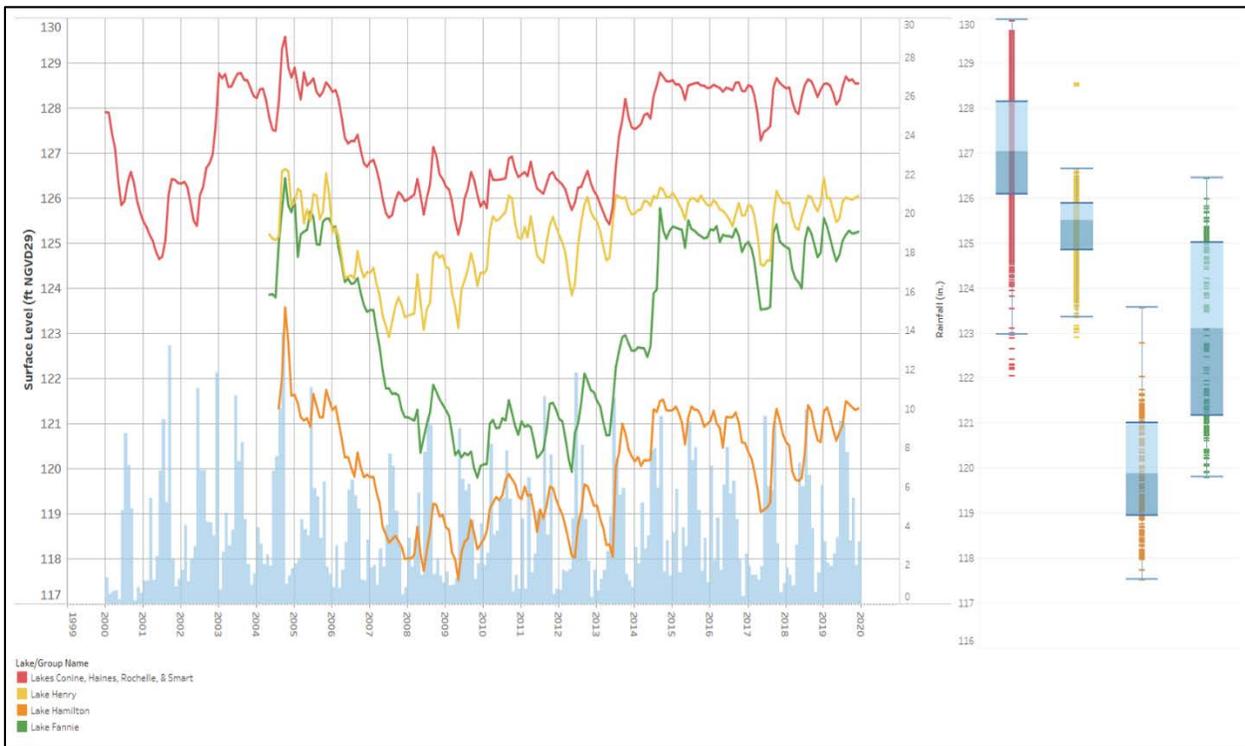
Figure 2-2. North Chain of Lakes hydrograph with box & whisker plots detailing long-term surface level variability. Annual rainfall totals indicate hydrologic response to precipitation.

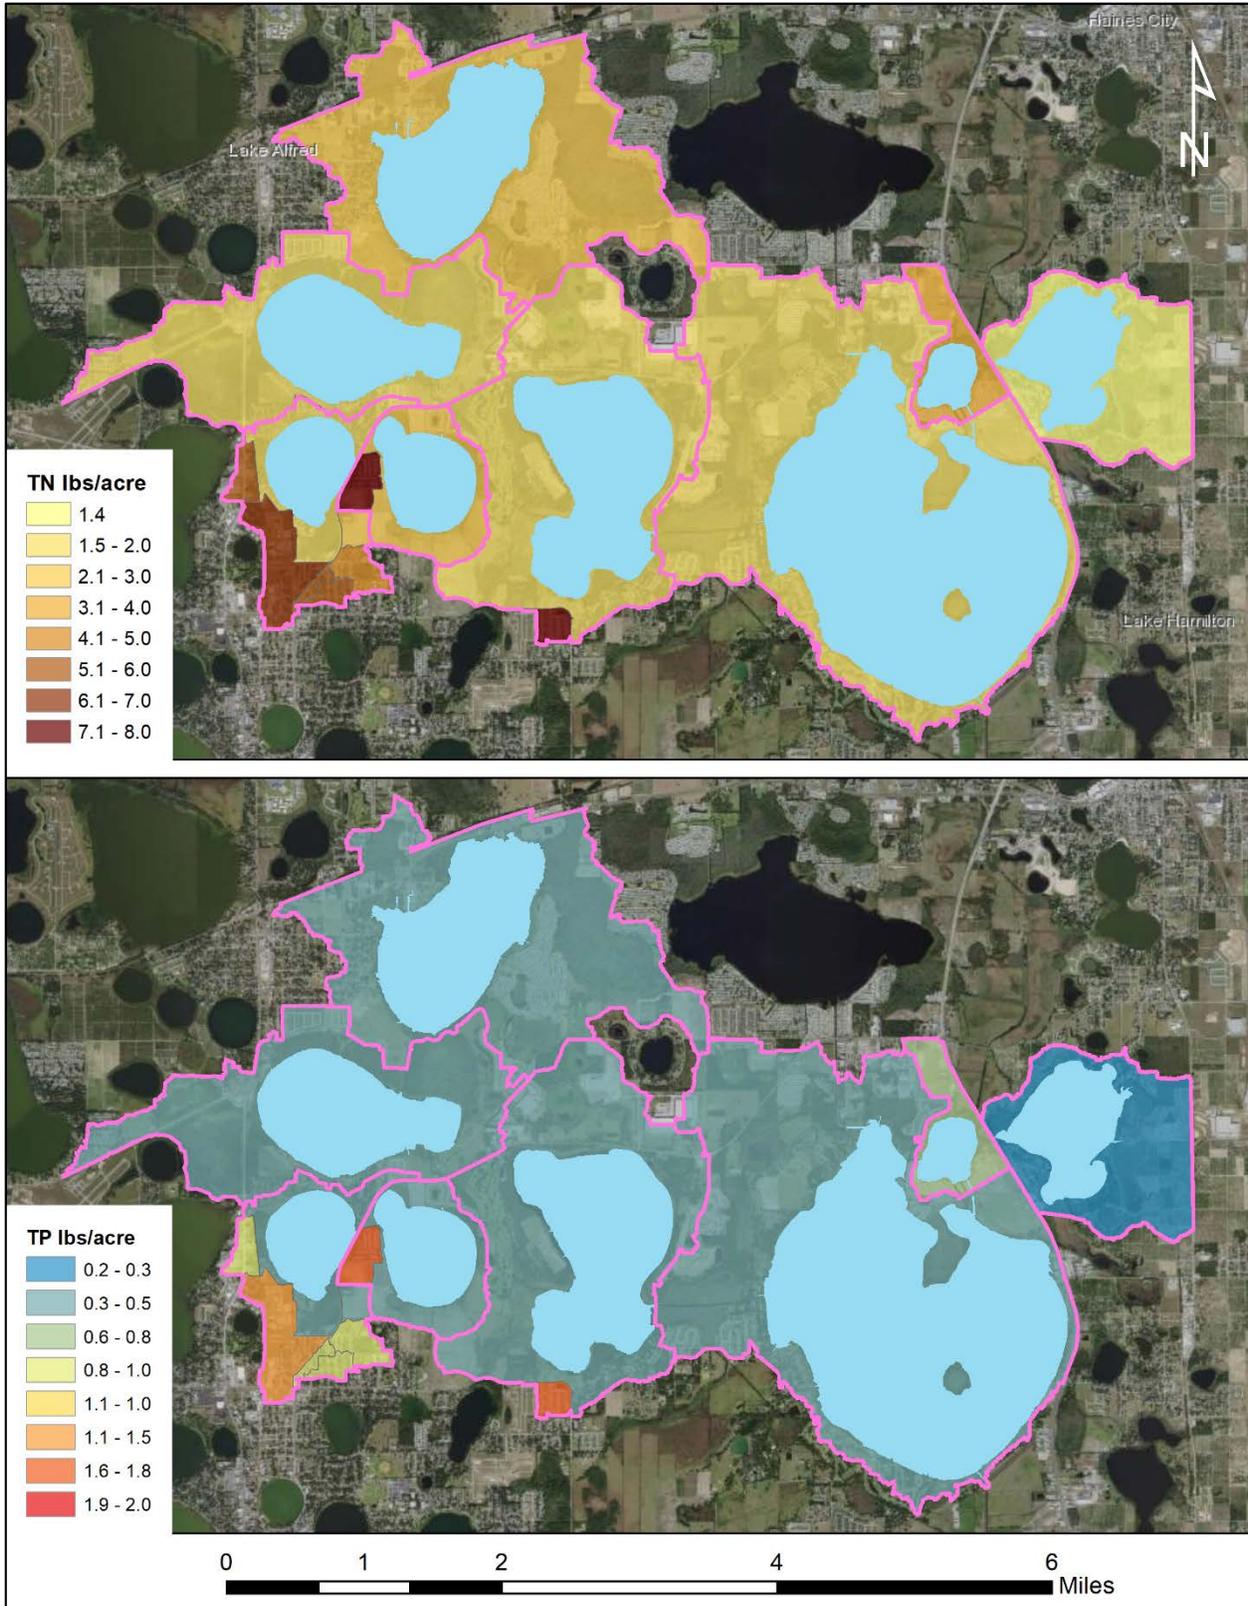
Figure 2-3. Areal TN & TP Loading for individual drainage basins in the North Chain of Lakes.

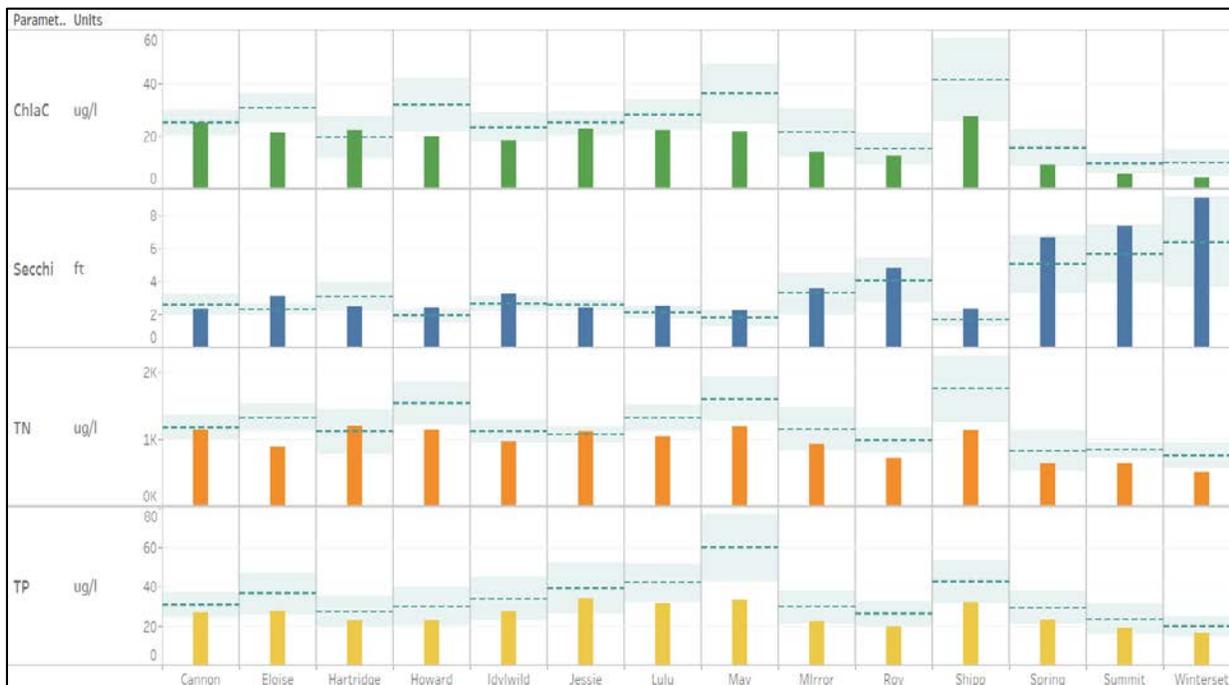
Figure 2-8. 2019 AGM Chla, TN, TP, & Secchi depth values for the South Chain of Lakes; dotted lines represent long-term mean and the shaded areas refer to the standard deviation range.

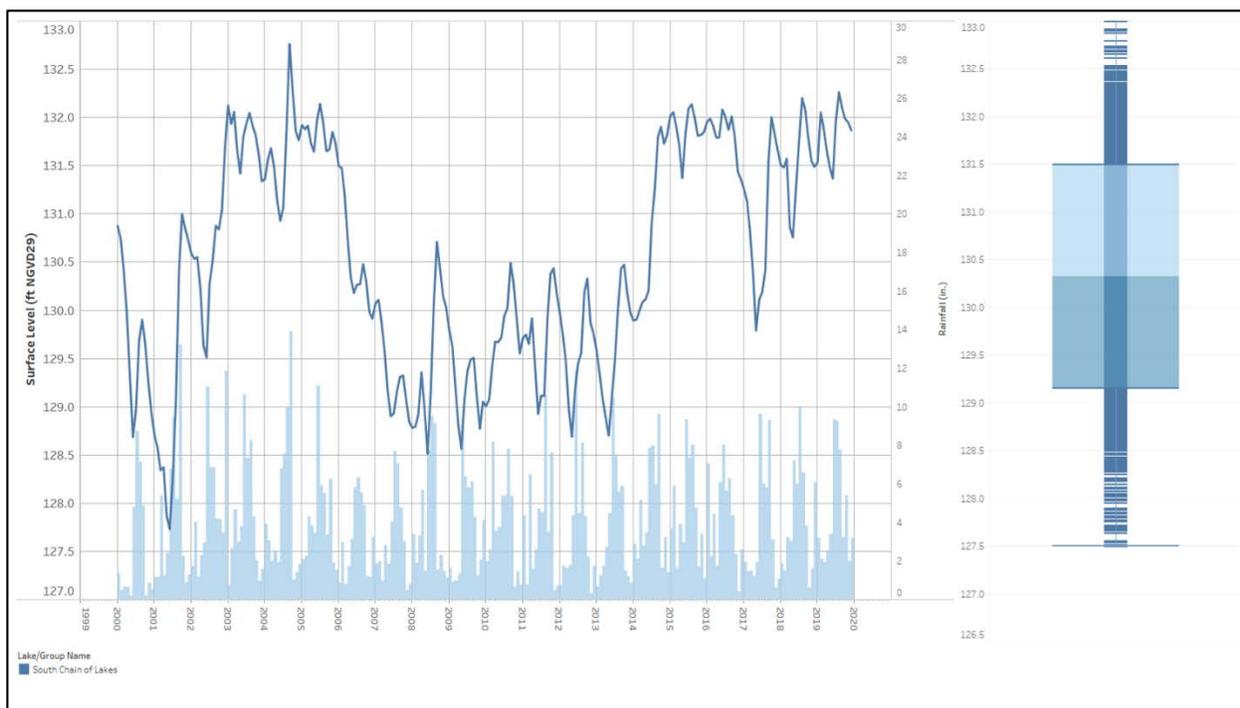
Figure 2-9. South Chain of Lakes hydrograph with box & whisker plots detailing long-term surface level variability. Annual rainfall totals indicate hydrologic response to precipitation.

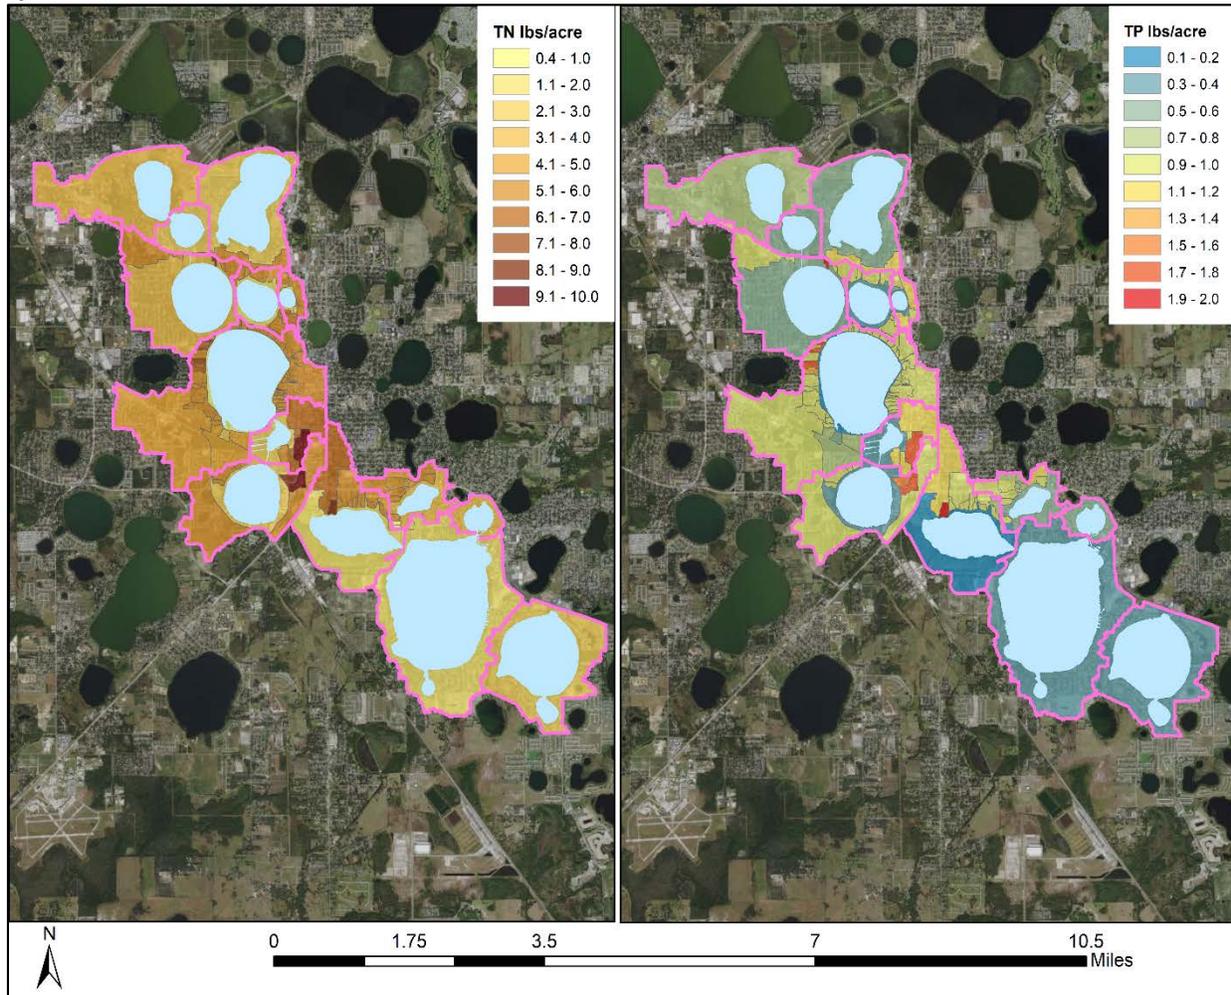
Figure 2-10. Areal TN & TP Loading for individual drainage basins in the South Chain of Lakes.

At first glance, the lowest areal TN and TP loads are located in the drainage basins of the peripheral lakes listed above (Figure 2-10). These basins primarily consist of low-medium density residential and open lands with moderate to high soil infiltration rates and the inclusion of stormwater BMPs in the form of retention/detention ponds. With a few exceptions, some of the highest loading rates are present in Lulu, May, and Shipp basins. These areas have a greater proportion of commercial and industrial land uses as well as a greater percentage of impervious surfaces—leading to increased runoff volume and pollutant concentrations. The previously mentioned exception are the basins located in older residential areas around Lakes Howard, Cannon, Mirror, and Spring. These neighborhoods were constructed prior to regulations mandating on-site stormwater

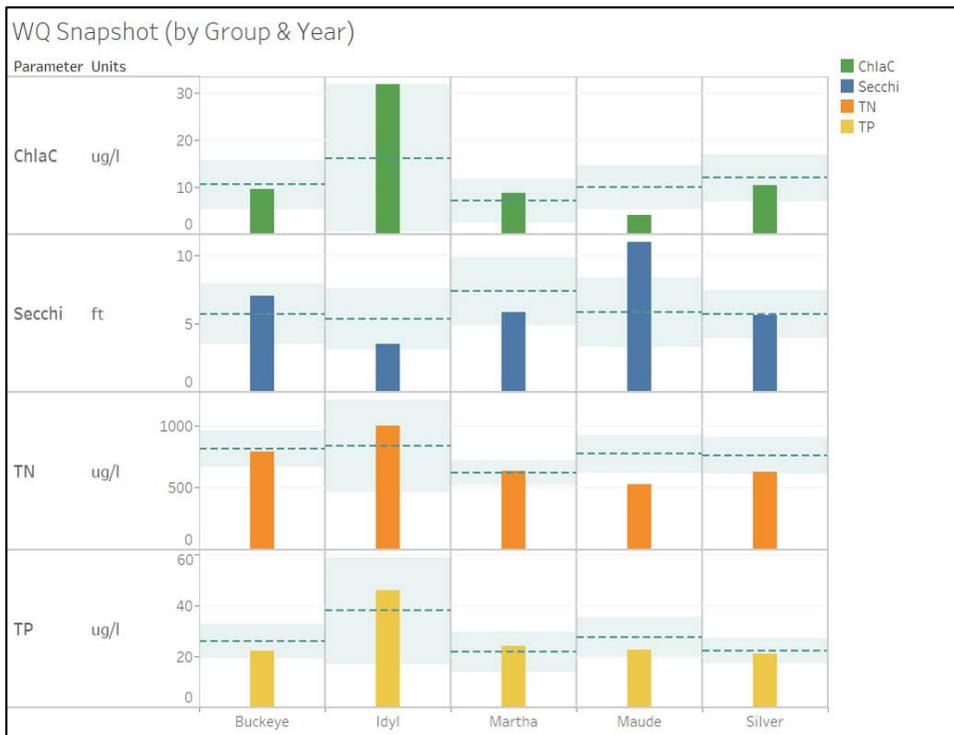
Figure 2-15. 2019 AGM Chla, TN, TP, & Secchi depth values for the North Central Lakes; dotted lines represent long-term mean and the shaded areas refer to the standard deviation range.

2019 AGM Chla, TN, TP, and Secchi depth values with each lake's long-term average and normal range (+/- 1 standard deviation) are used to compare current water quality conditions with historic values. Based on this comparison, it can be observed that Lakes Buckeye, Maude, and Silver are currently experiencing at or
