*W***INTER HAVEN**  
*The Chain of Lakes City*

# Annual Lakes Report

Presented by the Lakes Advisory  
Committee

CITY OF WINTER HAVEN  
Public Works Department  
Natural Resources Division

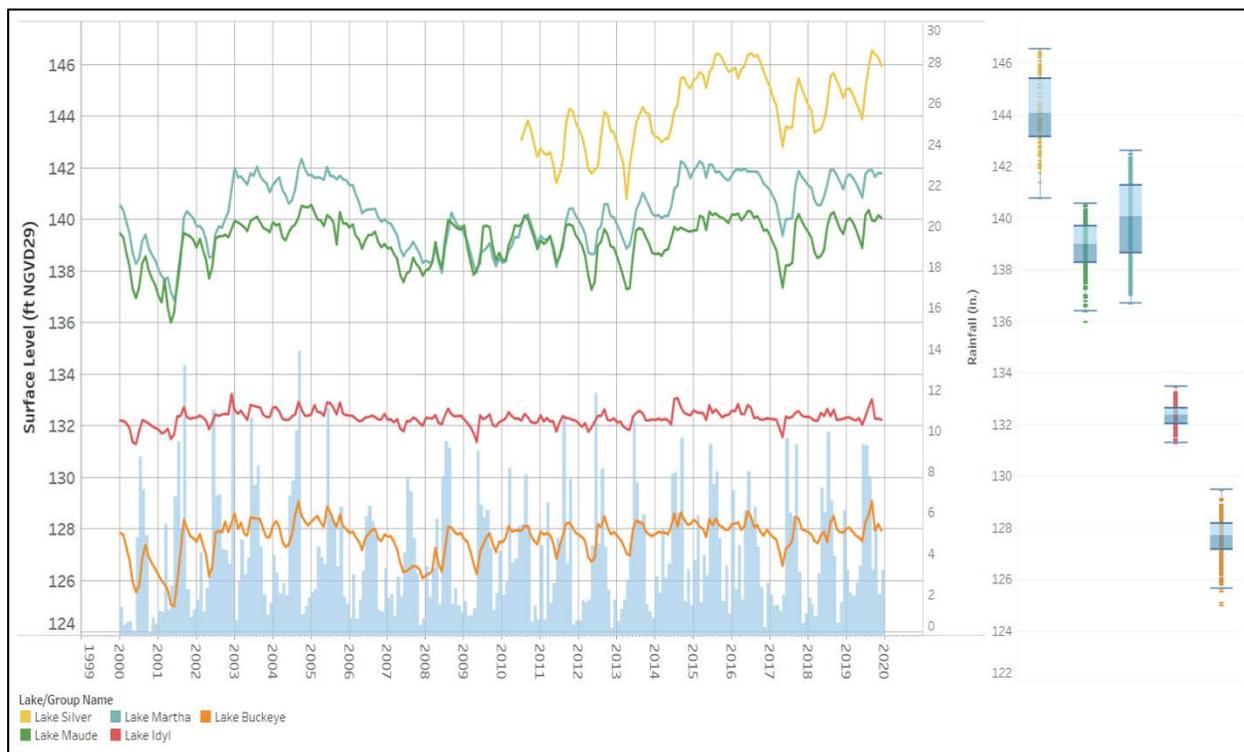
Figure 2-16. North Central Lakes hydrographs with box & whisker plots detailing long-term surface level variability. Annual rainfall totals indicate hydrologic response to precipitation.

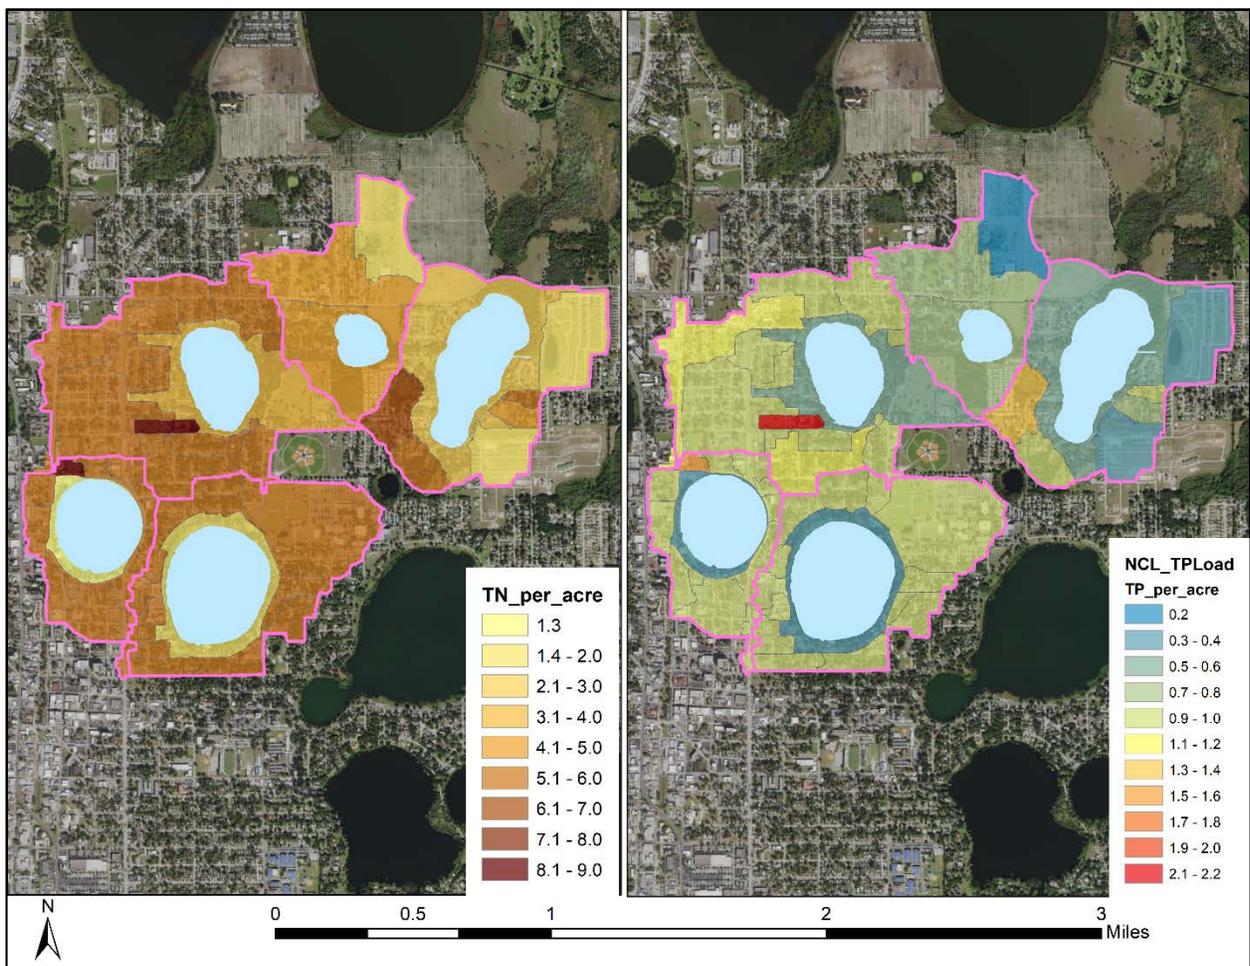
Figure 2-17. Areal TN & TP Loading for individual drainage basins in the North Central Lakes.

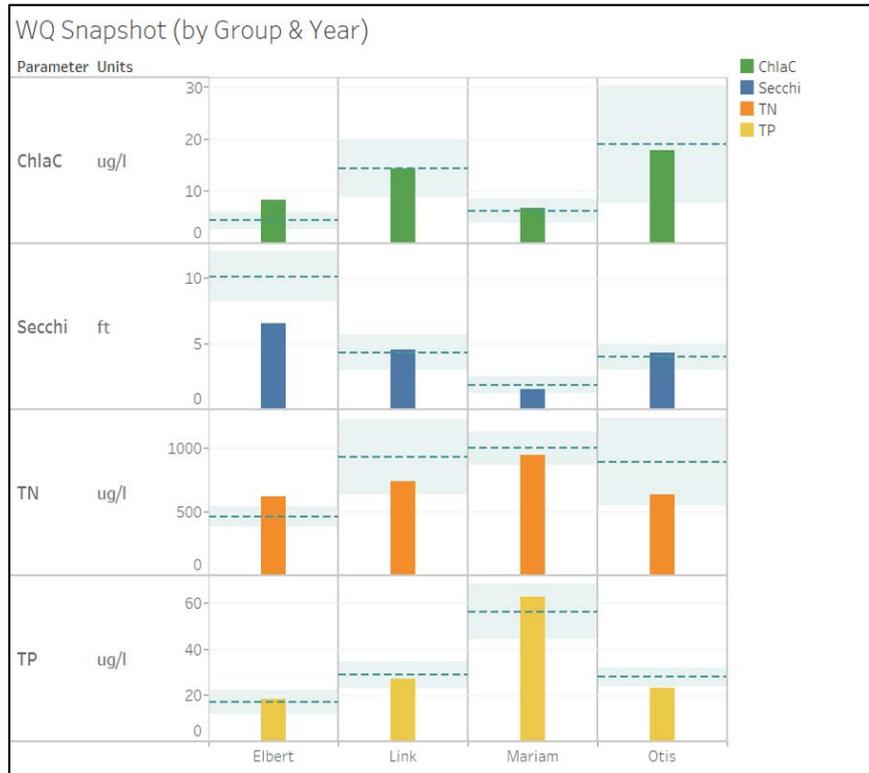
Figure 2-22. 2019 AGM Chla, TN, TP, & Secchi depth values for the South Central Lakes; dotted lines represent long-term mean and the shaded areas refer to the standard deviation range.

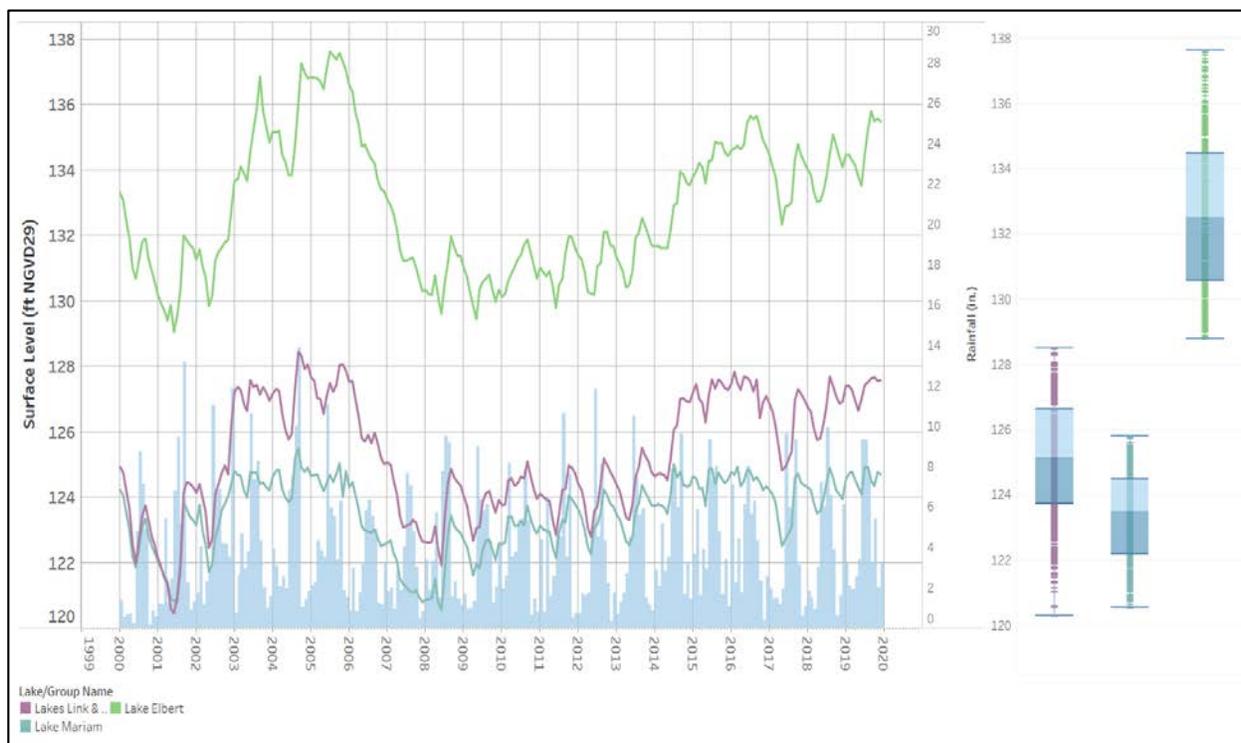
Figure 2-23. South Central Lakes hydrographs with box & whisker plots detailing long-term surface level variability. Monthly rainfall totals indicate hydrologic response to precipitation.

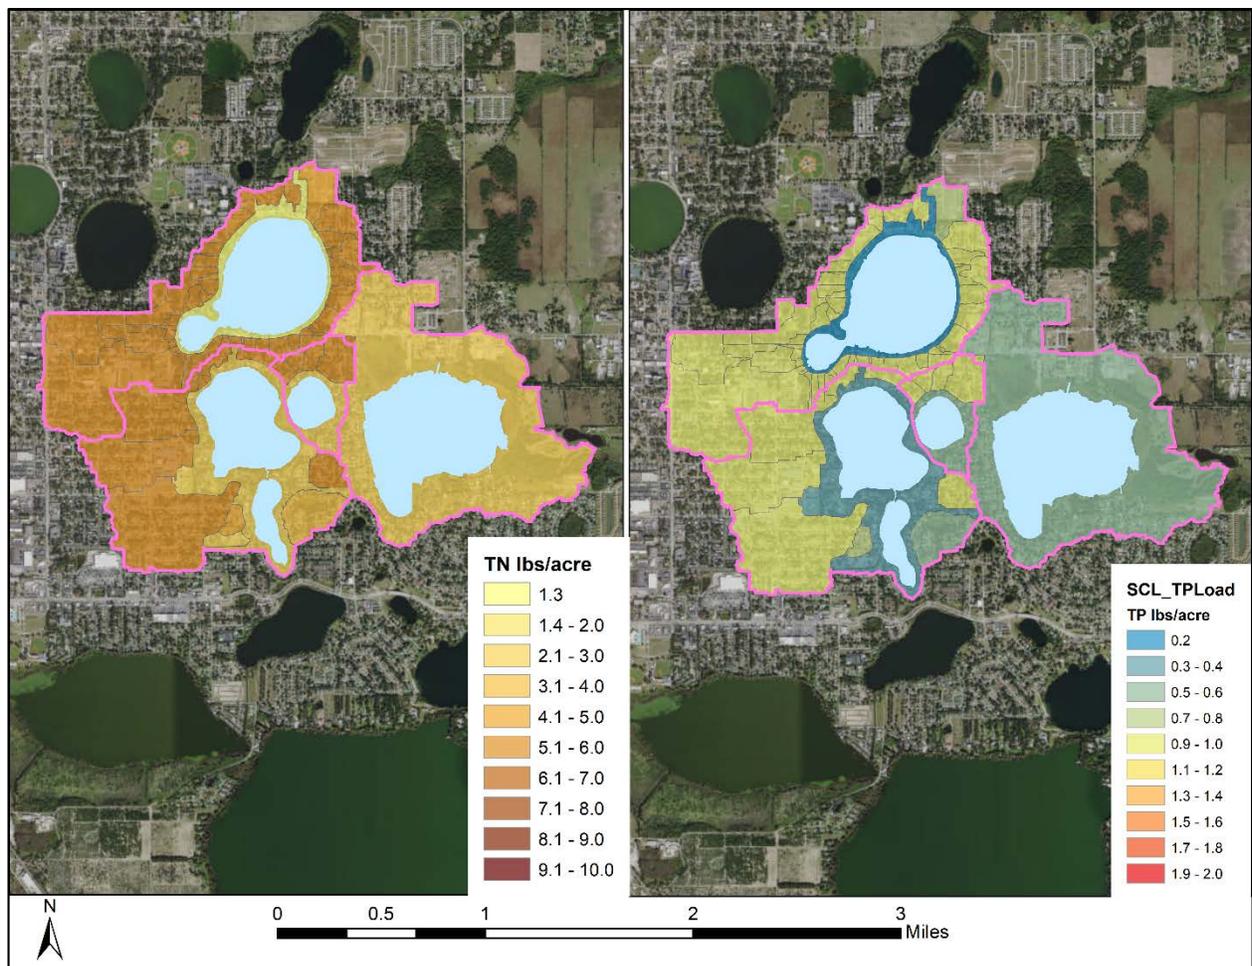
Figure 2-24. Areal TN & TP Loading for individual drainage basins in the South Central Lakes.

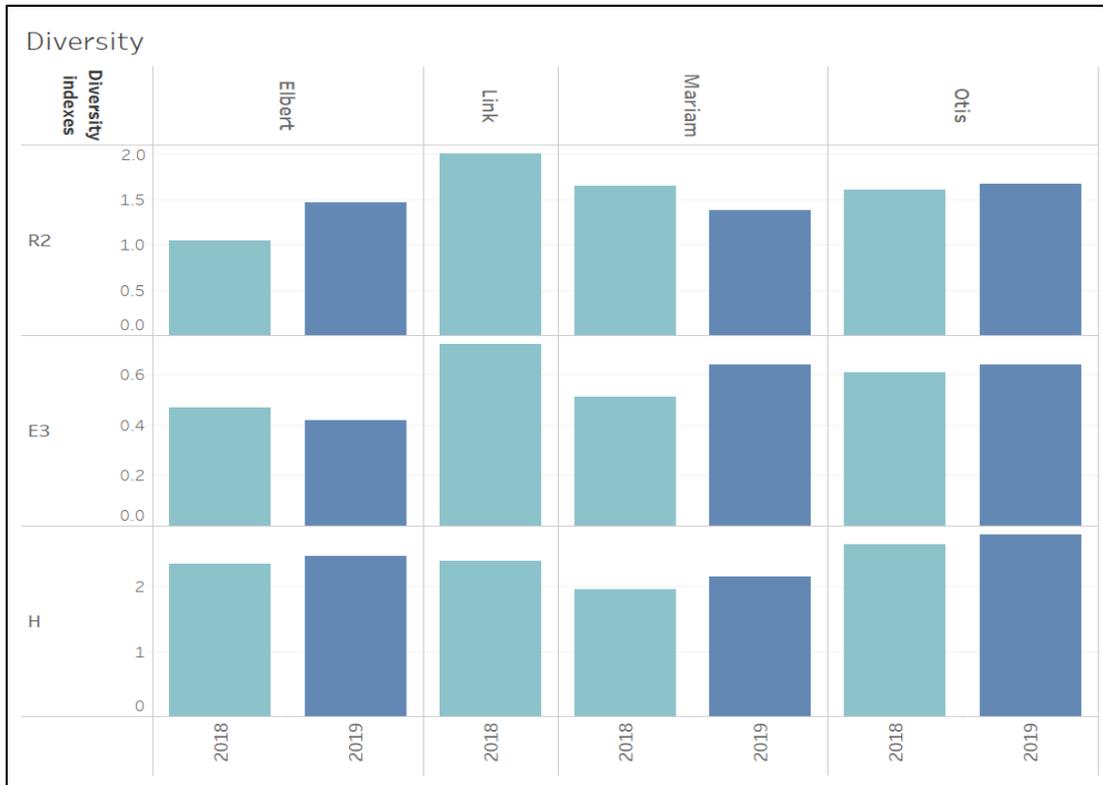
**Hill’s Evenness #3 (E3):** An increase in species evenness is preferred as it correlates to improvement in community resilience. Lakes Mariam and Otis showed increasing values, with Lake Elbert decreasing in evenness in 2019.

**Shannon’s Diversity (H):** As a combination of species richness and evenness, Shannon’s index indicates the overall species diversity for each site. Lakes Elbert, Mariam, and Otis exhibited an increase in Shannon’s diversity from 2018 to 2019.

Figure 2-28. South Central Lakes annual index values for species richness, evenness, and diversity.

Through analysis of the vegetation data for this lake group, a few things can be concluded. First, focus should be placed on management of Lake Mariam’s biological community since it lacks vegetation abundance and an SAV presence. Based on observations while sampling, the primary sediment type in Mariam is organic muck which is not the best benthic habitat to support most native aquatic plants. Therefore, alternative solutions may be necessary to provide nutrient uptake—floating wetlands is one such novel solution that the City has used to treat urban stormwater ponds.

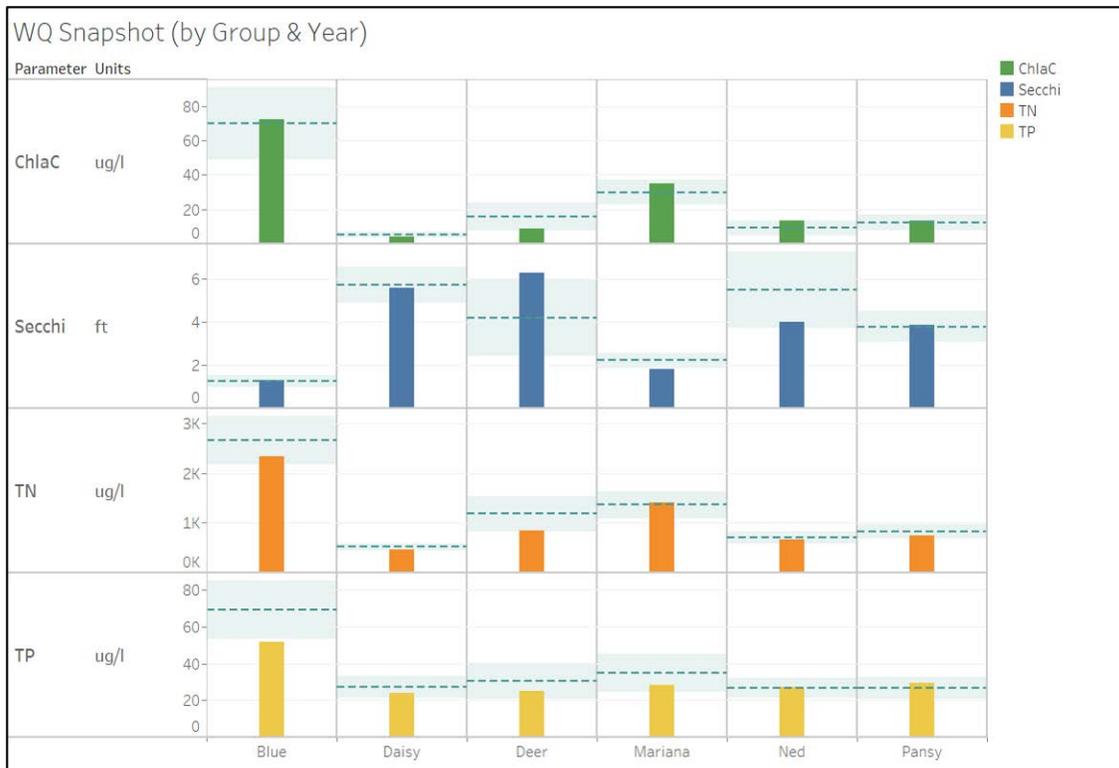
Figure 2-29. 2019 AGM Chla, TN, TP, & Secchi depth values for the Outlying Lakes; dotted lines represent long-term mean and the shaded areas refer to the standard deviation range.

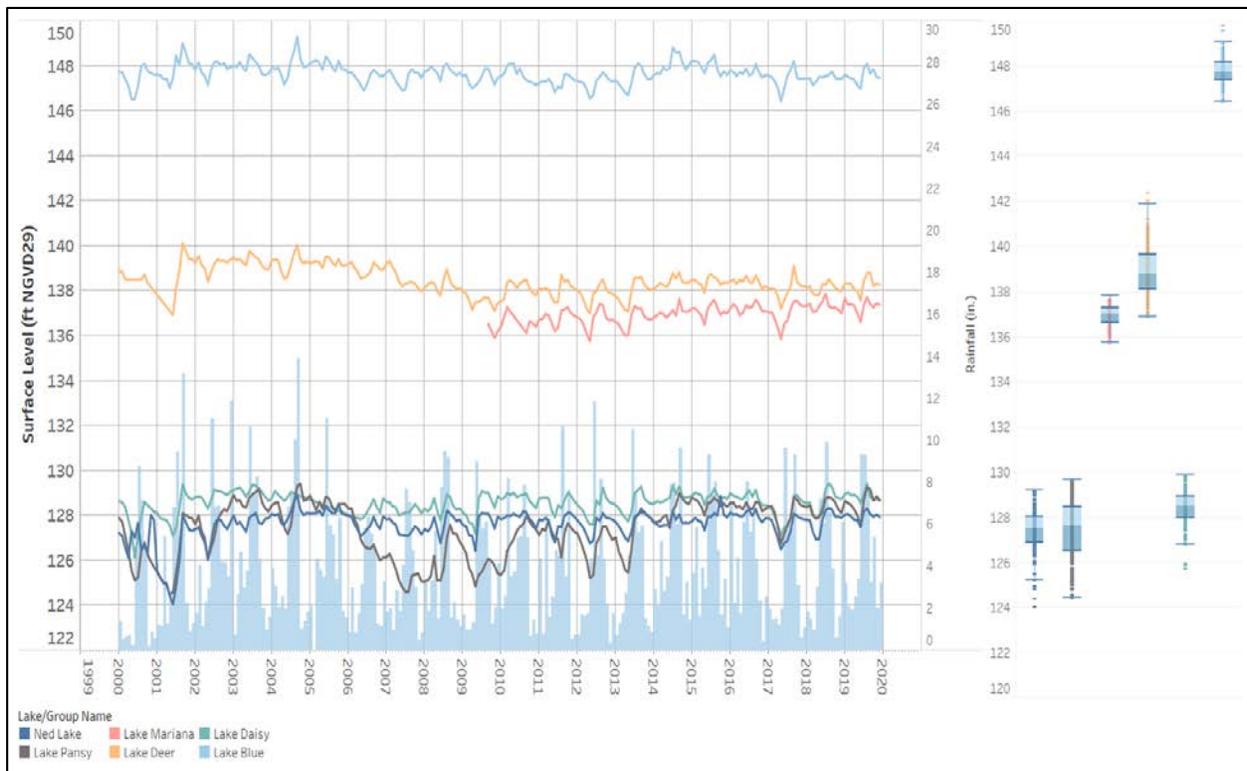
Figure 2-30. Outlying Lakes hydrographs with box & whisker plots detailing long-term surface level variability. Monthly rainfall totals indicate hydrologic response to precipitation.

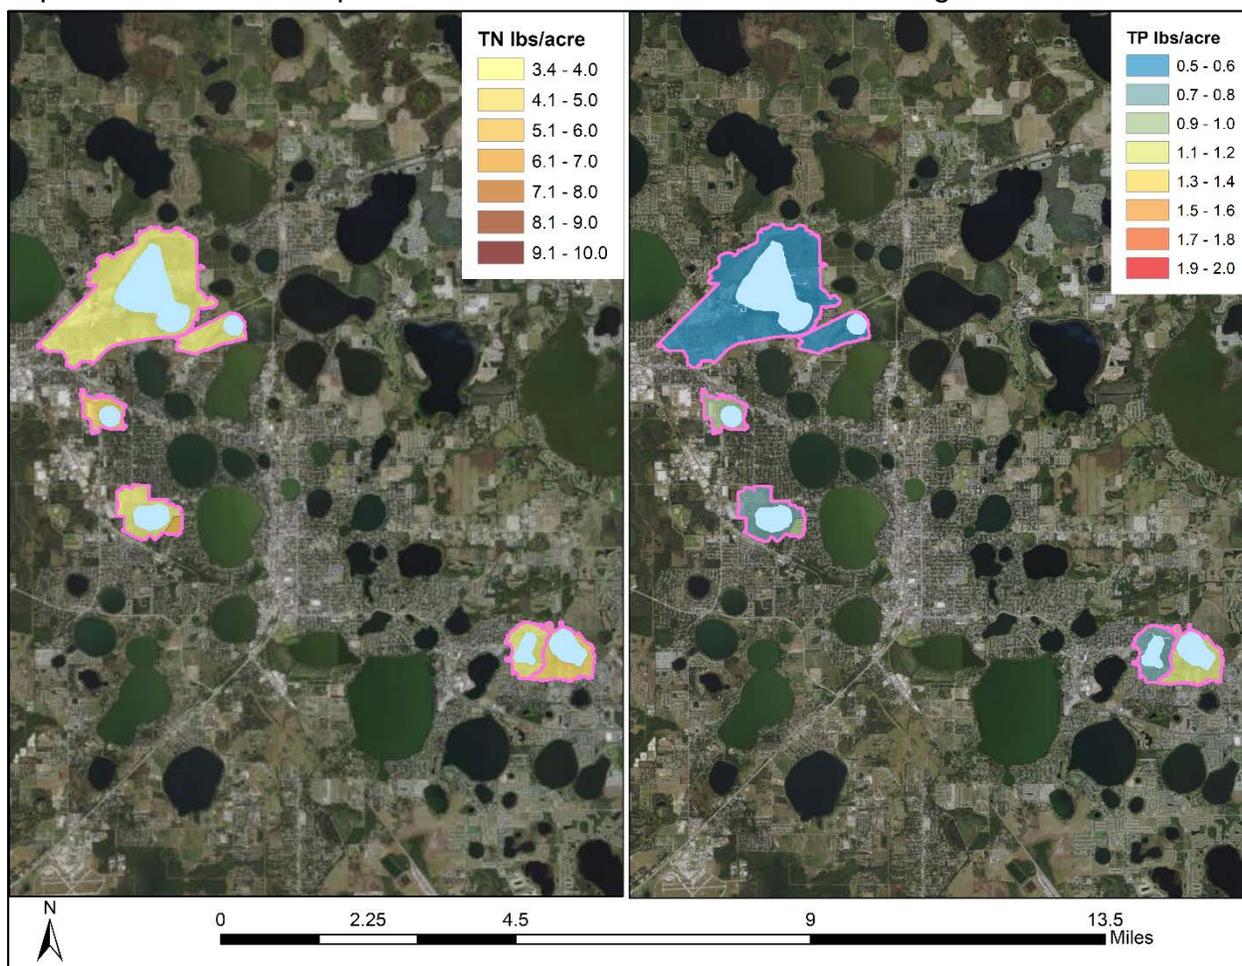
Figure 2-31. Areal TN & TP Loading for individual drainage basins in the Outlying Lakes.

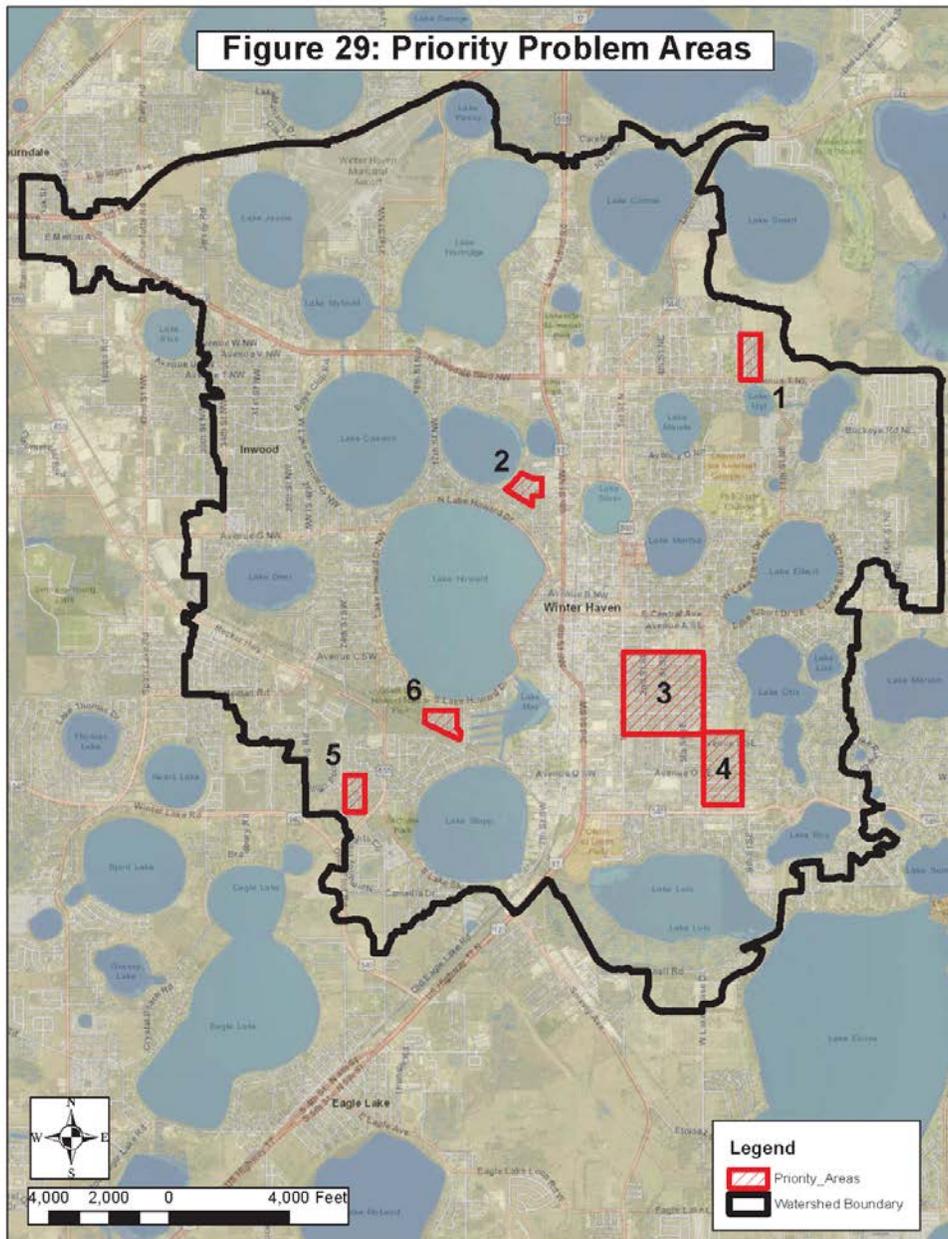
Figure 3-1. Priority sites indicated by increased flooding and pollutant load potential as determined by the Winter Haven SAIP.

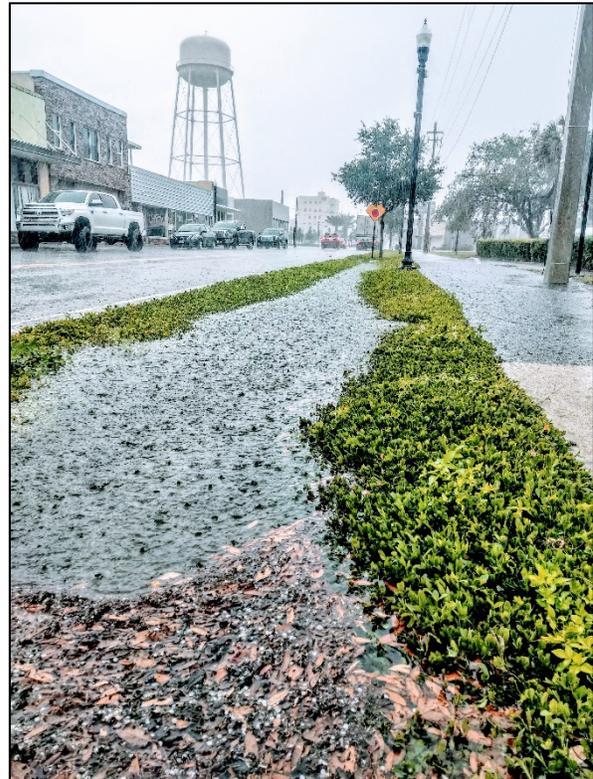
Figure 3-3. Photo of a raingarden capturing runoff and road debris in downtown Winter Haven.

Low impact development (LID) and green infrastructure are terms referring to practices that incorporate natural processes in the development of stormwater systems. Traditional, or “gray”, stormwater infrastructure relies on impervious materials, gutters, and pipes to transfer runoff from one area to another. Typically, these systems are implemented in urban areas to prevent flooding by directing stormwater to a nearby catchment or basin. In the Winter Haven area, gray infrastructure diverts runoff, as well as any pollutants, directly to lakes or stormwater ponds. In contrast, green infrastructure and LIDs utilize plants and soil characteristics to promote stormwater treatment and groundwater infiltration; resulting in cleaner and/or less runoff entering local waterbodies. Examples of green infrastructure and LIDs include raingardens, bioswales, pervious pavement, and exfiltration structures (French drains). Figure 3-3 displays one of several raingardens located within downtown Winter Haven.

Currently the City has constructed over 60 raingardens and exfiltration systems in and around Winter Haven’s urban center. Lakes receiving stormwater benefits from these systems include: Lakes Elbert, Howard, Martha, Maude, May, Otis, Roy, and Silver. Nutrient removal capabilities are minimal on an individual basis, however LIDs can collectively have a greater impact in larger numbers as more stormwater is treated. Moreover, relatively low construction costs in addition to the aforementioned benefits

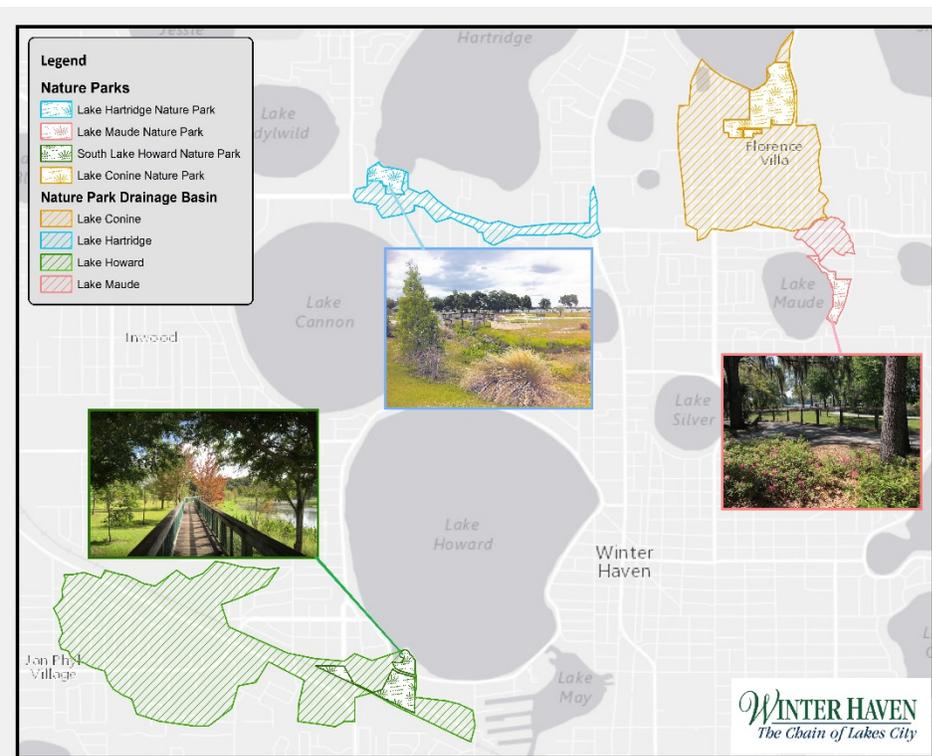
Figure 3-4. Map depicting the Winter Haven nature parks and their drainage basins. Also included is the proposed location of the Lake Conine Nature Park.

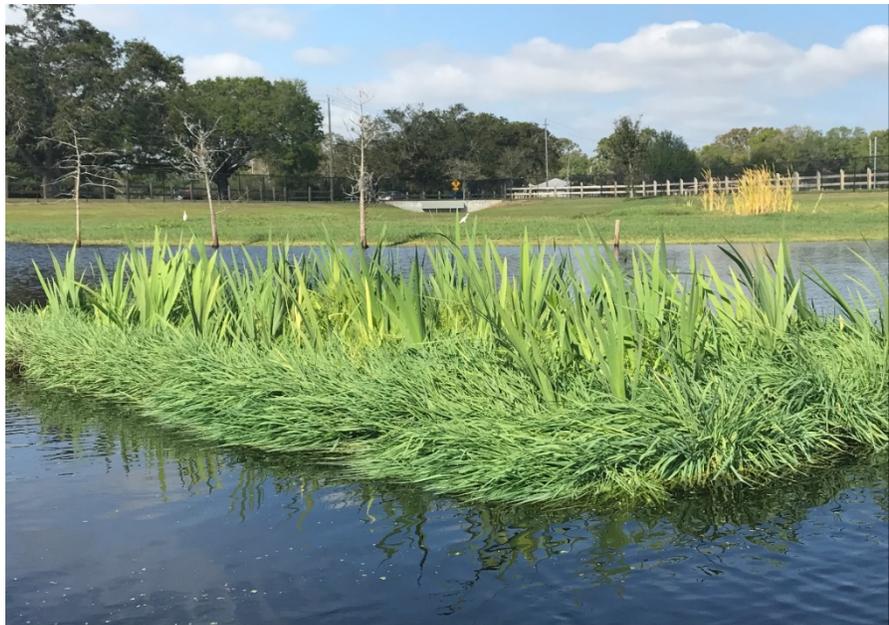
Figure 3-5. Photo of Floating Treatment Wetland installed at Polk State College recreational complex.

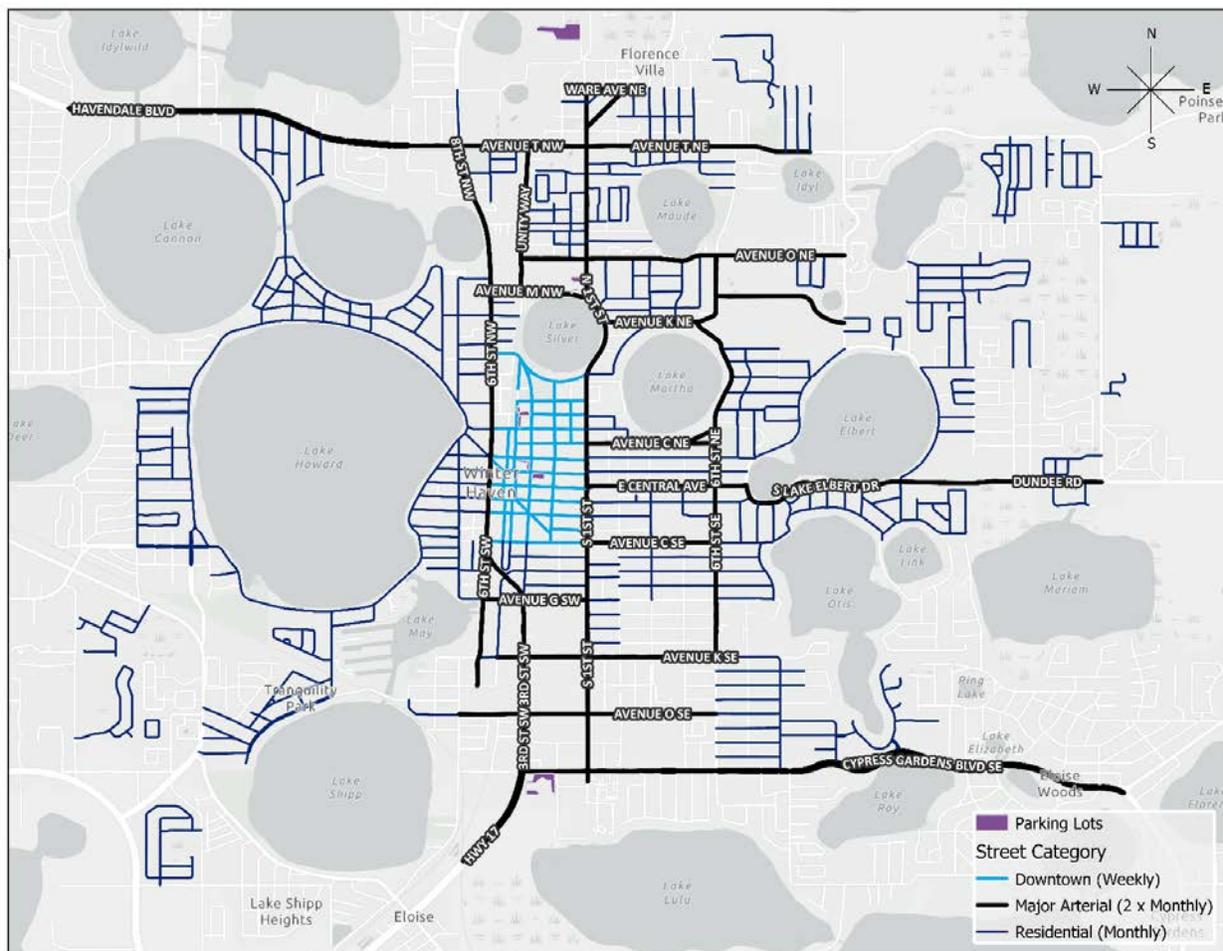
Figure 3-6. Map depicting roadways undergoing street sweeping. Legend indicates sweeping frequency of each street category.

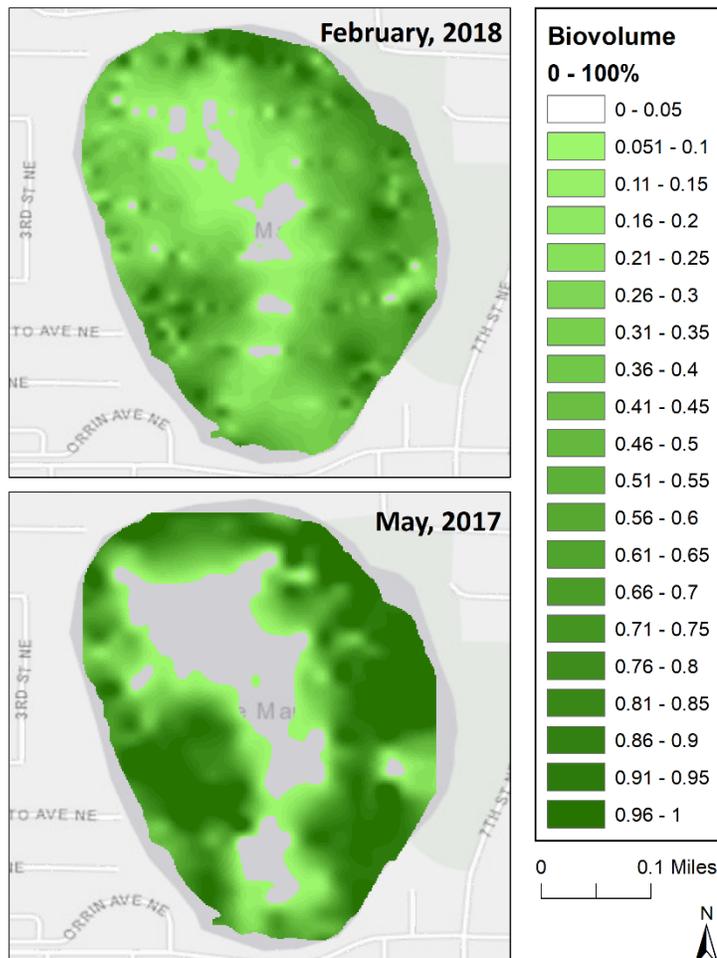
Figure 3-7. Biovolume heat map of Lake Maude. Color scale represents percent of water column occupied by plants.
