WINTER HAVEN
The Chain of Lakes City

Annual Lakes Report

Presented by the Lakes Advisory
Committee

CITY OF WINTER HAVEN
Public Works Department
Natural Resources Division

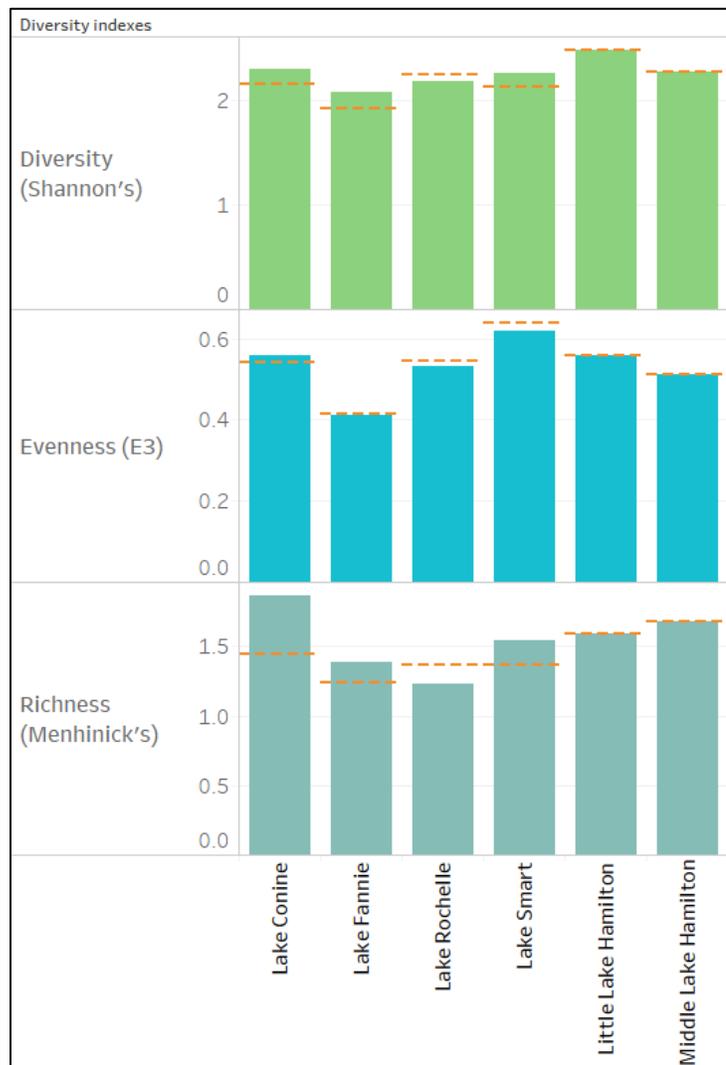
Figure 2-7. North Chain of Lakes annual index values for species richness, evenness, and diversity.

Observing the relative changes in aquatic vegetation species diversity provides insights into the overall health of a waterbody. Each waterbody’s annual values for the three most prominent diversity indices are displayed in relation to their respective long-term averages (Figure 2-7). It must be stressed that these index values are dependent on site-specific sampling effort. As such, these values are not meant to be compared between lakes—only as a comparison of changes to individual lakes over time. Index values at or exceeding the long-term average are given a point toward that lake’s diversity index score (for a possible total of 3); index values that fall below this threshold are given no points.

Shannon’s Diversity (H): As a combination of species richness and evenness, Shannon’s index indicates the overall species diversity for each site. Lakes Conine, Fannie, Smart, Little Hamilton, and Middle Hamilton met or exceeded their average values in 2021. Lake Rochelle’s 2021 H value fell below its average.

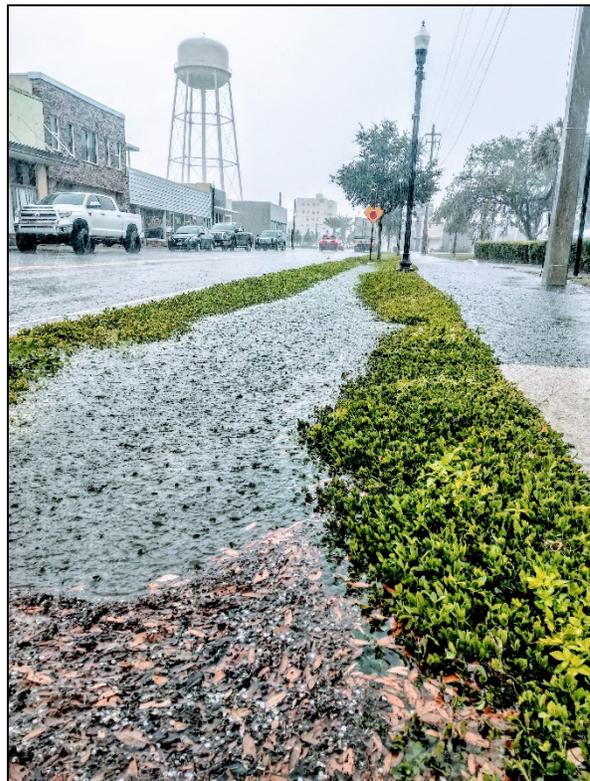
Figure 3-3. Photo of a raingarden capturing runoff and road debris in downtown Winter Haven.

Low impact development (LID) and green infrastructure are terms referring to practices that incorporate natural processes in the development of stormwater systems. Traditional, or “gray”, stormwater infrastructure relies on impervious materials, gutters, and pipes to transfer runoff from one area to another. Typically, these systems are implemented in urban areas to prevent flooding by directing stormwater to a nearby catchment or basin. In the Winter Haven area, gray infrastructure diverts runoff, as well as any pollutants, directly to lakes or stormwater ponds. In contrast, green infrastructure and LIDs utilize plants and soil characteristics to promote stormwater treatment and groundwater infiltration; resulting in cleaner and/or less runoff entering local waterbodies. Examples of green infrastructure and LIDs include raingardens, bioswales, pervious pavement, and exfiltration structures (French drains). Figure 3-3 displays one of several raingardens located within downtown Winter Haven.

Currently, the City has constructed over 60 raingardens and exfiltration systems in and around Winter Haven’s urban center. Lakes receiving stormwater benefits from these systems include: Lakes Elbert, Howard, Martha, Maude, May, Otis, Roy, and Silver. Nutrient removal capabilities are minimal on an individual basis, however, LIDs can collectively have a greater impact in larger numbers as more stormwater is treated. Moreover, relatively low construction costs in addition to the aforementioned benefits

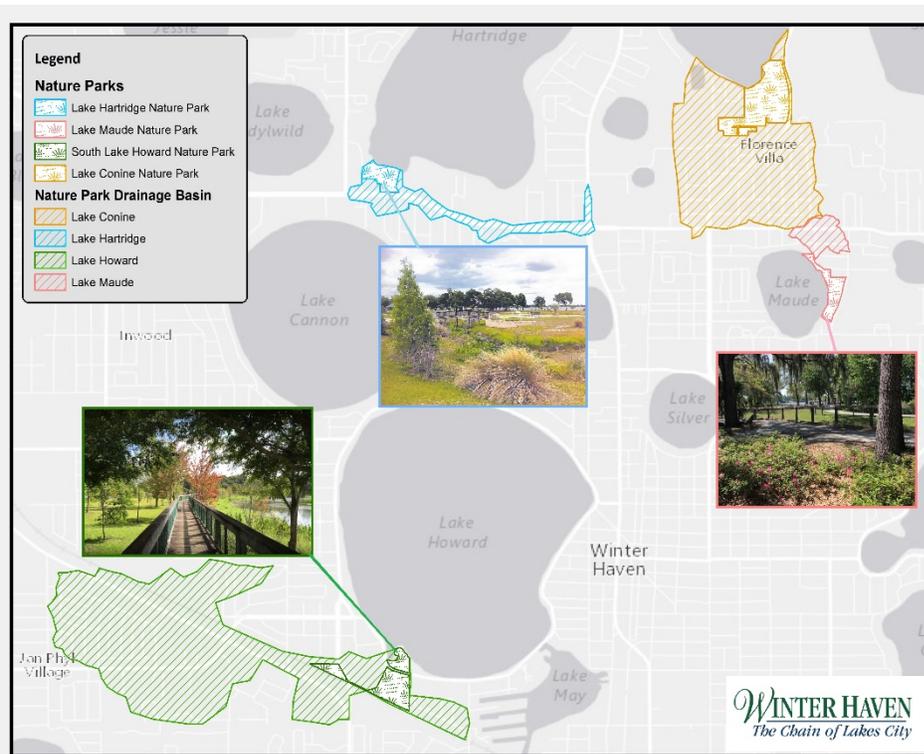
Figure 3-4. Map depicting the Winter Haven nature parks and their drainage basins. Also included is the proposed location of the Lake Conine Nature Park.

The City of Winter Haven maintains three nature parks adjacent to Lakes Howard, Hartridge, and Maude respectively. The South Lake Howard Nature Park is a roughly 16-acre park that treats a sizable 394-acre drainage area. The 9.4-acre Lake Hartridge Nature Park receives and treats runoff from a 56-acre basin. Lake Maude Nature Park, the smallest of the three at 6.4-

drainage area greater than 300 acres. A map of these nature parks and their drainage basins are displayed in Figure 3-4.
