Winter Haven Lakes Report

Presented by the Lakes Advisory Committee

2022

CITY OF WINTER HAVEN
Public Works Department
Natural Resources Division

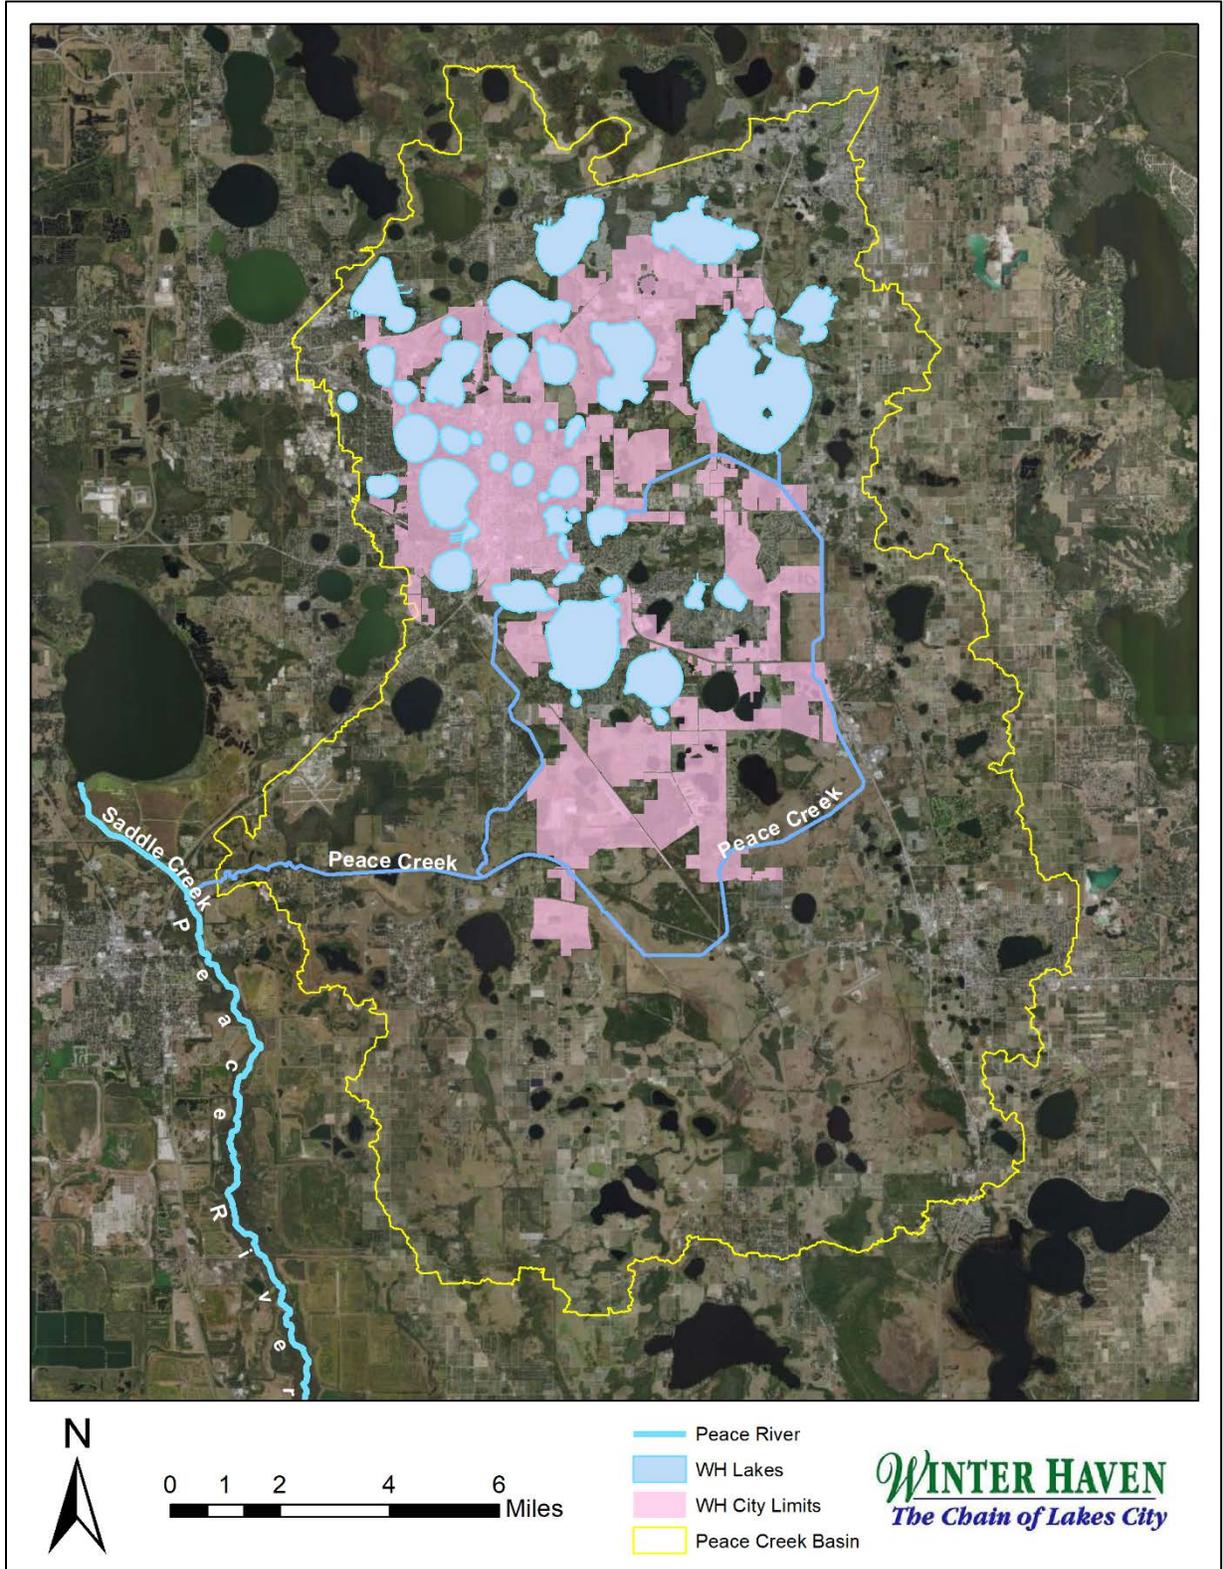
Figure 1-2. Map of the Peace Creek sub-basin, City of Winter Haven limits, contributing lakes and flow-ways.

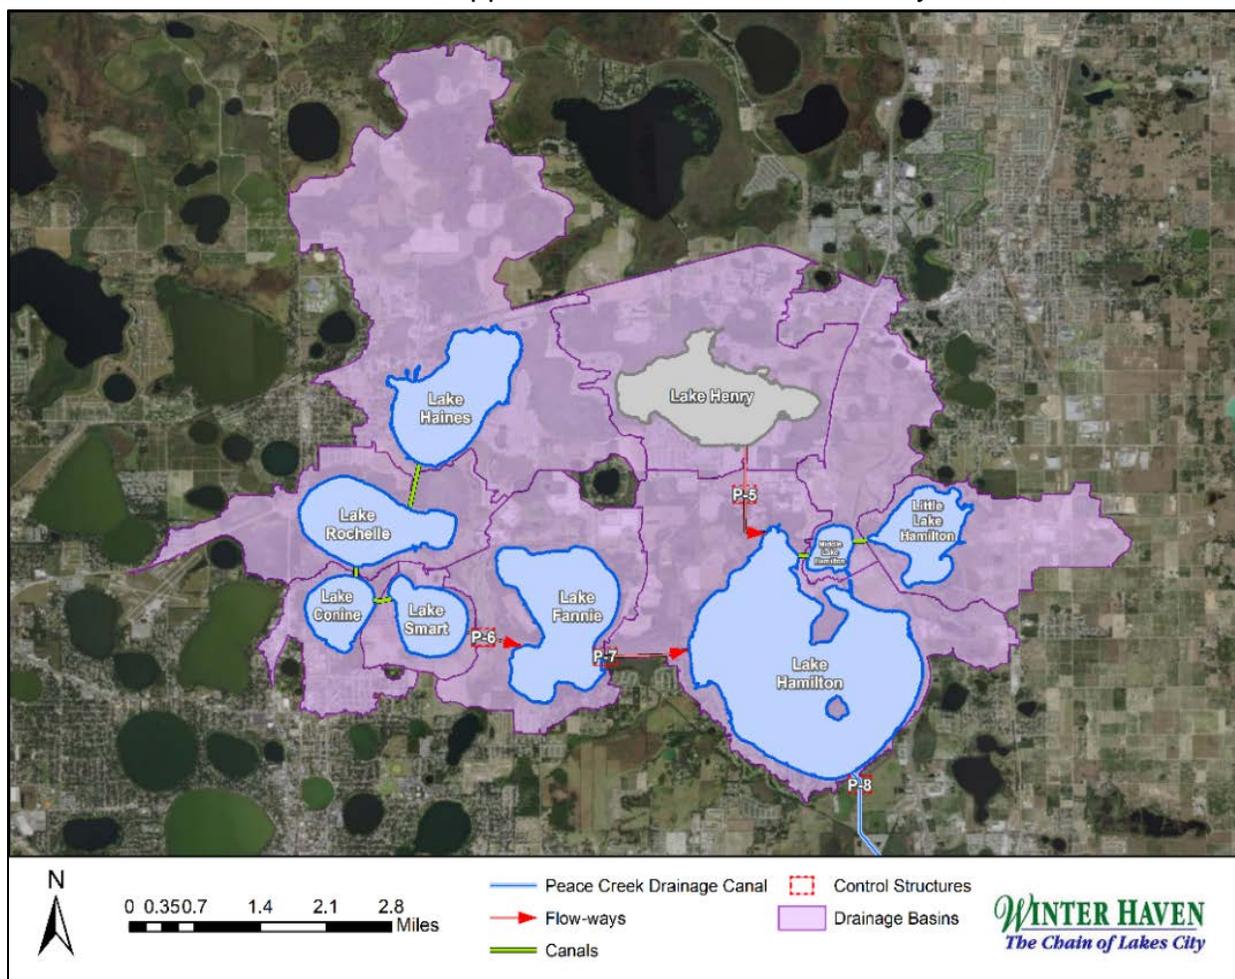
Figure 1-3. Map of North Chain of Lakes, Flow Pathways & Drainage Basins

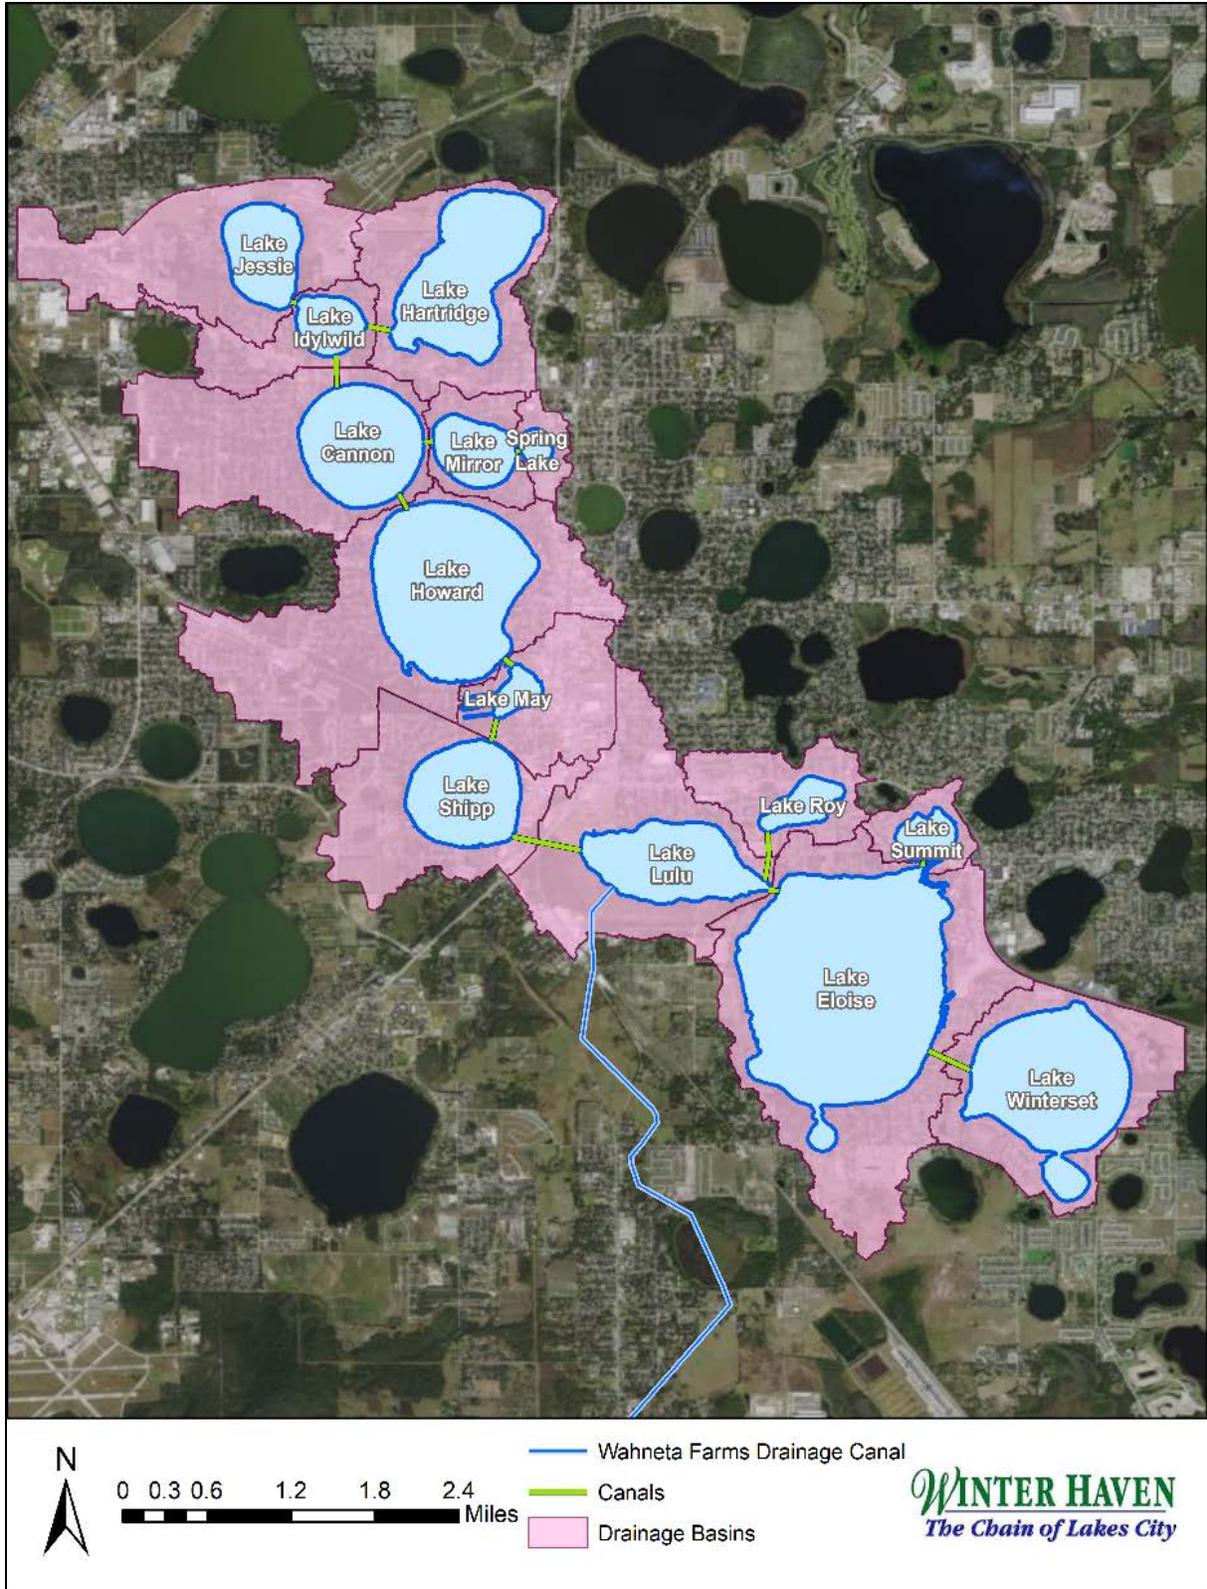
Figure 1-4. Map of South Chain of Lakes, Flow Pathways & Drainage Basins

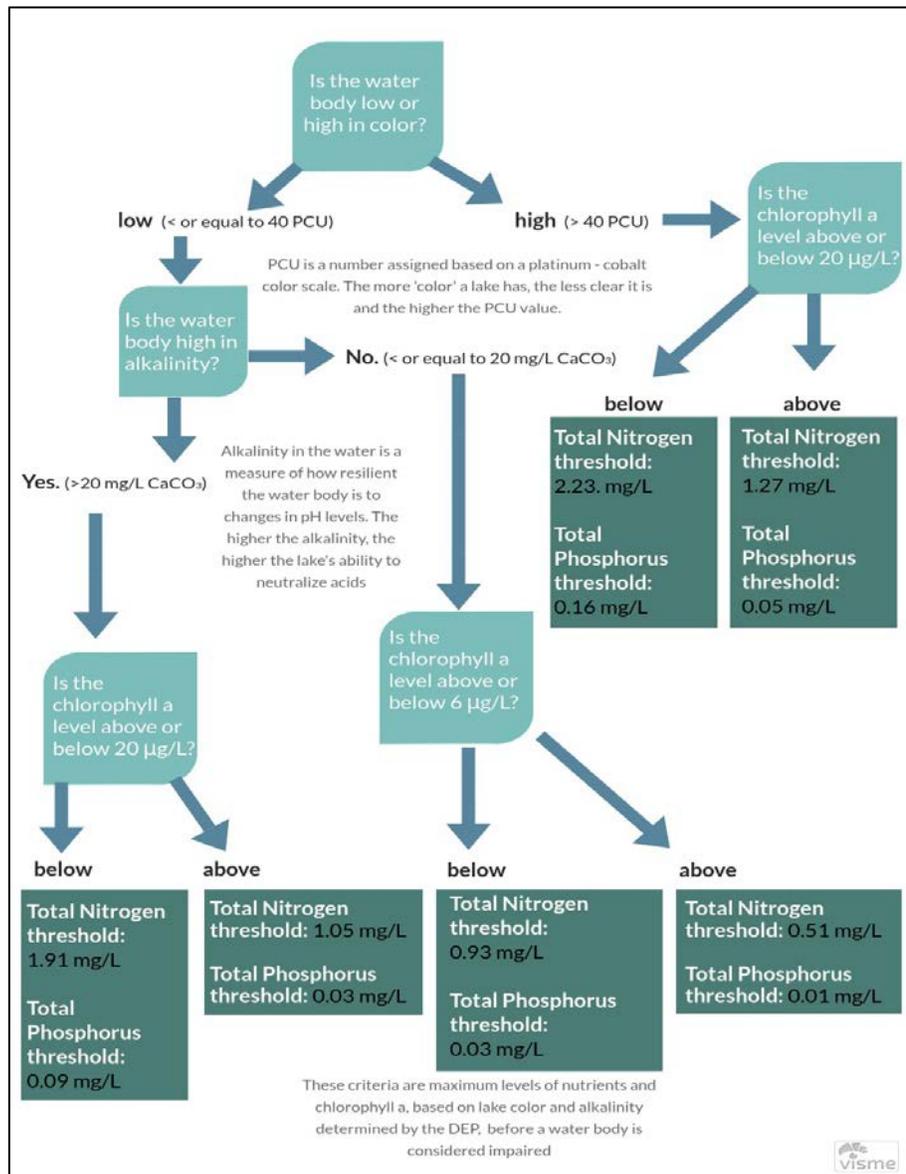
Figure 1-9. NNC Impairment Determination Flowchart

In 2011, under section 303(d) of the Clean Water Act, the US Environmental Protection Agency (EPA) and the Florida Department of Environmental Protection (FDEP) established sets of Numeric Nutrient Criteria (NNC) for all of Florida's surface waters. These criteria are based on a waterbody's intended use classification, estimated natural conditions, and the human-related influences that contribute to eutrophication.

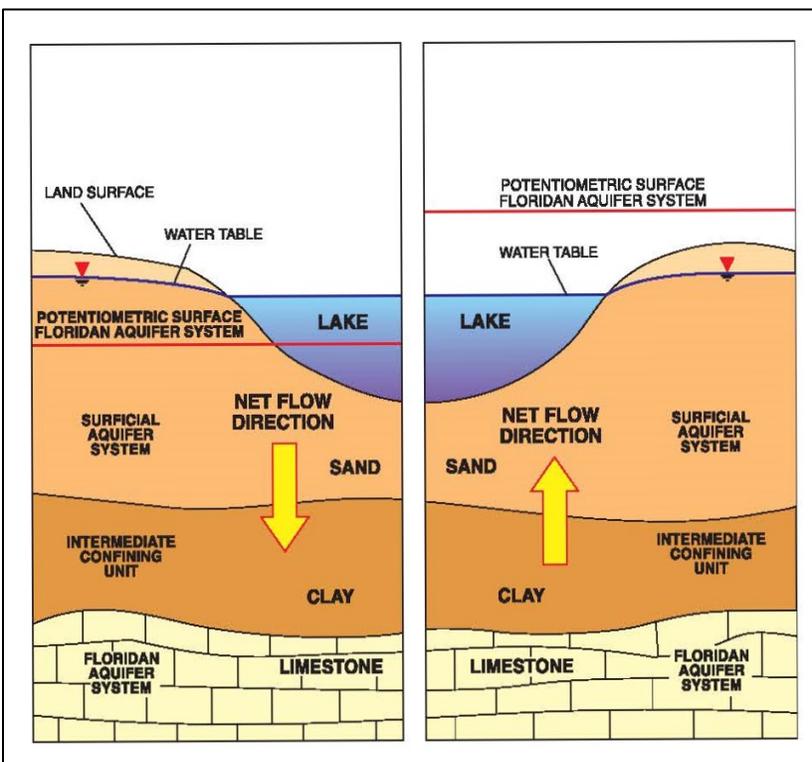
Figure 1-11. Diagram of Groundwater Interactions

There are two primary tiers of groundwater in Florida: the upper layer known as the surficial aquifer, and the deeper Floridan aquifer that is confined under a layer of impermeable clay. Measurement of the elevation above sea level of the upper surface of each aquifer is the accepted method for determining their current water quantity. The surficial aquifer level, referred to as the water table, generally fluctuates readily based on rainfall, soil saturation, temperature, and humidity. The Upper Floridan Aquifer is confined under pressure. As a result, its level is measured as the potentiometric surface, or the level at which water will rise in a well pipe due to the pressure exerted on it. Where there are breaks or perforations in this confining layer, water can be exchanged with the surface. Fluctuations of both the surficial and Upper Floridan levels can significantly impact lake surface levels (Figure 1-11). During periods of time or locations where the aquifer surfaces are high, water may flow to the surface via the bottom of lakes. Naturally, the opposite occurs when the water table and potentiometric surface are low.

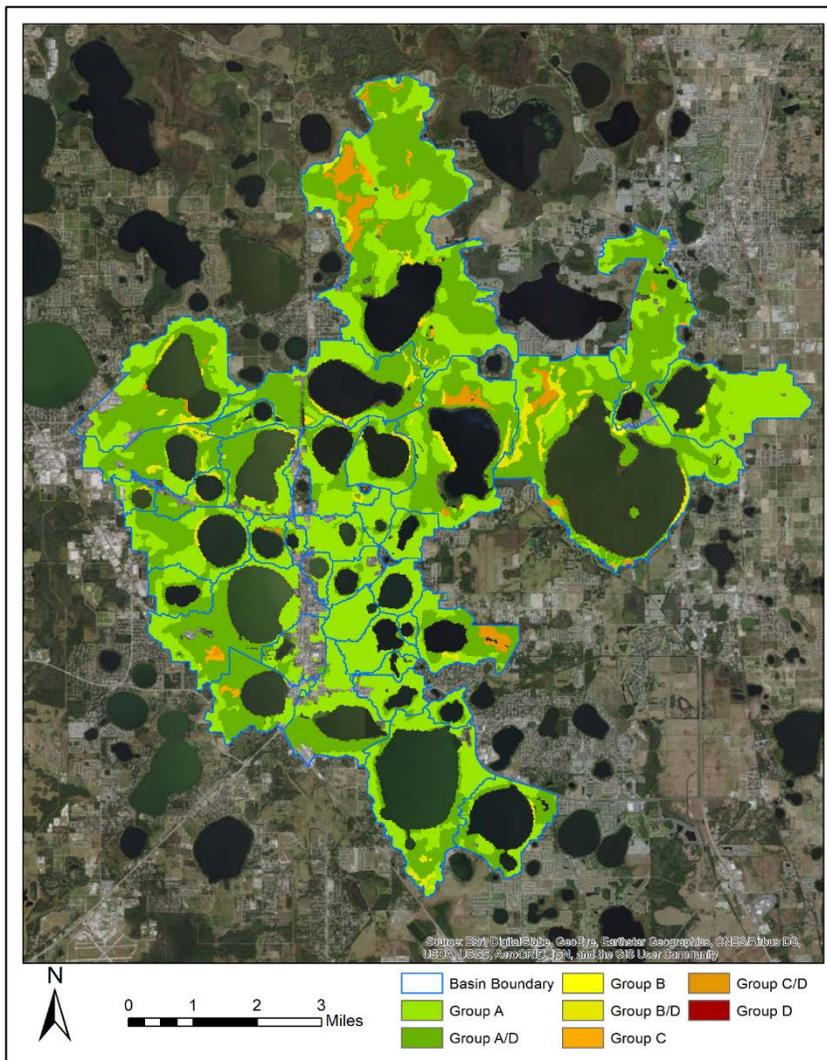
Figure 1-12. Hydrologic Soil Groups of the Winter Haven Lakes

The proportion of each soil group making up a given lake drainage basin can indicate the pre-development infiltration potential in that basin. This information can also be used to determine adequate locations for BMPs that promote groundwater recharge or treatment of stormwater. The majority of the Winter Haven area consists of Class A or A/D soils. However, notice that the proportion of poorly-drained soil types increases further from the downtown area (Figure 1-12). It can be inferred that stormwater infiltration BMPs will be more effective in the City center with surface water storage/treatment being relegated to the less well-drained lower elevations at the periphery of the downtown area.

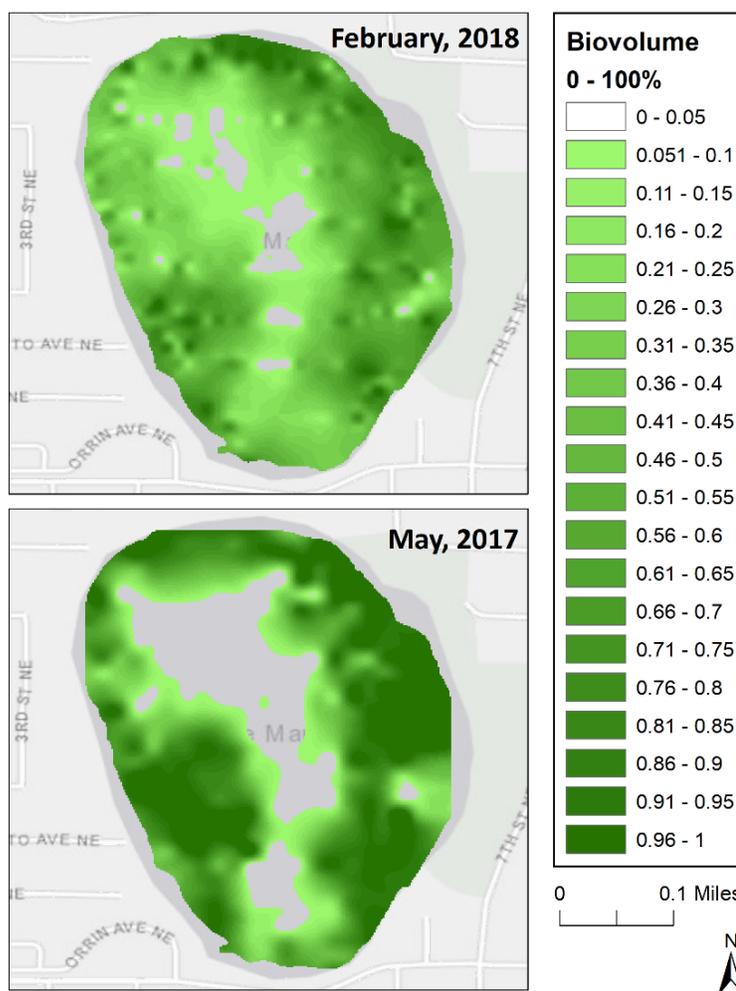
Figure 2-2. Biovolume heat map of Lake Maude. Color scale represents percent of water column occupied by plants.

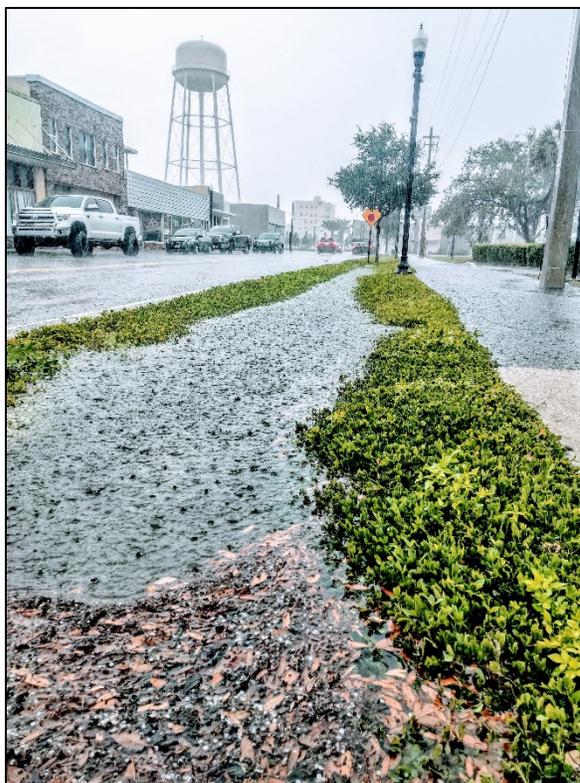
Figure 2-3. Photo of a raingarden capturing runoff and road debris in downtown Winter Haven.

Green stormwater infrastructure (GSI) is a term referring to practices that incorporate natural processes in the development of stormwater systems. Traditional, or “gray”, stormwater infrastructure relies on impervious materials, gutters, and pipes to transfer runoff from one area to another. Typically, these systems are implemented in urban areas to prevent flooding by directing stormwater to a nearby catchment or basin. In the Winter Haven area, gray infrastructure diverts runoff, as well as any pollutants, directly to lakes or stormwater ponds. In contrast, green infrastructure and LIDs utilize plants and soil characteristics to promote stormwater treatment and groundwater infiltration; resulting in cleaner and/or less runoff entering local waterbodies. Examples of green infrastructure and LIDs include raingardens (Figure 2-3), bioswales, pervious pavement, and exfiltration structures (French drains).

If designed properly and placed in appropriate areas, GSI are able to capture sediments, heavy metals, and other solid debris during the first flush of a rainfall event, preventing it from entering waterbodies at the “end of the pipe”. Employing well-drained soils to promote percolation, flooding along roadways can be reduced during 1-year to 10-year storm events. Planting of appropriate vegetation can also allow for nutrient uptake while also beautifying the urban landscape. In many cases, GSI can be utilized in lieu of traditional stormwater ponds in city planning; often occupying smaller footprints than traditional stormwater ponds while mitigating similar volumes of stormwater. Green infrastructure can benefit developers by reducing the area devoted to stormwater mitigation and can often be more aesthetically pleasing.

Currently, the City has constructed over 60 raingardens and exfiltration systems in and around Winter Haven’s urban center. Lakes receiving stormwater benefits from these systems include: Lakes Elbert, Howard, Martha, Maude, May, Otis, Roy, and Silver. Nutrient removal capabilities are minimal on an individual basis, however, GSI can collectively have a greater impact in larger numbers as more stormwater is treated.

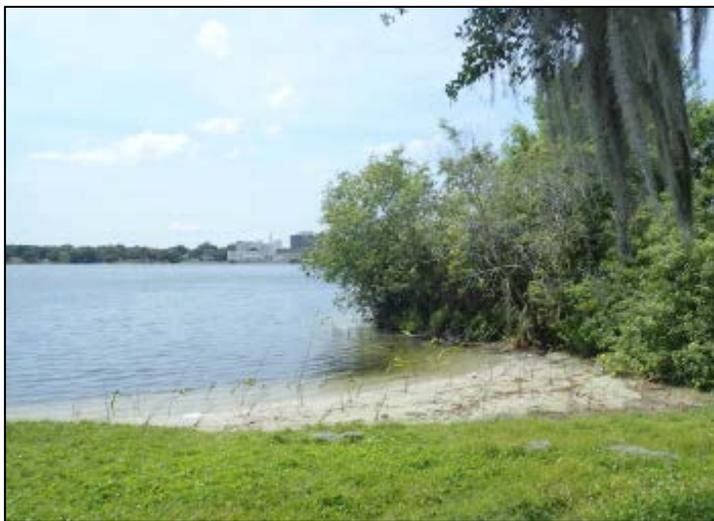
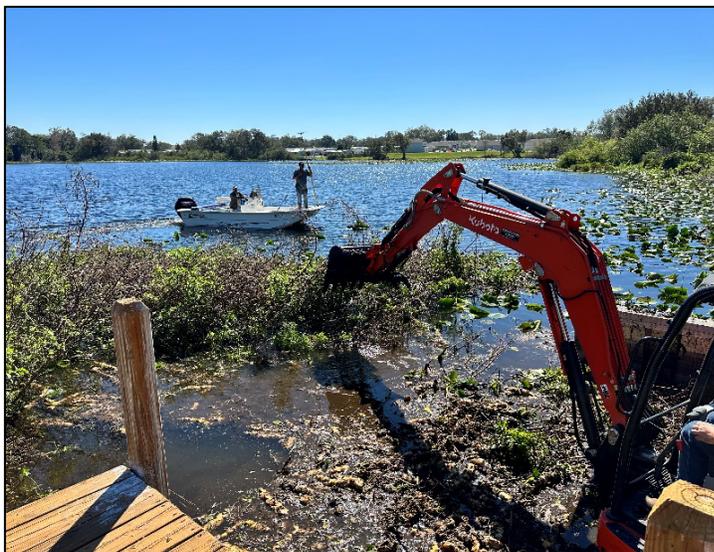
Figure 2-5. Photos of Lake Martha diesel spill remediation planting (top) and Lake Idyl tussock removal (bottom).

Natural Resources staff have conducted shoreline vegetation plantings in Lake Martha in 2013 and Lake Silver in 2017. City staff also assisted FDEP and the Winter Haven Hospital with remediation efforts in Lake Martha after a diesel spill in 2020 (Figure 2-5). More recently, staff have coordinated with residents and the Lakes Region Lakes Management District to remove tussocks from Lakes May and Idyl (Figure 2-5). In 2022, staff entered into discussions with the FWC's Aquatic Habitat Restoration and Enhancement Subsection (AHRES) to deploy fish attractors in Lake Martha as well.

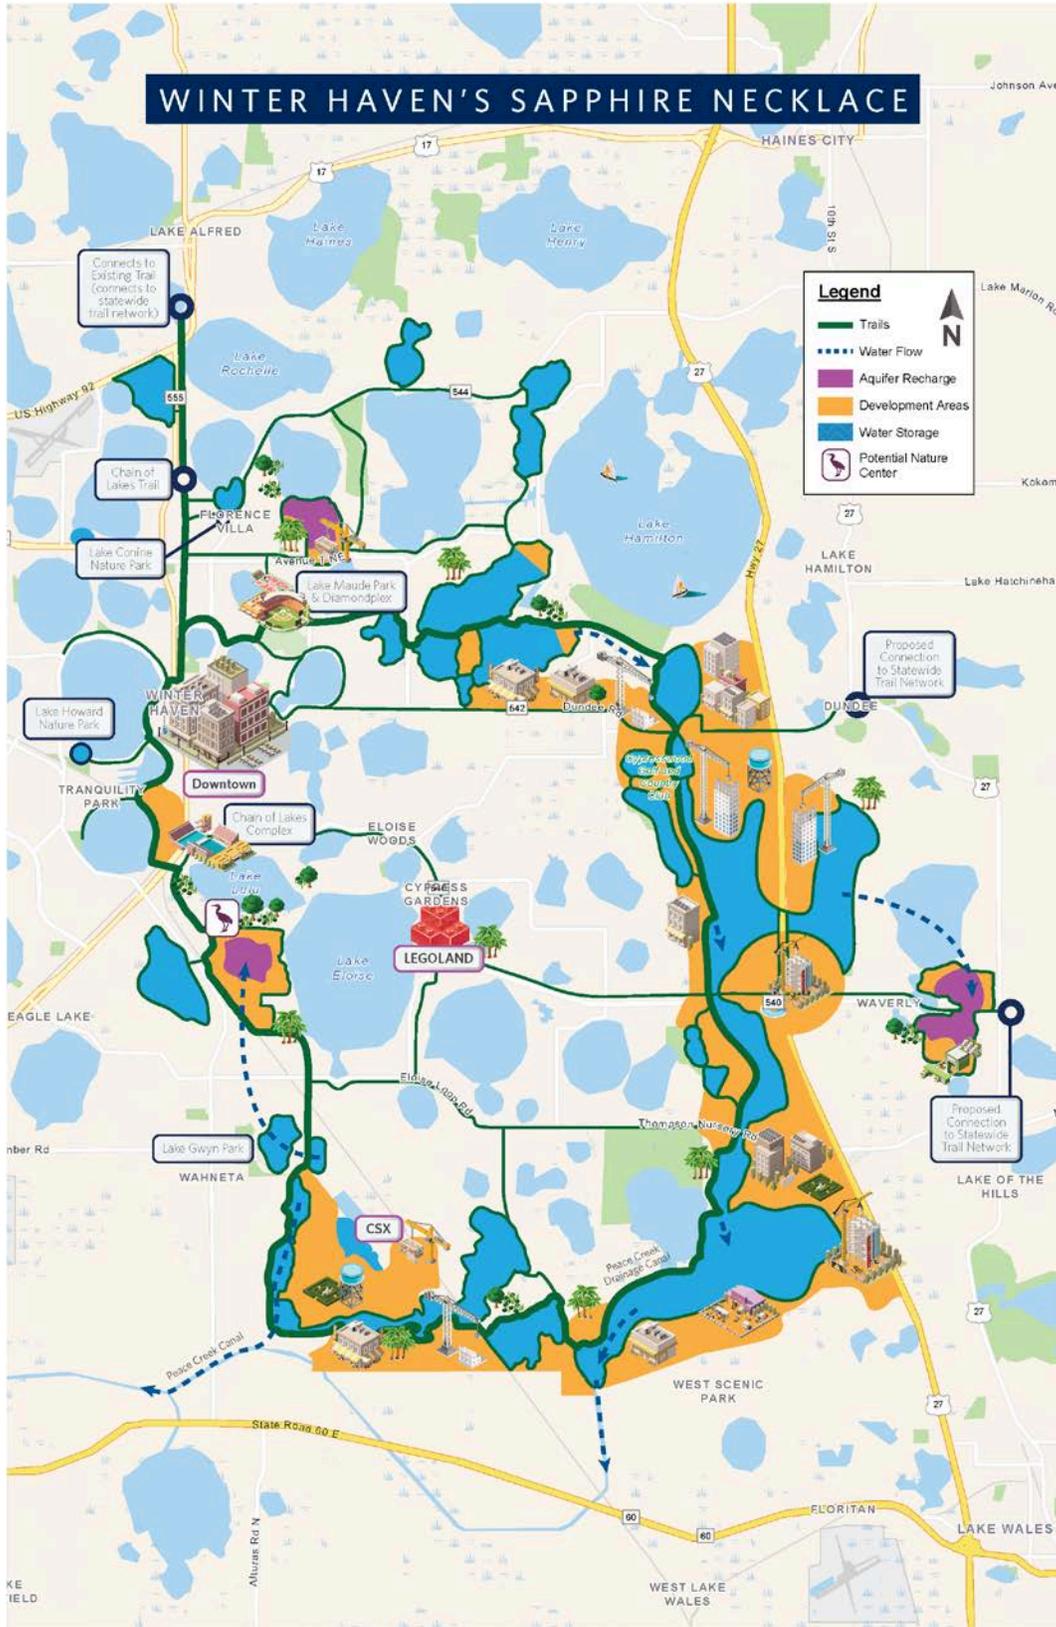
Figure 2-6. Rendering of the Sapphire Necklace concept that includes water storage, aquifer recharge, and nature park areas.

One of the signature recommendations evaluated and accepted as part of the One Water Master Plan is the Sapphire Necklace—a conceptual design of Winter Haven ringed by approximately 5000 acres of restored wetlands and nature parks (Figure 2-6). These sites would provide water storage, groundwater infiltration, wildlife habitat, and the backdrop for recreational amenities such as an expanded trail network—all of which benefit Winter Haven’s lakes and the residents that utilize them.

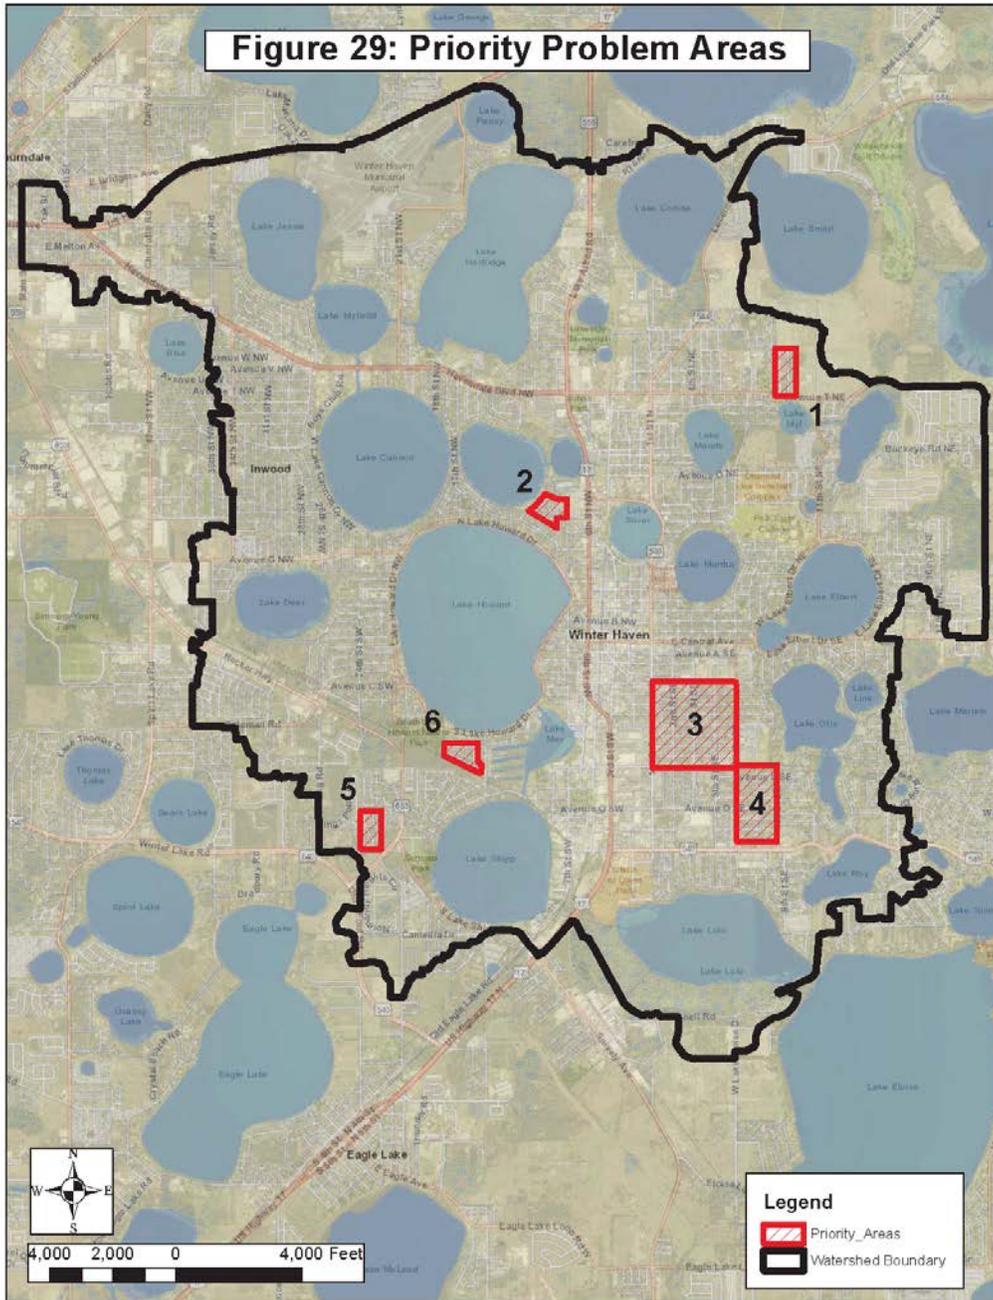
Figure 2-8. Priority sites indicated by increased flooding and pollutant load potential as determined by the Winter Haven SAIP.

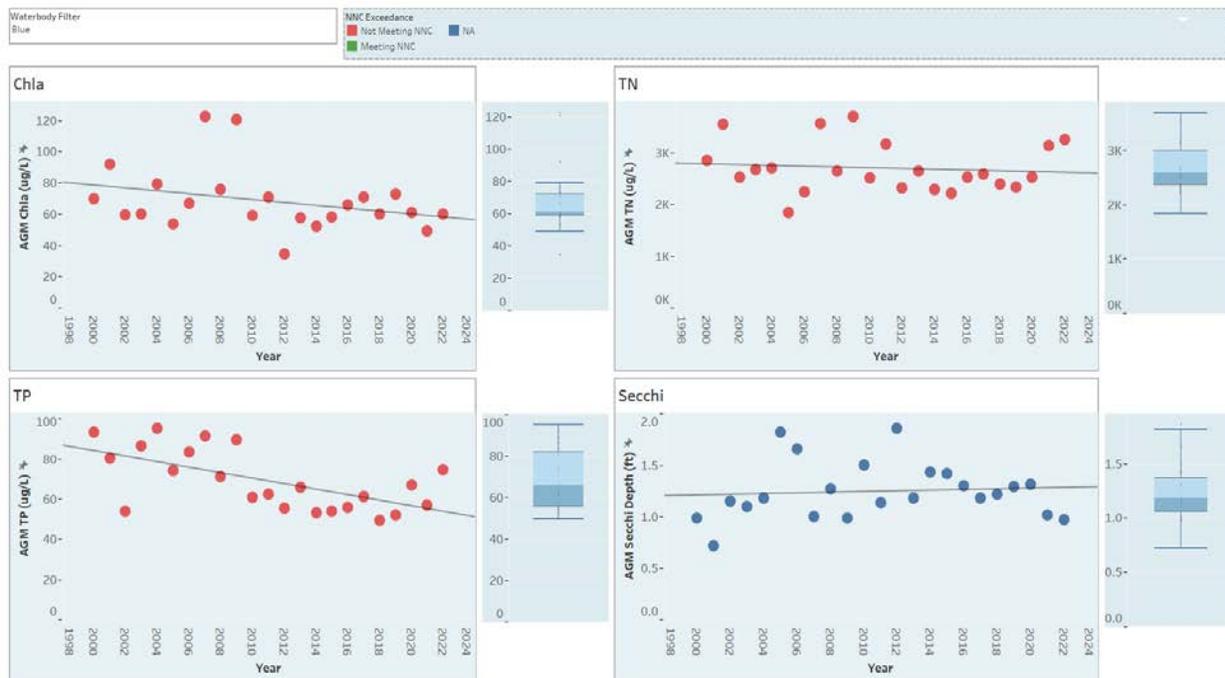
Figure 3-6. Lake Blue AGM Chl-a, TN, TP, and Secchi depth values from 2000 to 2022. Data points colored in red depict NNC exceedances. Also detailed are trend lines and box & whisker plots that show relative variance.

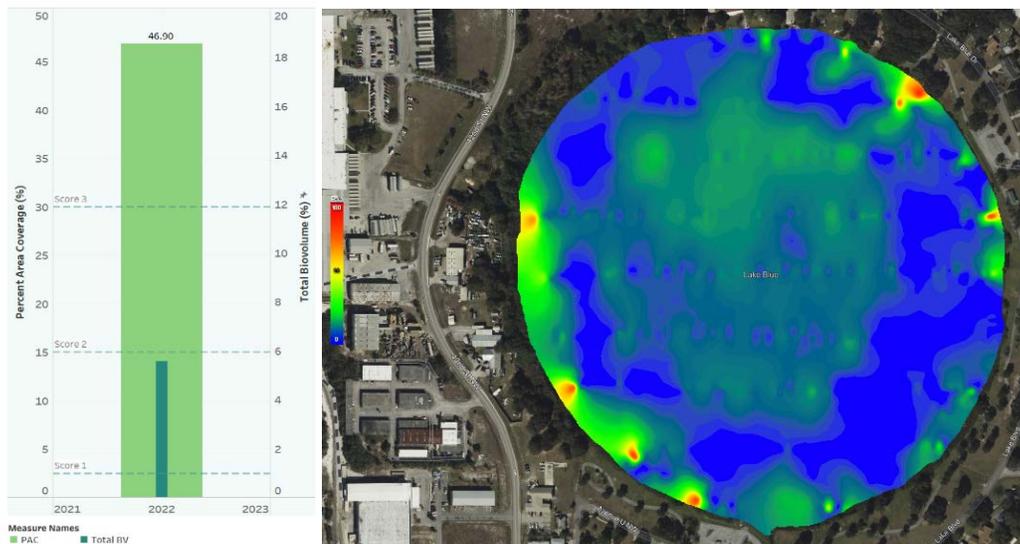
Figure 3-7. Graph depicting 2022 PAC/BV and biovolume heatmap; biovolume values range from green (lowest) to red (highest).

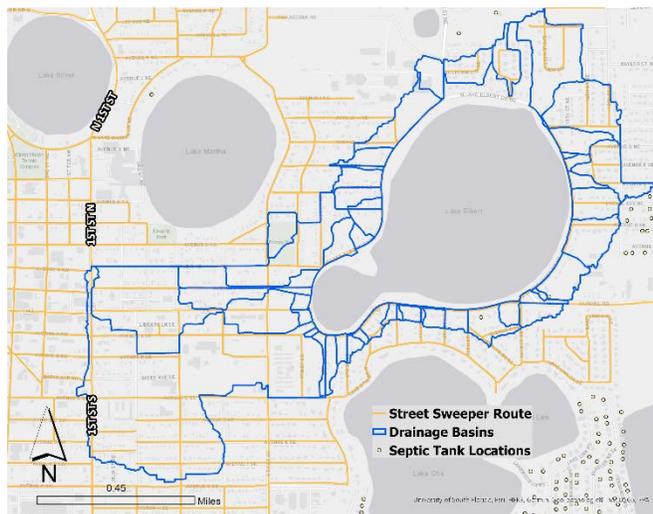
Figure 3-52. Map of Lake Elbert’s drainage basin, City street sweeper routes, and nearby septic systems.

Stormwater is conveyed to this waterbody from a 439 acre urbanized drainage basin made up of 50 individual sub-basins (Figure 3-52). By far the largest proportion of land use in this basin is comprised of medium density residential, followed by institutional, commercial, residential, and open land. Based on stormwater modelling, these land uses contribute up to 2365 lbs of TN and 385 lbs of TP to the lake annually. There are very few known Onsite Sewage Treatment and Disposal (OSTD/septic) systems within the vicinity of Lake Elbert. Completely within City limits, Winter Haven conducts monthly street sweeping services of up to 33.5 miles within this basin.

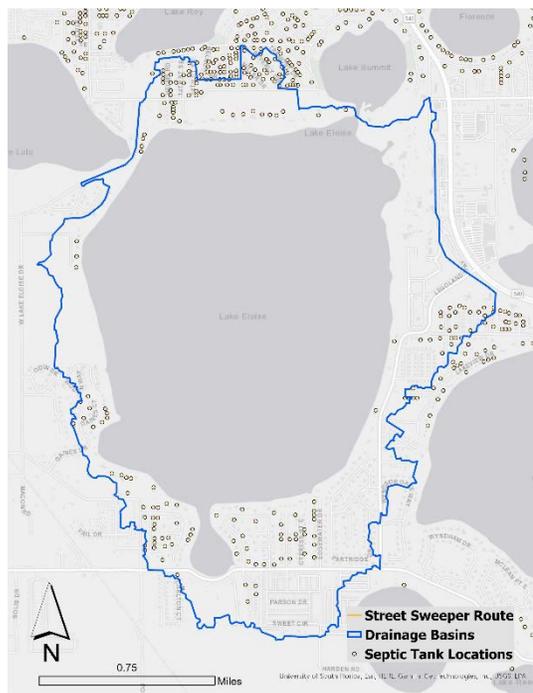
Figure 3-60. Map of Lake Eloise’s drainage basin and nearby septic systems.

Stormwater is conveyed to this waterbody from a 1981 acre drainage basin—of which the lake makes up the majority (Figure 3-60). The terrestrial areas of the basin are comprised of medium density residential, recreational, low density residential, high density residential and agricultural; ranked from highest to lowest. These land uses contribute up to 3875 lbs of TN and 665 lbs of TP to the lake annually. There are 186 Onsite Sewage Treatment and Disposal (OSTD/septic) systems within this basin—mostly congregated at the north and south areas of the basin. There exist few City-owned roadways with stormwater infrastructure that drain to the lake. As a result, the City does not conduct street sweeping services in this basin.

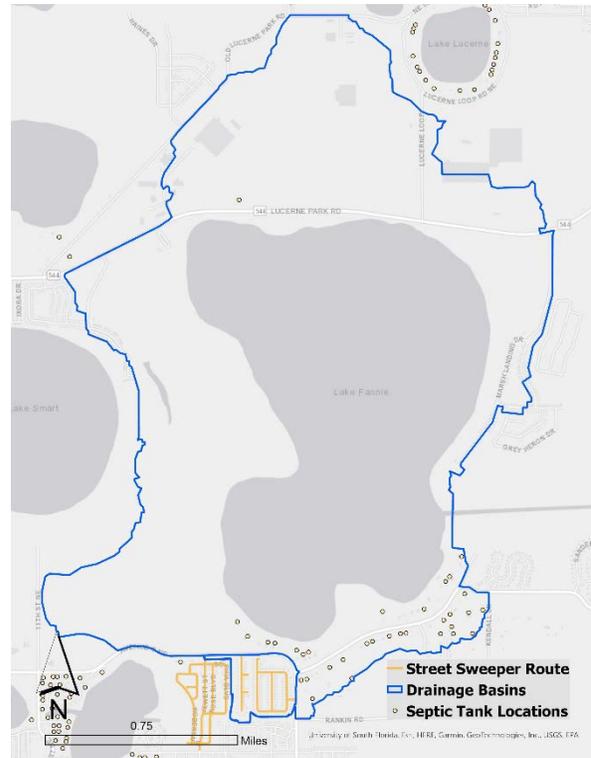
Figure 3-68. Map of Lake Fannie's drainage basin, City street sweeping services, and nearby septic systems.

Stormwater is conveyed to this waterbody from a 2208 acre, mostly rural drainage basin (Figure 3-68). Aside from the lake itself, the primary land uses within this basin are wetlands, agricultural, industrial, and recreational (golf courses). These land uses contribute 4133 lbs of TN and 717 lbs of TP to the lake annually. There are 33 Onsite Sewage Treatment and Disposal (OSTD/septic) systems within this drainage basin. However, due to their low density this isn't a major concern from a pollutant loading standpoint. Lacking much stormwater infrastructure in the area, the City sweeps a small section in the southern portion of the watershed.

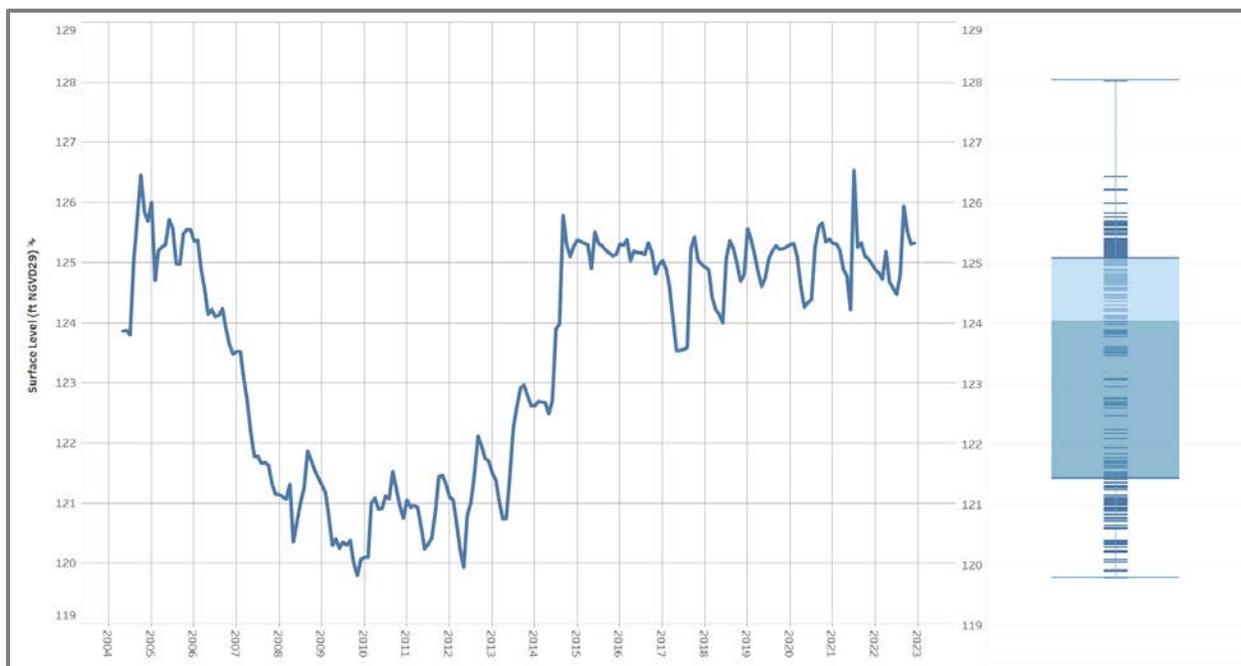
Figure 3-69. Hydrograph of Lake Fannie depicting monthly surface level readings from 2000 to 2022. A box and whisker plot details total range, median, and normal range of surface level during the period of record.

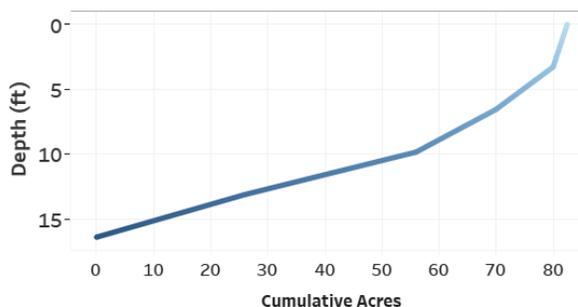
Figure 3-75. Hypsograph of Lake Haines depicting cumulative area at regular depth intervals. Demonstrates the slope and morphology of the lake bed.

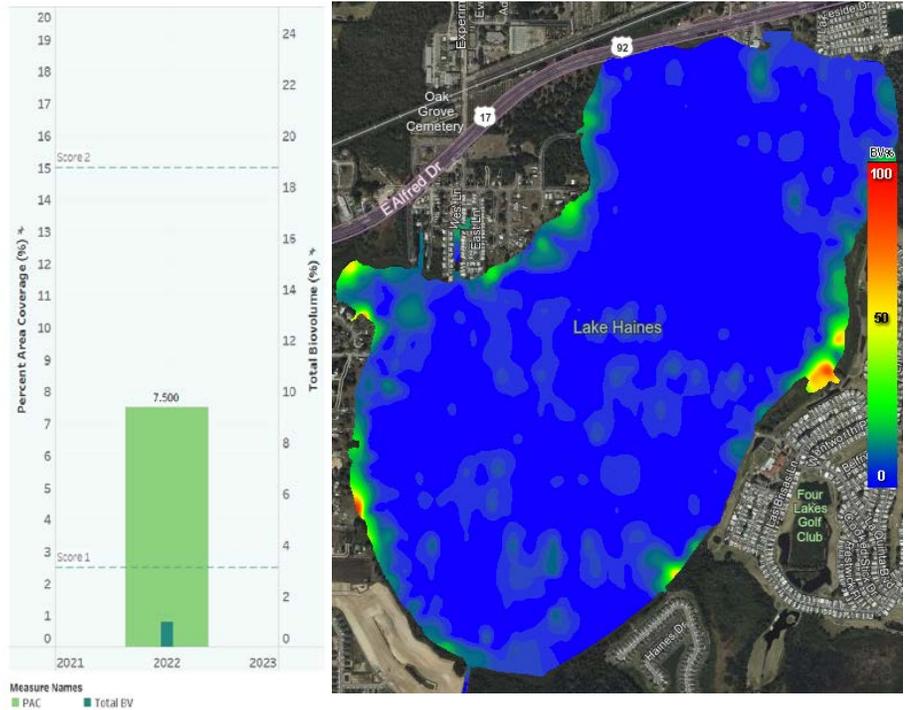
Figure 3-79. Graph depicting 2022 PAC/BV and biovolume heatmap of Lake Haines; biovolume values range from green (lowest) to red (highest).

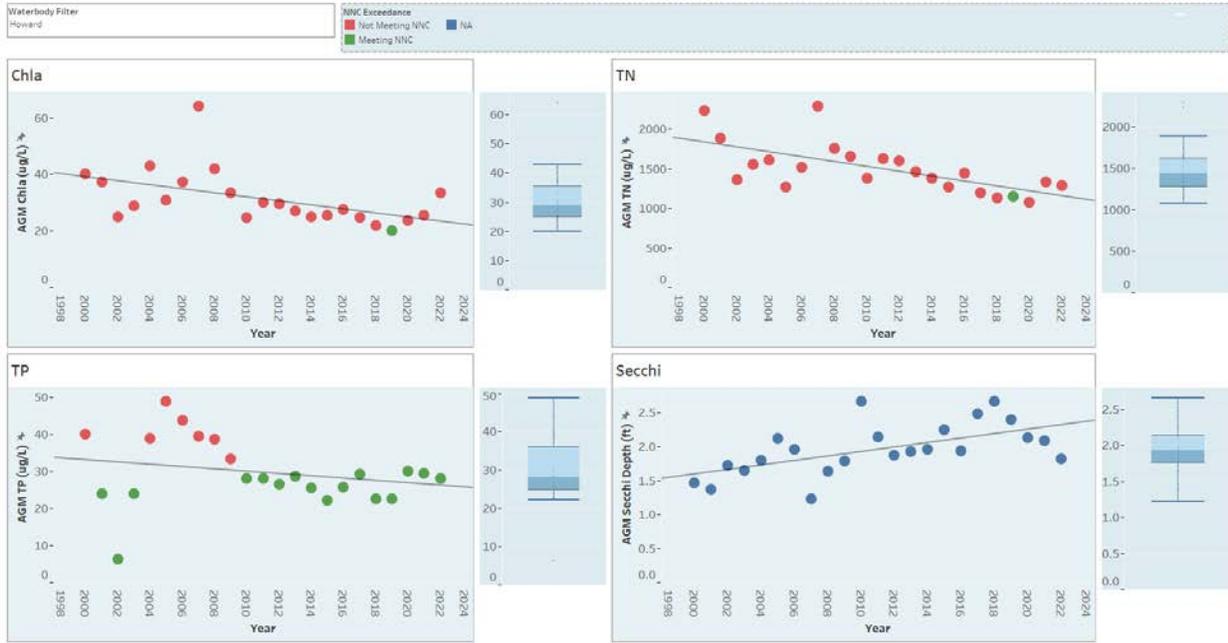
Figure 3-102. Lake Howard AGM Chla, TN, TP, and Secchi depth values from 2000 to 2022. Data points colored in red depict NNC exceedances. Also detailed are trend lines and box & whisker plots that show relative variance.

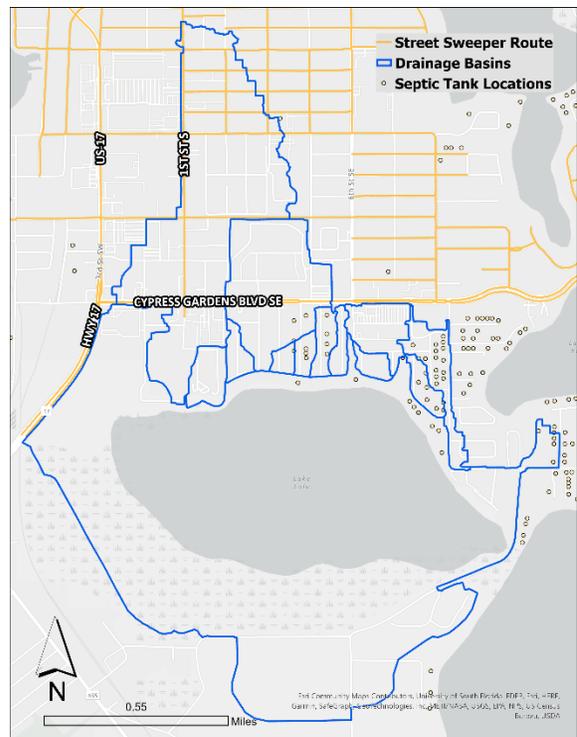
Figure 3-140. Map of Lake Lulu’s drainage basin, City street sweeper routes, and nearby septic systems.

Stormwater is conveyed to this waterbody from a 1006 acre drainage basin comprised of 13 individual sub-basins (Figure 3-140). Ranked by area, the primary land uses in this drainage area are commercial, medium density residential, wetlands, agricultural, and high density residential. Based on stormwater pollutant modelling, this basin contributes 2791 lbs of TN and 483 lbs of TP to Lake Lulu annually. There are 46 Onsite Sewage Treatment and Disposal (OSTD/septic) systems located within the County portion of the basin. This constitutes a moderate density which can have potential impacts on water quality. To combat stormwater pollutant loading, the City conducts 11.6 miles of street sweeping on a monthly basis.

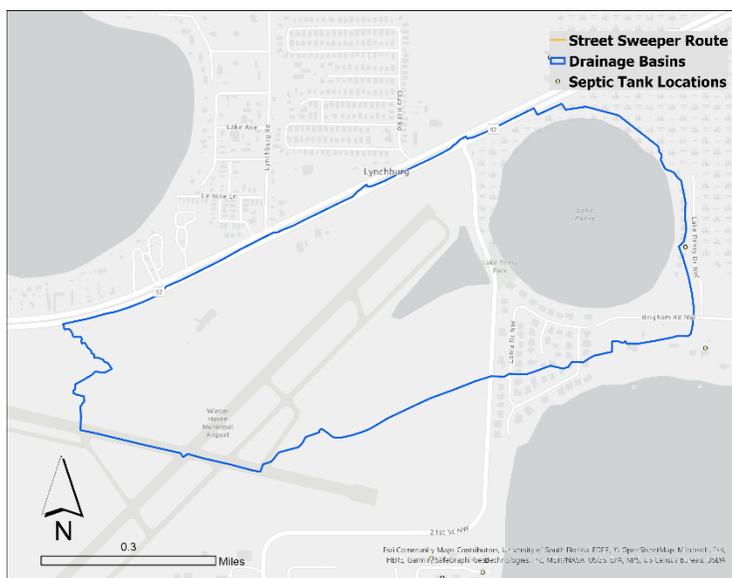
Figure 3-212. Map of Lake Pansy’s drainage basin and nearby septic systems.

Stormwater is conveyed to this waterbody from a 244 acre drainage basin (Figure 3-212). The majority of this basin is comprised of the Winter Haven Airport, a transportation land use; while the remaining land uses include medium density residential and wetlands. Based on stormwater pollutant load modelling, this drainage area contributes 880 lbs of TN and 111 lbs of TP to the lake annually. There are no known Onsite Sewage Treatment and Disposal (OSTD/septic) systems within the drainage basin. While the airport drainage is treated via a stormwater pond prior to discharging to Lake Pansy, the City does not conduct any street sweeping services in this basin. However, 21st Street is a potential sweeper route expansion area.

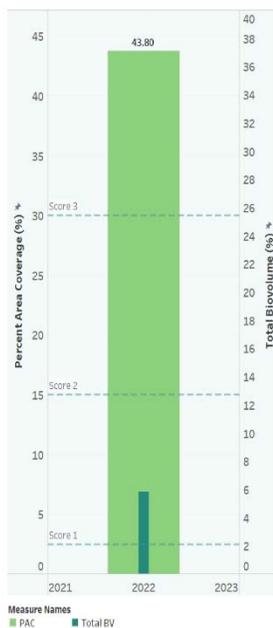
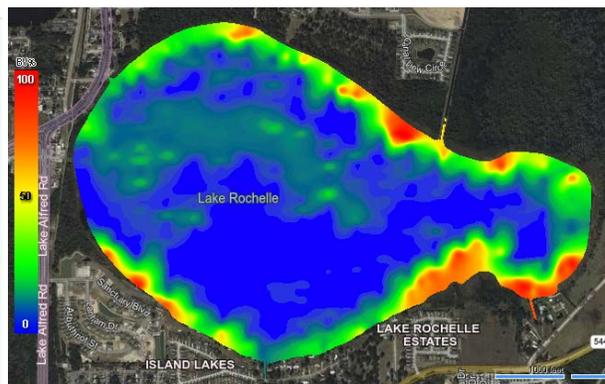
Figure 3-223. Graph depicting 2022 PAC/BV and biovolume heatmap of Lake Rochelle; biovolume values range from green (lowest) to red (highest).

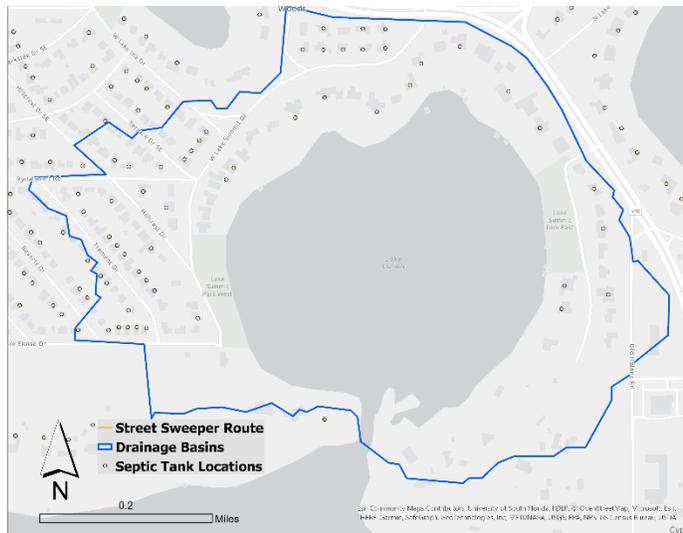
Figure 3-267. Map of Lake Summit's drainage basin and nearby septic systems.

Stormwater is conveyed to this waterbody from a 166 acre drainage basin (Figure 3-268). The basin is dominated by medium density residential land use, followed by recreational and low density residential, respectively. Based on stormwater pollutant load modelling, this drainage area contributes 513 lbs of TN and 83 lbs of TP to the lake annually. There are 52 Onsite Sewage Treatment and Disposal (OSTD/septic) systems present in the basin. This constitutes a moderate density that may contribute some pollutant loading through groundwater leaching. Due to the drainage basin being mostly outside of Winter Haven limits, the City does not conduct any street sweeping that benefits this lake.
