Winter Haven Lakes Report

Presented by the Lakes Advisory Committee

2023

CITY OF WINTER HAVEN
Public Works Department
Natural Resources Division

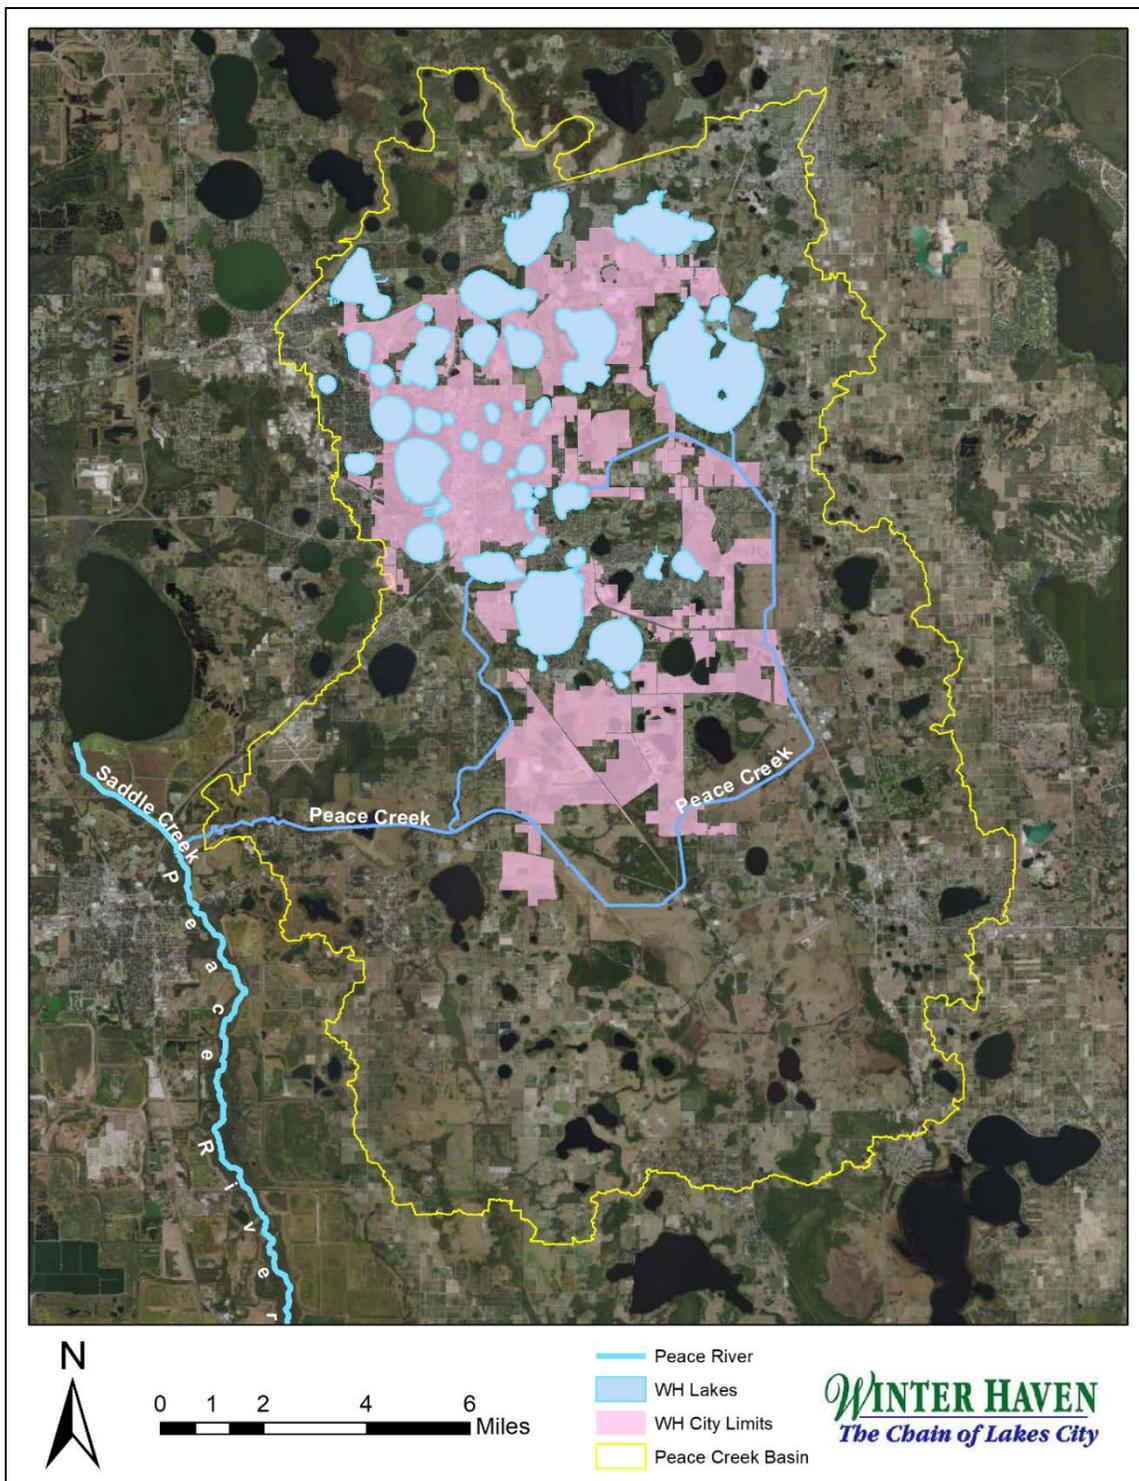
Figure 1-2. Map of the Peace Creek sub-basin, City of Winter Haven limits, contributing lakes and flow-ways.

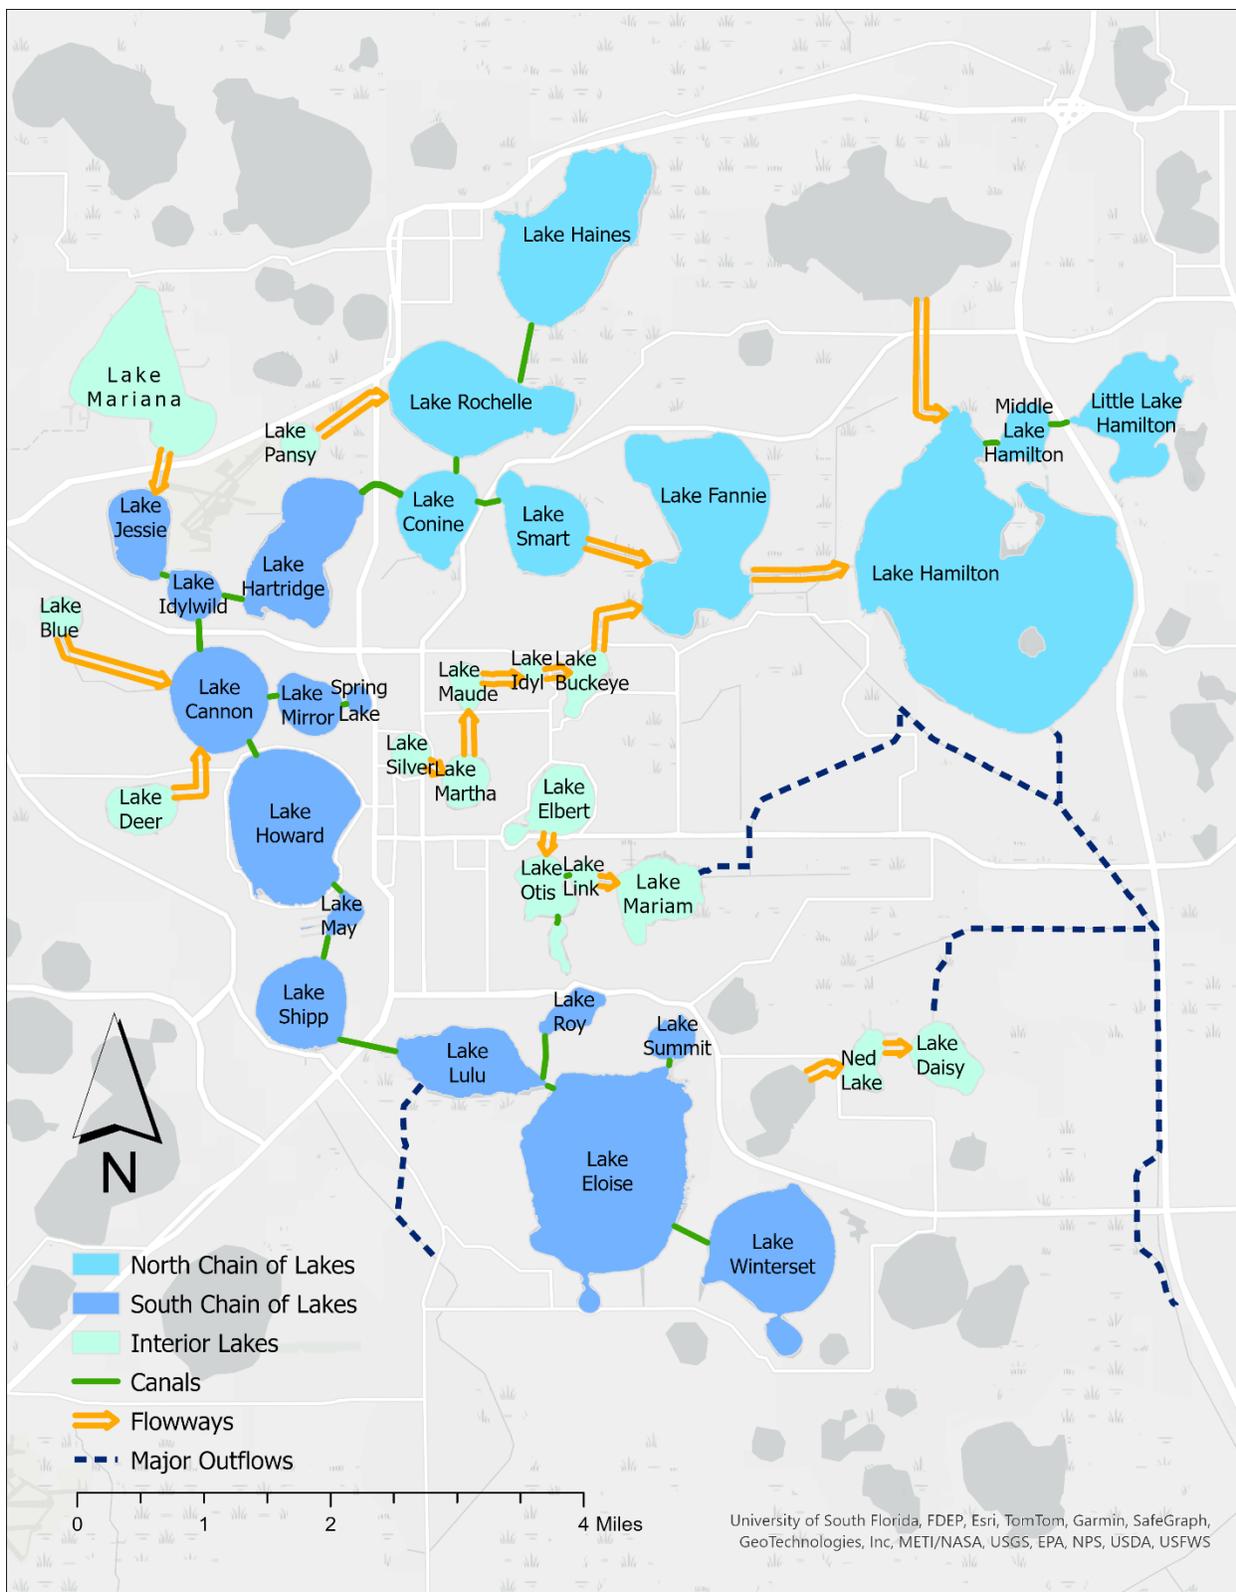
Figure 1-3. Map of Winter Haven Lakes, navigable canals, non-navigable flow-ways, and major outflows.

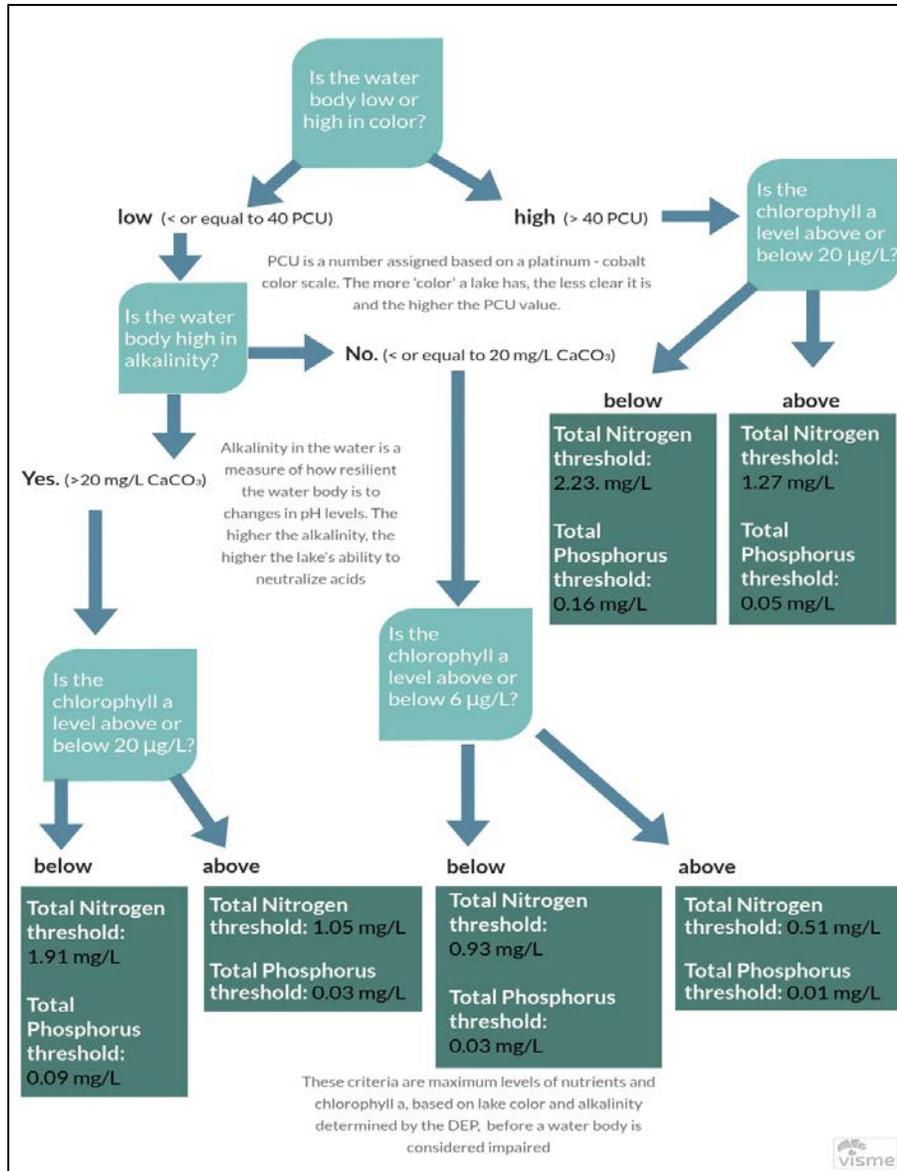
Figure 1-5. NNC Impairment Determination Flowchart

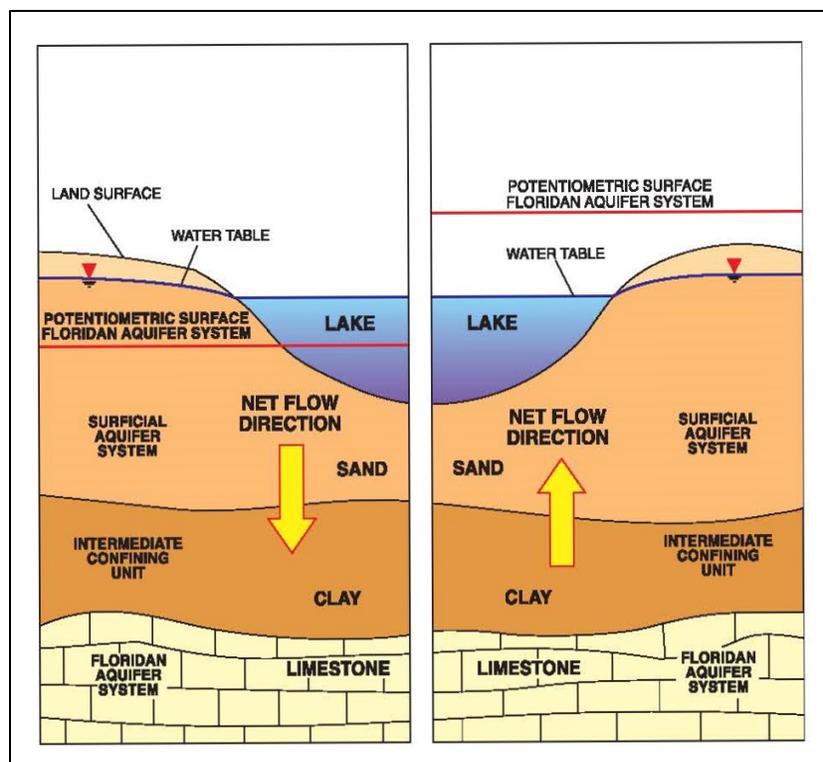
Figure 1-7. Diagram of Groundwater Interactions.

There are two primary tiers of groundwater in Florida: the upper layer known as the surficial aquifer, and the deeper Floridan aquifer that is confined under a layer of impermeable clay. Measurement of the elevation above sea level of the upper surface of each aquifer is the accepted method for determining their current water quantity. The surficial aquifer level, referred to as the water table, generally fluctuates readily based on rainfall, soil saturation, temperature, and humidity. The Upper Floridan Aquifer is confined under pressure. As a result, its level is measured as the potentiometric surface, or the level at which water will rise in a well pipe due to the pressure exerted on it. Where there are breaks or perforations in this confining layer, water can be exchanged with the surface. Fluctuations of both the surficial and Upper Floridan levels can significantly impact lake surface levels (Figure 1-7). During periods of time or locations where the aquifer surfaces are high, water may flow to the surface via the bottom of lakes. Naturally, the opposite occurs when the water table and potentiometric surface are low.

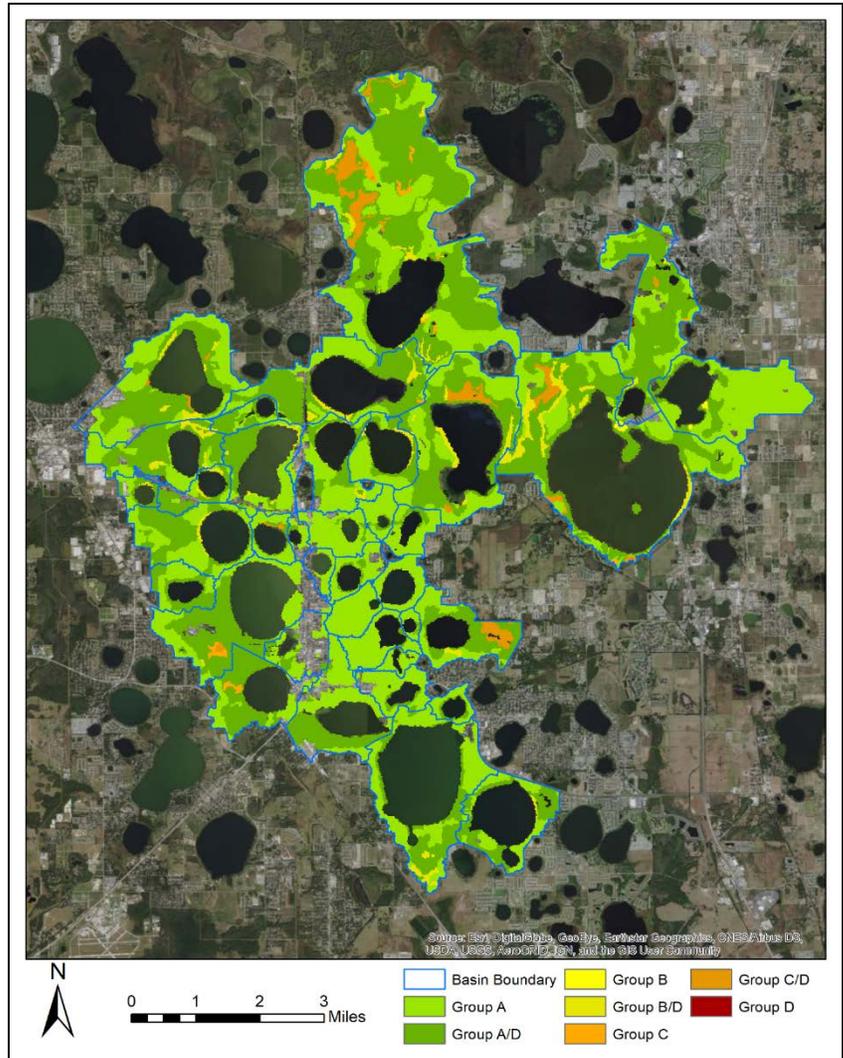
Figure 1-8. Hydrologic Soil Groups of the Winter Haven Lakes.

- **Group A:** Soils consisting mostly of excessively drained sands or gravel with a high infiltration rate when thoroughly wet.
- **Group B:** Soils consisting of moderately well-drained coarse or fine texture sediments with a moderate infiltration rate when thoroughly wet.
- **Group C:** Soils consisting of fine textures having a layer that impedes the downward movement of water with a slow infiltration rate when thoroughly wet.
- **Group D:** Soils consisting chiefly of clays or clay layers near the surface or over nearly impervious material with a very slow infiltration rate.
- **Dual Groups: (A/D, B/D, C/D)** Mixed soils with no dominant type where the designation applies to their status when 'drained'/'saturated'.

The proportion of each soil group making up a given lake drainage basin can indicate the pre-development infiltration potential in that basin. This information can also be used to determine adequate locations for BMPs that promote groundwater recharge or treatment of stormwater. The majority of the Winter Haven area consists of Class A or A/D soils. However, notice that the proportion of poorly-drained soil types increases further from the downtown area (Figure 1-8). It can be inferred that stormwater infiltration BMPs will be more effective in the City center with surface water storage/treatment being relegated to the less well-drained lower elevations at the periphery of the downtown area.

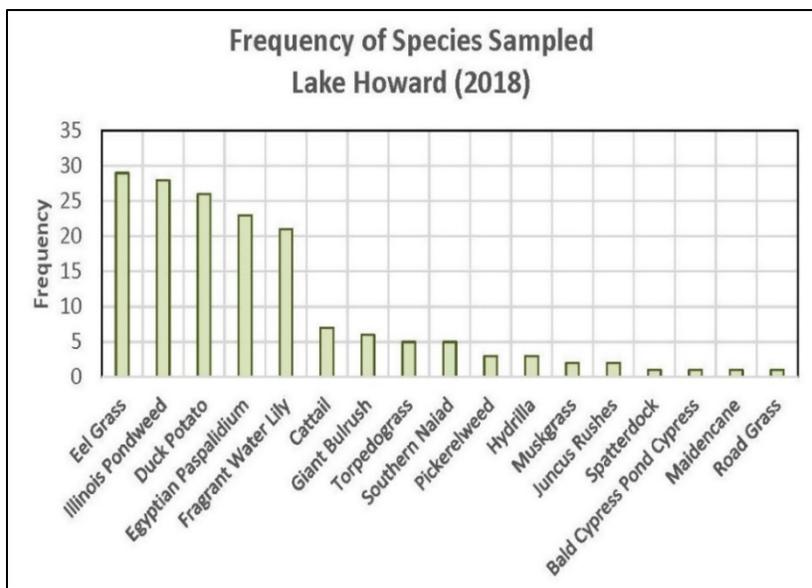
Figure 1-12. Species Frequency Chart of Aquatic Vegetation in Lake Howard.

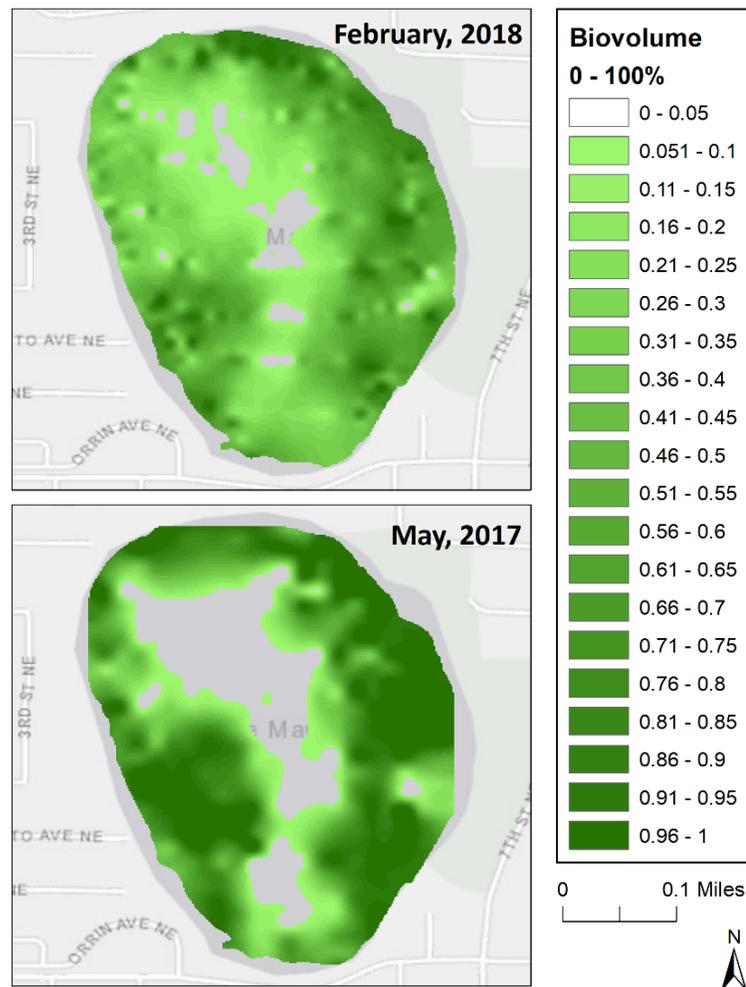
Figure 2-2. Biovolume heat map of Lake Maude. Color scale represents percent of water column occupied by plants.

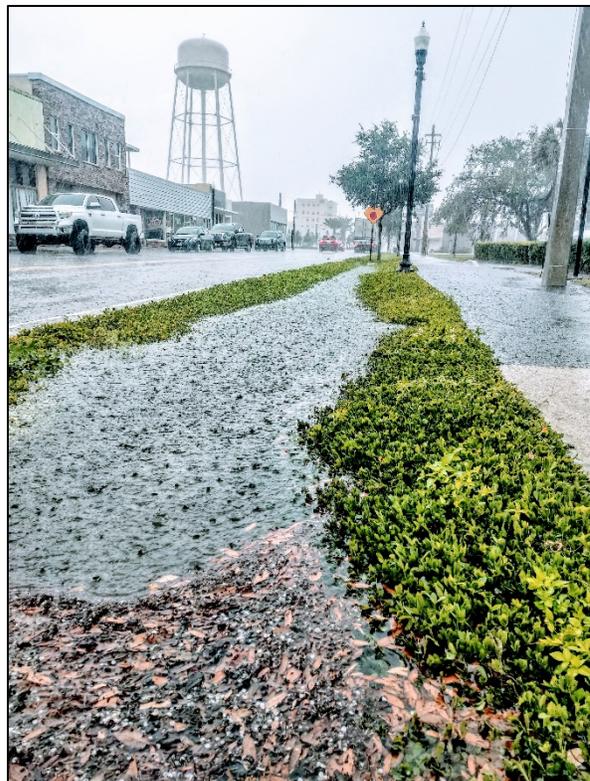
Figure 2-3. Photo of a raingarden capturing runoff and road debris in downtown Winter Haven.

Green stormwater infrastructure (GSI) is a term referring to practices that incorporate natural processes in the development of stormwater systems. Traditional, or “gray”, stormwater infrastructure relies on impervious materials, gutters, and pipes to transfer runoff from one area to another. Typically, these systems are implemented in urban areas to prevent flooding by directing stormwater to a nearby catchment or basin. In the Winter Haven area, gray infrastructure diverts runoff, as well as any pollutants, directly to lakes or stormwater ponds. In contrast, green infrastructure and LIDs utilize plants and soil characteristics to promote stormwater treatment and groundwater infiltration; resulting in cleaner and/or less runoff entering local waterbodies. Examples of green infrastructure and LIDs include raingardens (Figure 2-3), bioswales, pervious pavement, and exfiltration structures (French drains).

Currently, the City has constructed over 60 raingardens and exfiltration systems in and around Winter Haven’s urban center. Lakes receiving stormwater benefits from these systems include: Lakes Elbert, Howard, Martha, Maude, May, Otis, Roy, and Silver. Nutrient removal capabilities are minimal on an individual basis, however, GSI can collectively have a greater impact in larger numbers as more stormwater is treated.

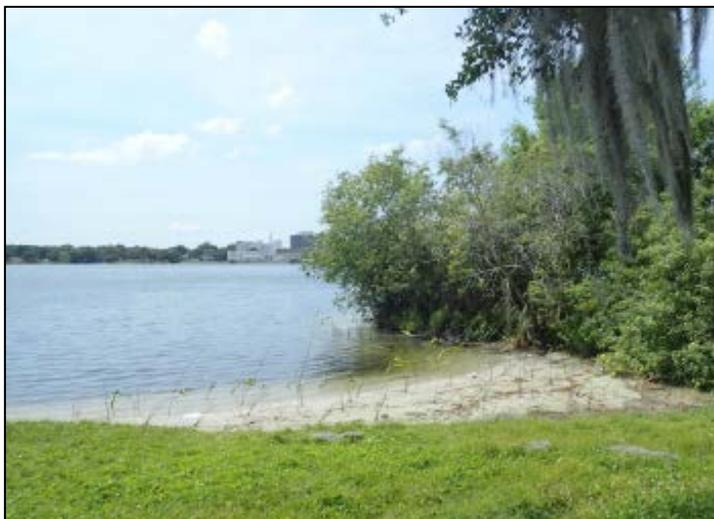
Figure 2-5. Photos of Lake Martha diesel spill remediation planting (top) and Lake Idyl tussock removal (bottom).

Natural Resources staff have conducted shoreline vegetation plantings in Lake Martha in 2013 and Lake Silver in 2017. City staff also assisted FDEP and the Winter Haven Hospital with remediation efforts in Lake Martha after a diesel spill in 2020 (Figure 2-5). More recently, staff have coordinated with residents and the Lakes Region Lakes Management District to remove tussocks from Lakes May and Idyl (Figure 2-5). In 2022, staff entered into discussions with the FWC’s Aquatic Habitat Restoration and Enhancement Subsection (AHRES) to deploy fish attractors in Lake Martha as well.

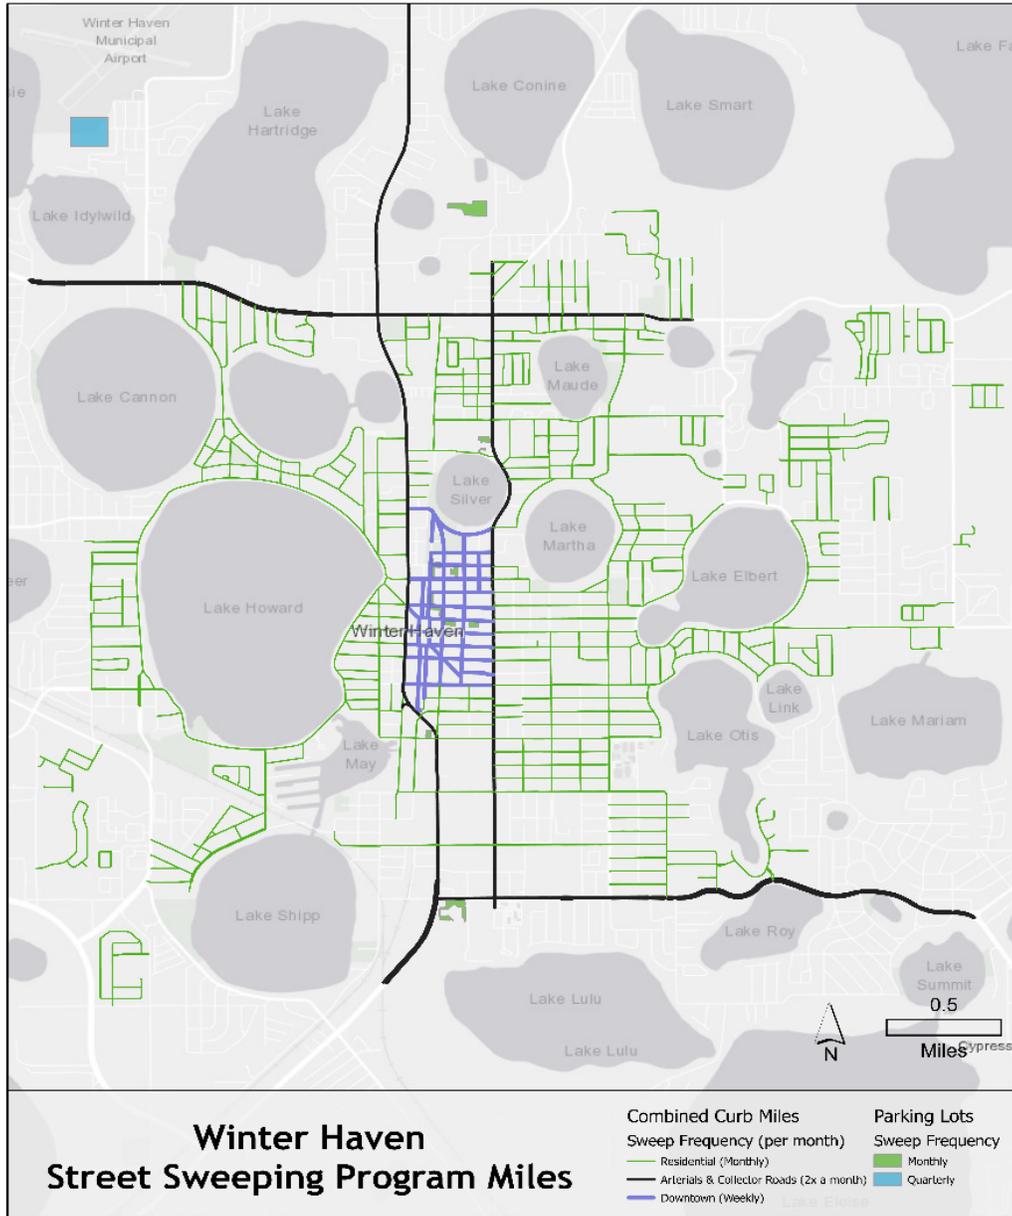
Figure 2-10. Map depicting roadways undergoing street sweeping. Legend indicates sweeping frequency of each street category.

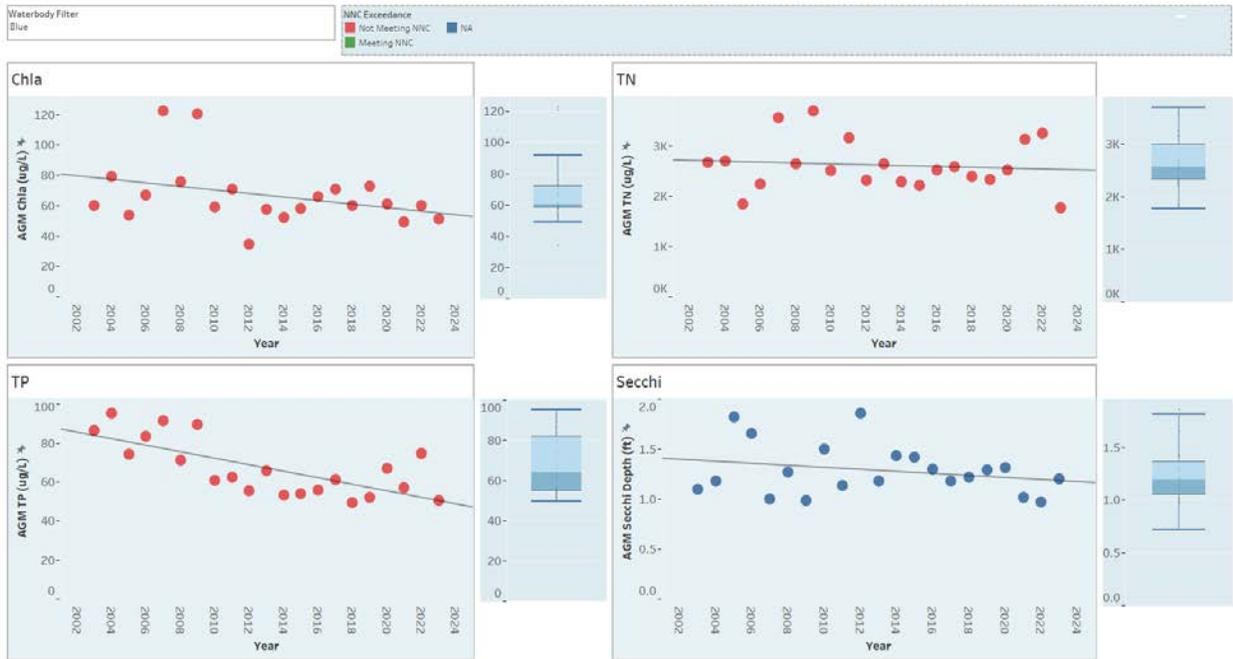
Figure 3-6. Lake Blue AGM Chl-a, TN, TP, and Secchi depth values from 2003 to 2023. Data points colored in red depict NNC exceedances. Also detailed are trend lines and box & whisker plots that show relative variance.

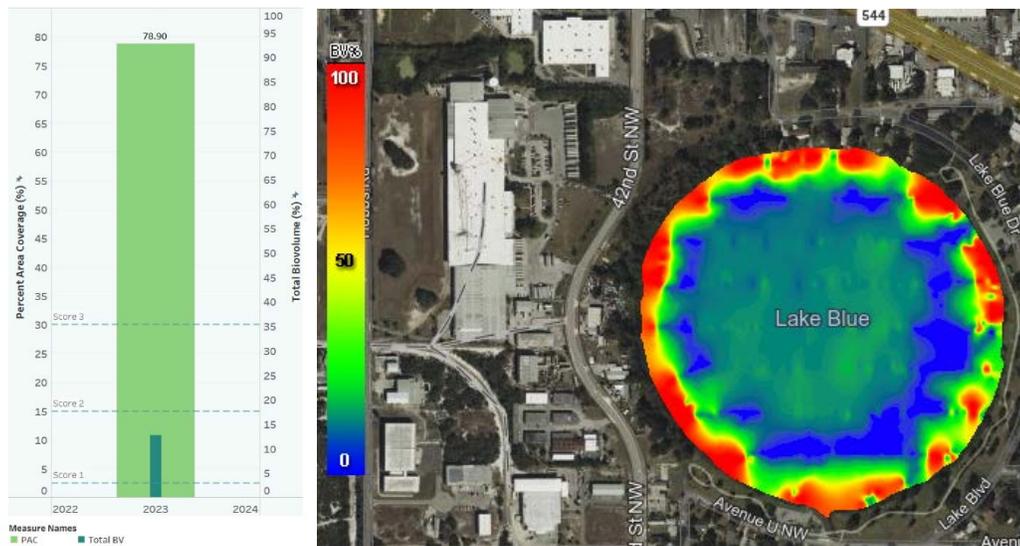
Figure 3-7. Graph depicting 2023 PAC/BV and biovolume heatmap; biovolume values range from green (lowest) to red (highest).

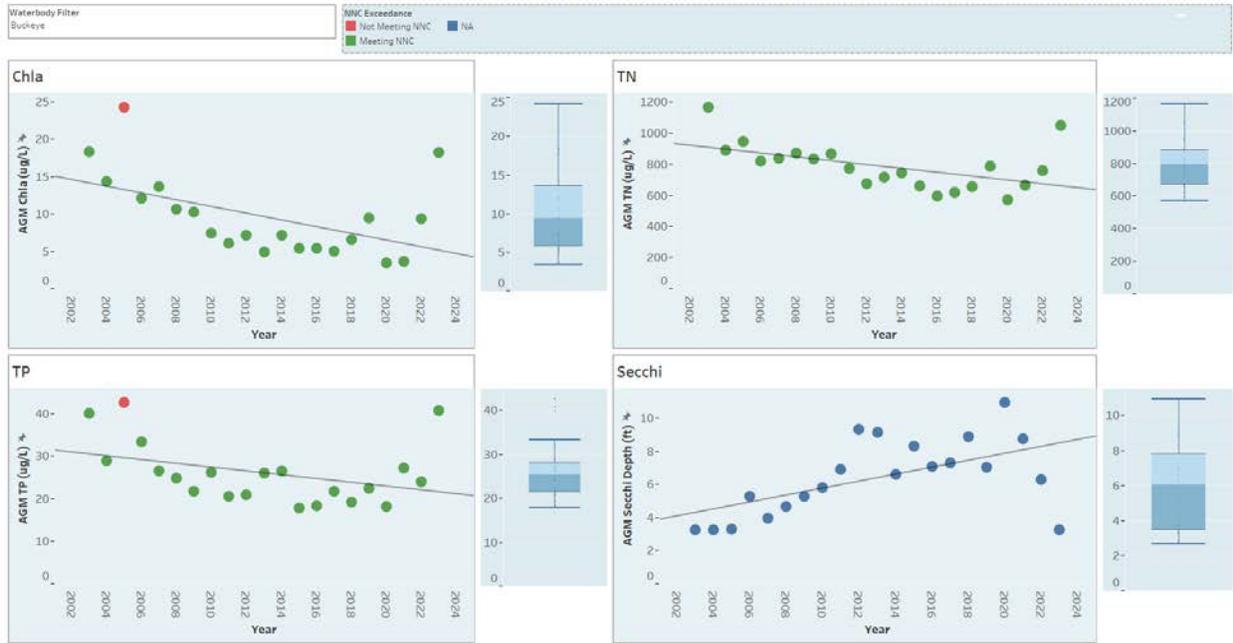
Figure 3-14. Lake Buckeye AGM Chl-a, TN, TP, and Secchi depth values from 2003 to 2023. Data points colored in red depict NNC exceedances. Also detailed are trend lines and box & whisker plots that show relative variance.

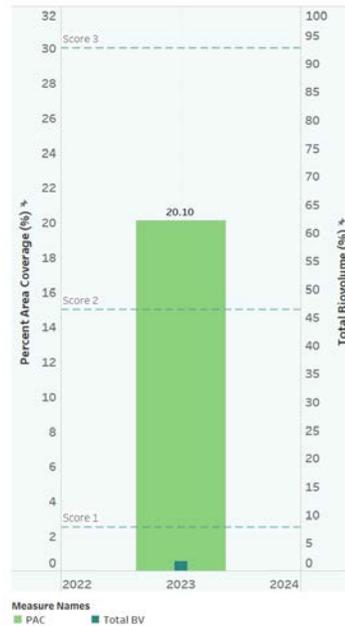
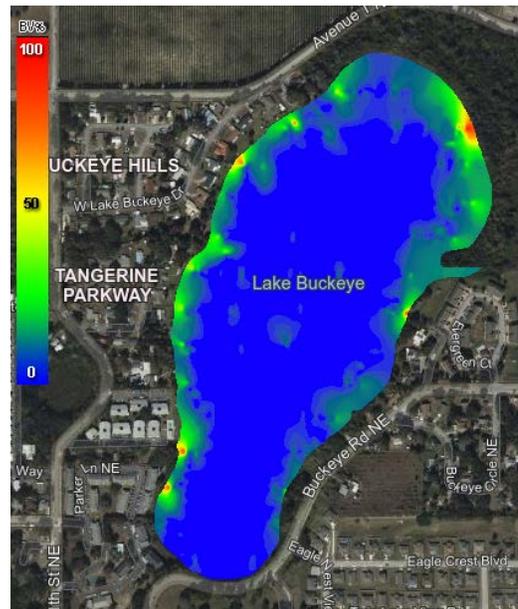
Figure 3-15. Graph depicting 2023 PAC/BV and biovolume heatmap; biovolume values range from green (lowest) to red (highest).

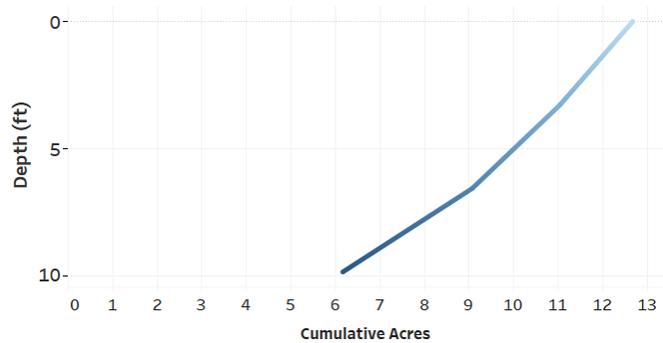
Figure 3-35. Hypsograph of Lake Daisy depicting cumulative area at regular depth intervals. Demonstrates the slope and morphology of the lake bed.

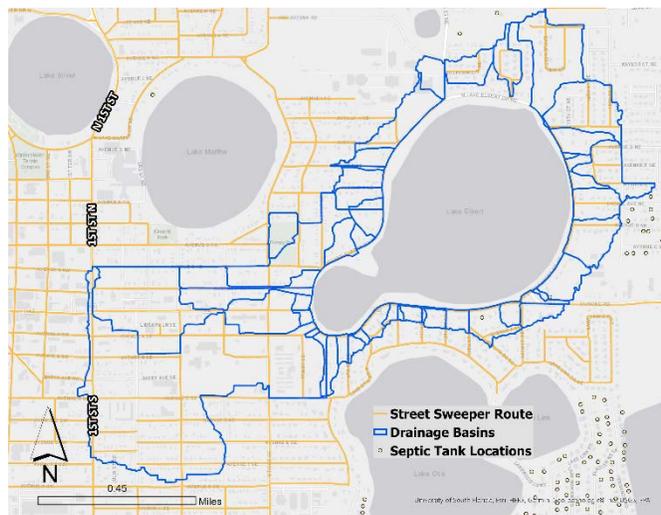
Figure 3-52. Map of Lake Elbert’s drainage basin, City street sweeper routes, and nearby septic systems.

Stormwater is conveyed to this waterbody from a 439 acre urbanized drainage basin made up of 50 individual sub-basins (Figure 3-52). By far the largest proportion of land use in this basin is comprised of medium-density residential, followed by institutional, commercial, and open land. Based on stormwater modelling, these land uses contribute up to 2,365 lbs of TN and 385 lbs of TP to the lake annually. There are very few known Onsite Sewage Treatment and Disposal (OSTD/septic) systems within the vicinity of Lake Elbert. Completely within City limits, Winter Haven conducts monthly street sweeping services of up to 33.5 miles within this basin.

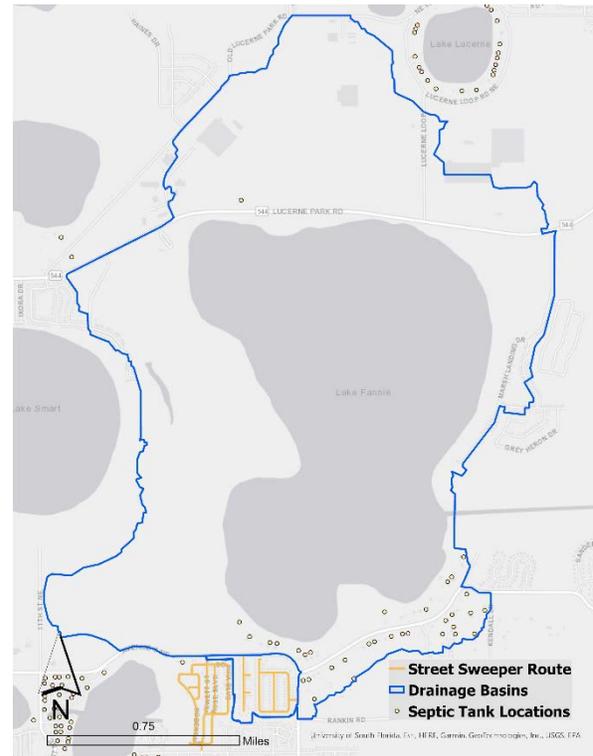
Figure 3-68. Map of Lake Fannie's drainage basin, City street sweeping services, and nearby septic systems.

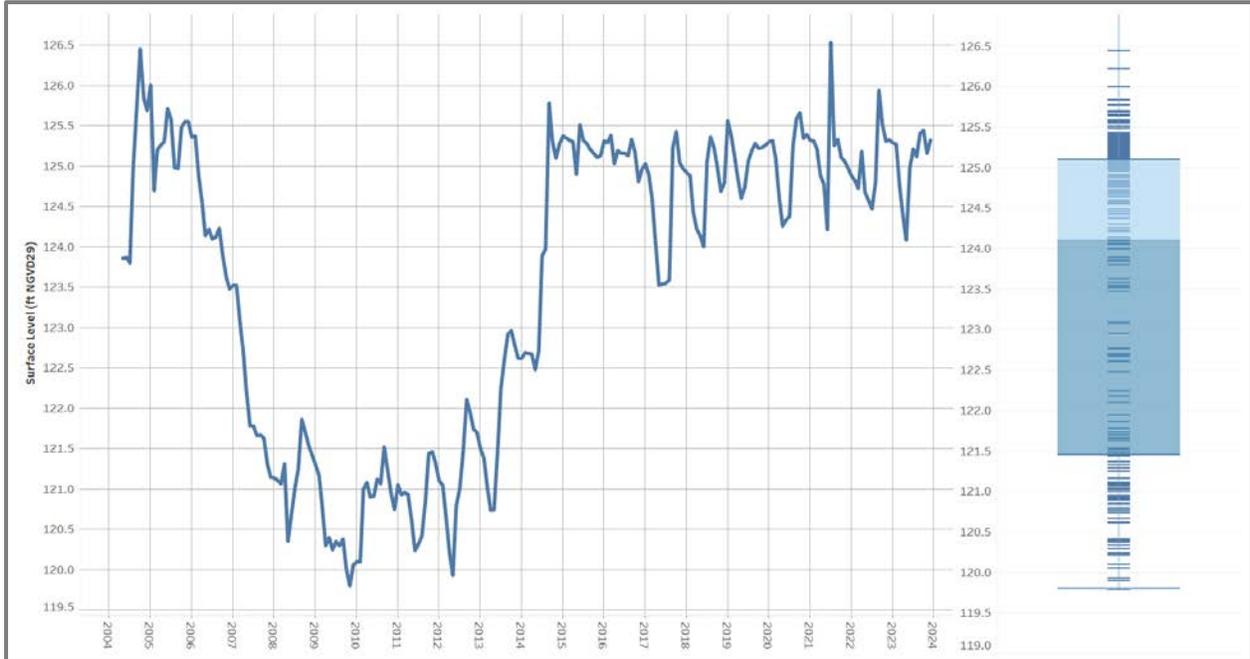
Figure 3-69. Hydrograph of Lake Fannie depicting monthly surface level readings from 2000 to 2023. A box and whisker plot details total range, median, and normal range of surface level during the period of record.

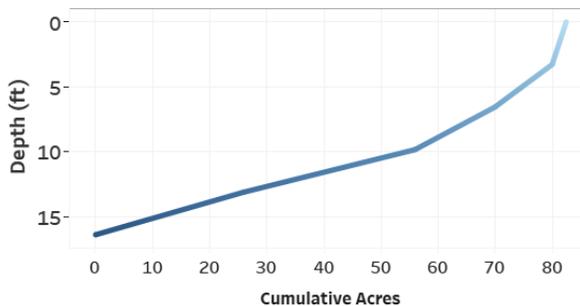
Figure 3-75. Hypsograph of Lake Haines depicting cumulative area at regular depth intervals. Demonstrates the slope and morphology of the lake bed.

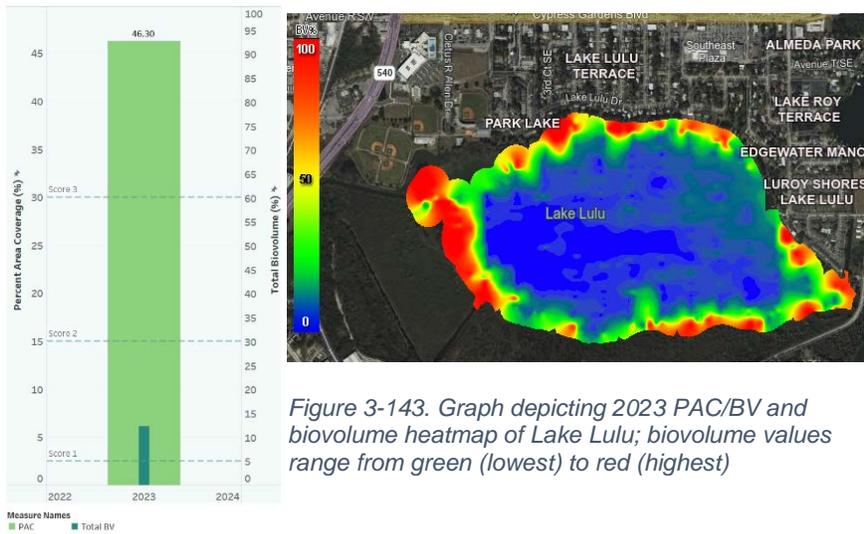
Figure 3-143. Graph depicting 2023 PAC/BV and biovolume heatmap of Lake Lulu; biovolume values range from green (lowest) to red (highest)

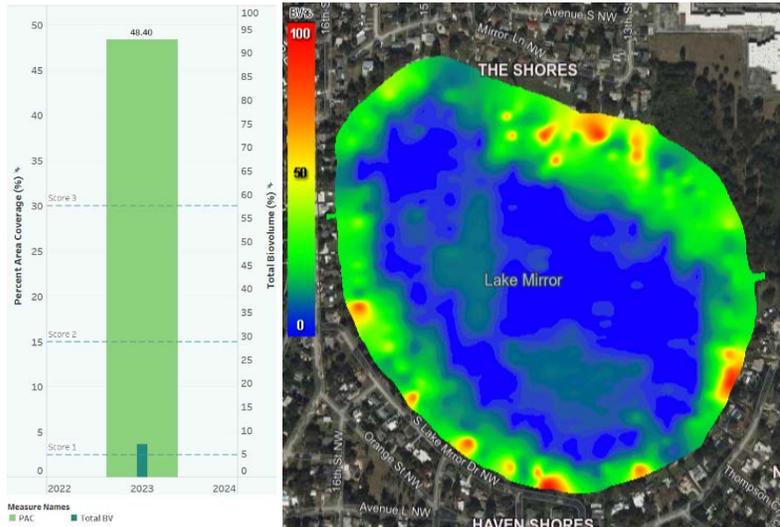
Figure 3-191. Graph depicting 2023 PAC/BV and biovolume heatmap of Lake Mirror; biovolume values range from green (lowest) to red (highest).

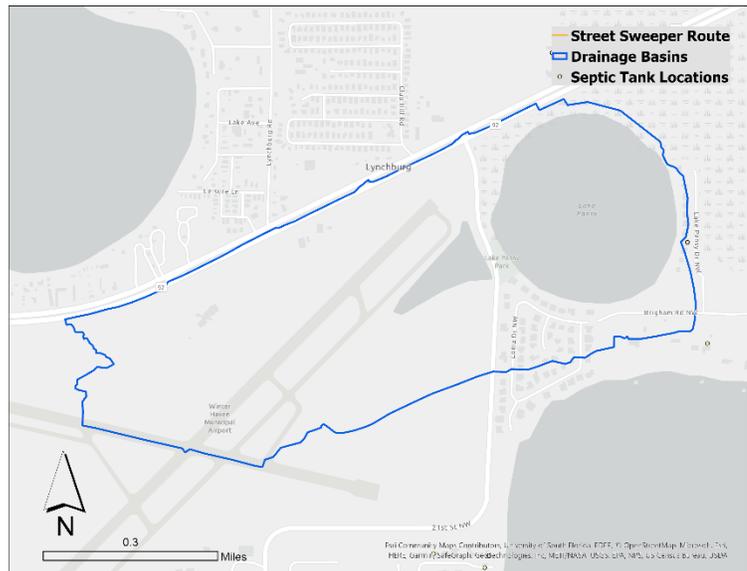
Figure 3-212. Map of Lake Pansy’s drainage basin and nearby septic systems.

Stormwater is conveyed to this waterbody from a 244-acre drainage basin (Figure 3-212). The majority of this basin is comprised of the Winter Haven Airport, a transportation land use; while the remaining land uses include medium-density residential and wetlands. Based on stormwater pollutant load modelling, this drainage area contributes 880 lbs of TN and 111 lbs of TP to the lake annually. There are no known Onsite Sewage Treatment and Disposal (OSTD/septic) systems within the drainage basin. While the airport drainage is treated via a stormwater pond prior to discharging to Lake Pansy, the City does not conduct any street sweeping services in this basin. However, 21st Street is a potential sweeper route expansion area.

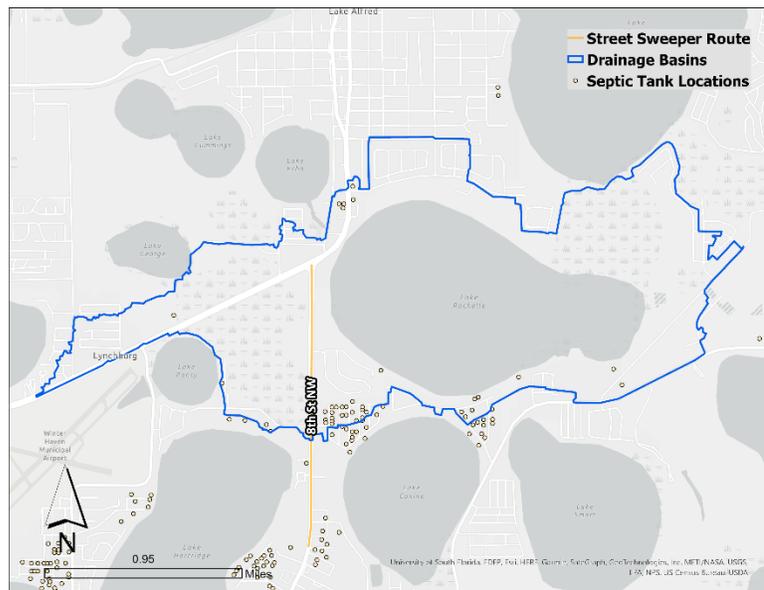
Figure 3-219. Map of Lake Rochelle’s drainage basin, City street sweeper routes, and nearby septic systems.

Stormwater is conveyed to this waterbody from a 1,670 acre, relatively rural drainage basin (Figure 3-220). Ranked by area, the primary land uses comprising this basin are wetlands, medium-density residential, agricultural, high-density residential, and commercial. Based on stormwater pollutant load modelling, this drainage area contributes 3,002 lbs of TN and 522 lbs of TP to the lake annually. There are over 40 Onsite Sewage Treatment and Disposal (OSTD/septic) systems within the basin. These constitute a relatively low density based on the number of systems per acre. To mitigate stormwater pollutant loading, the City conducts 4.4 miles of street sweeping twice monthly along US Highway 17.

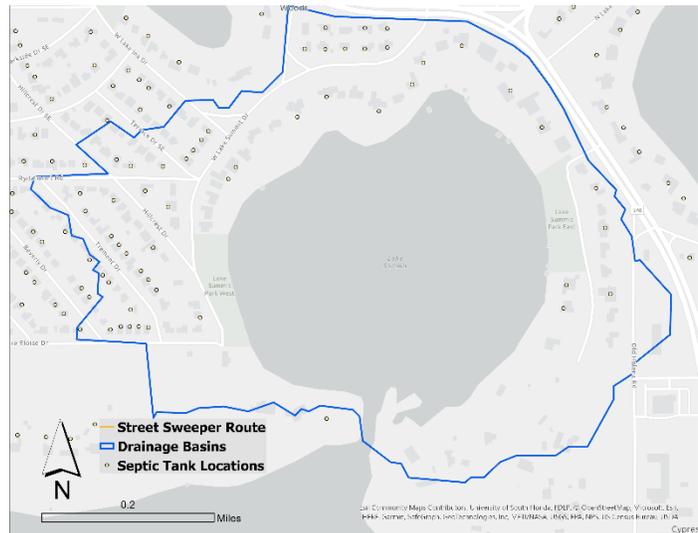
Figure 3-267. Map of Lake Summit's drainage basin and nearby septic systems.

Stormwater is conveyed to this waterbody from a 166-acre drainage basin (Figure 3-268). The basin is dominated by medium-density residential land use, followed by recreational and low-density residential, respectively. Based on stormwater pollutant load modelling, this drainage area contributes 513 lbs of TN and 83 lbs of TP to the lake annually. There are 52 Onsite Sewage Treatment and Disposal (OSTD/septic) systems present in the basin. This constitutes a moderate density that may contribute some pollutant loading through groundwater leaching. Due to the drainage basin being mostly outside of Winter Haven limits, the City does not conduct any street sweeping that benefits this lake.

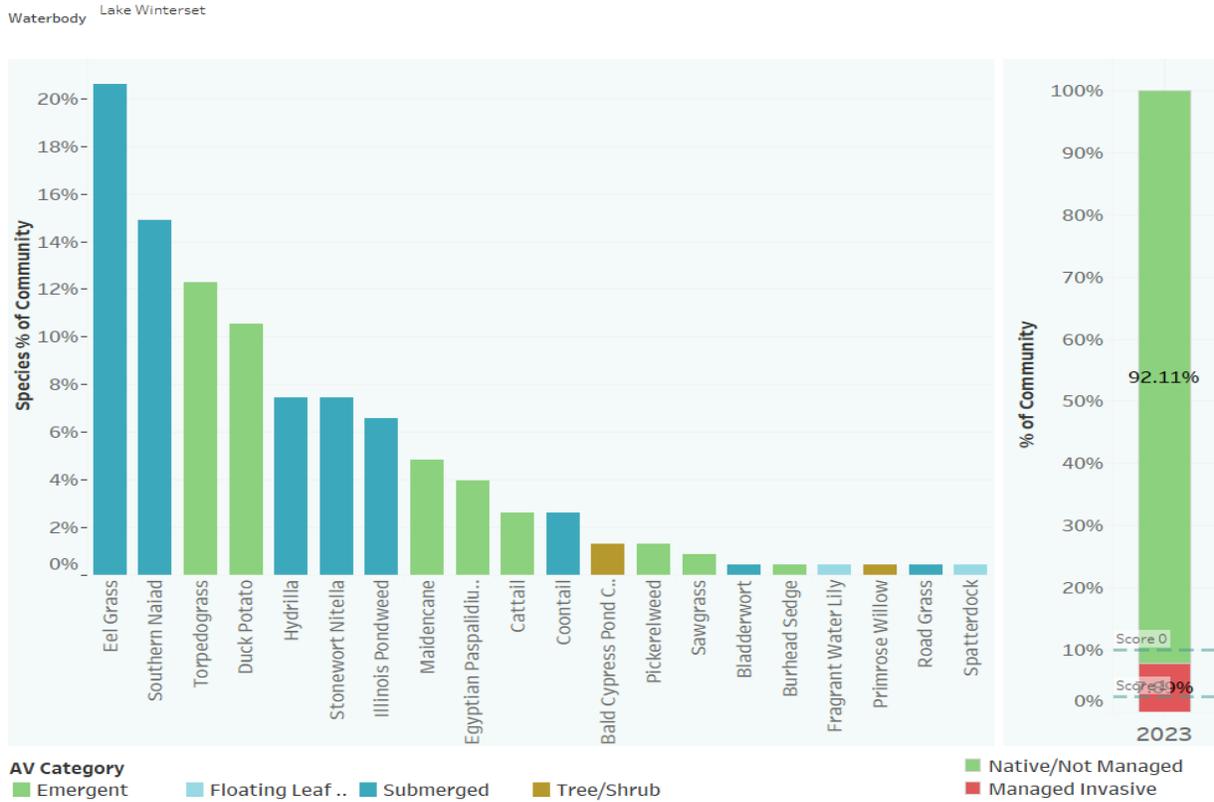
Figure 3-280. Chart depicting species frequency and invasive species presence of Lake Winterset during 2023.

to an invasive percentage score of 1. It should be noted that invasive treatment efforts resulted in a reduction of invasives by 10 percentage points since 2022.
