# Winter Haven Lakes Report

2024

**CITY OF WINTER HAVEN**  
**Public Works Department**  
**Natural Resources Division**

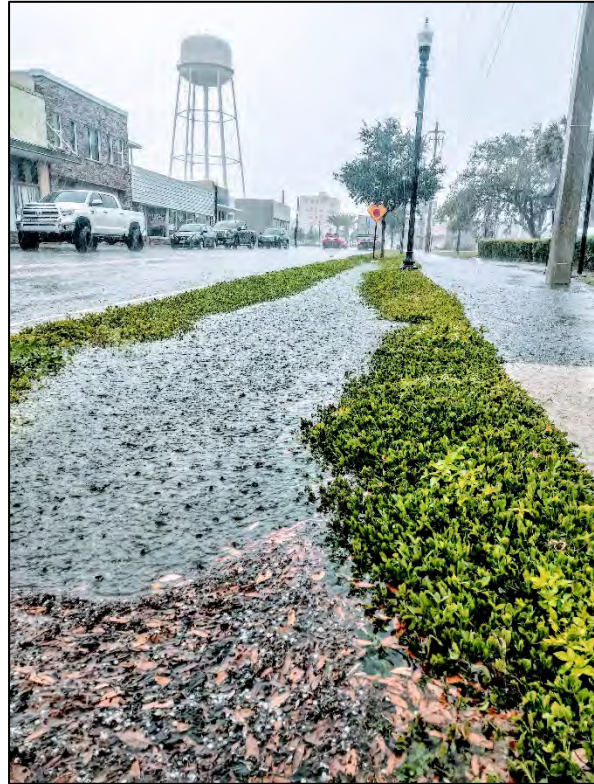
Figure 2-2. Photo of a raingarden capturing runoff and road debris in downtown Winter Haven.

The purpose of these types of GSI practices is to capture sediments, heavy metals, and other solid debris during the first flush of a rainfall event, preventing it from entering waterbodies at the “end of the pipe”. Taking advantage of well-drained soils to promote infiltration, flooding along roadways can be reduced during 1-year to 10-year storm events. Planting of appropriate vegetation can also allow for nutrient uptake while also beautifying the urban landscape. Under the right soil conditions, these types of GSI can be utilized in lieu of conventional stormwater practices; often occupying smaller footprints than traditional stormwater ponds while providing improved pollutant capture. The common types of infiltration GSI practices include raingardens (Figure 2-2), vegetated swales, and exfiltration pipes (i.e. French drains). Practices such as raingardens can also be a relatively low-cost option for residents to reduce minor flooding and improve aesthetics on private property as well. Currently, the City has constructed over 60 raingardens, bioswales, and exfiltration systems in and around Winter Haven’s urban center. Waterbodies receiving stormwater benefits from these systems include: Lakes Elbert, Howard, Martha, Maude, May, Otis, Roy, and Silver.

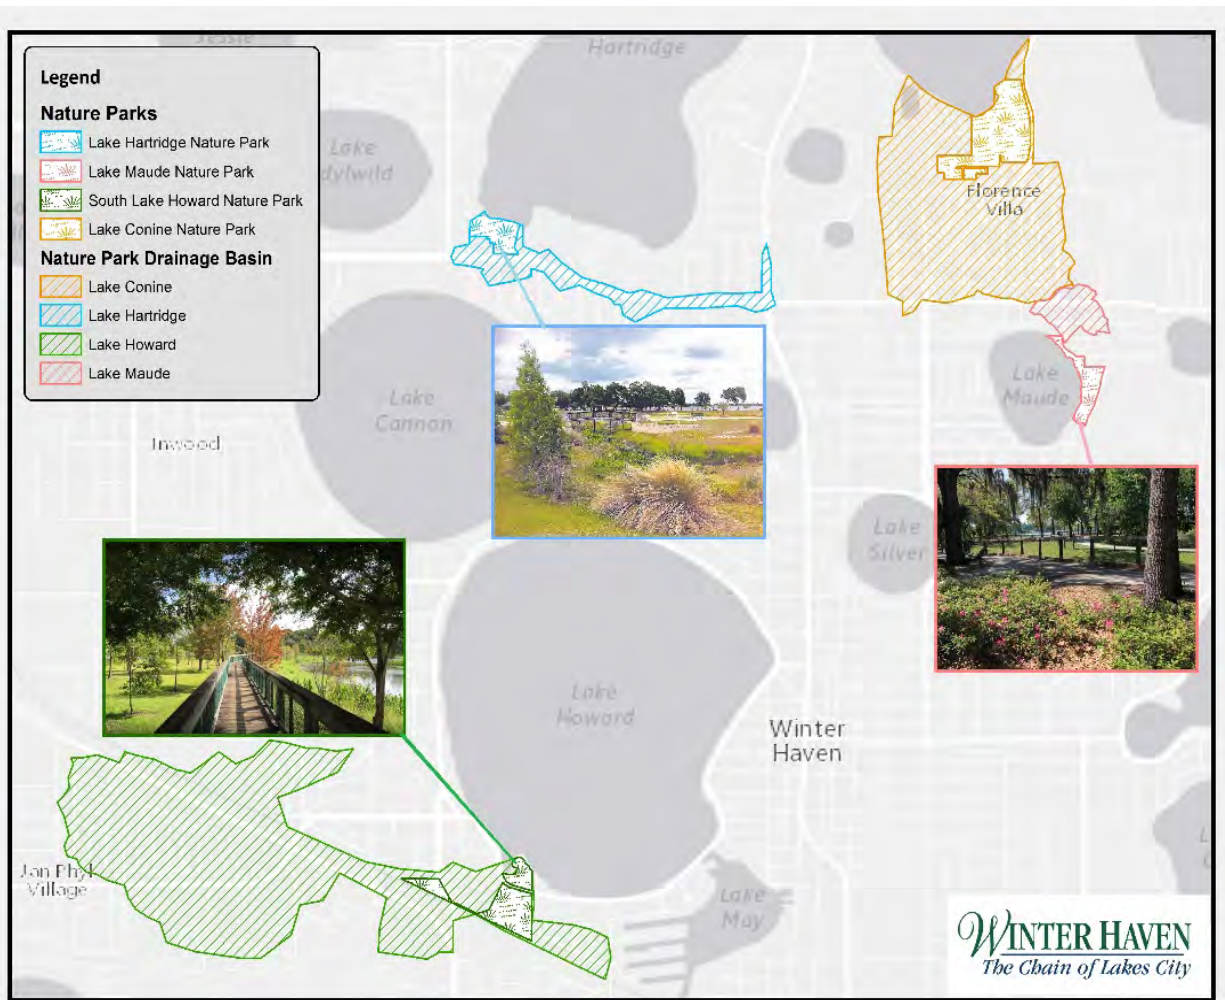
Figure 2-3. Map depicting the Winter Haven nature parks and their drainage basins.

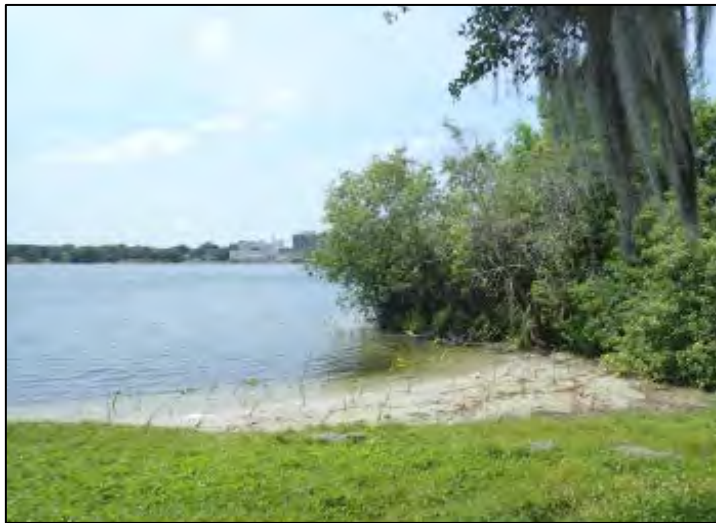
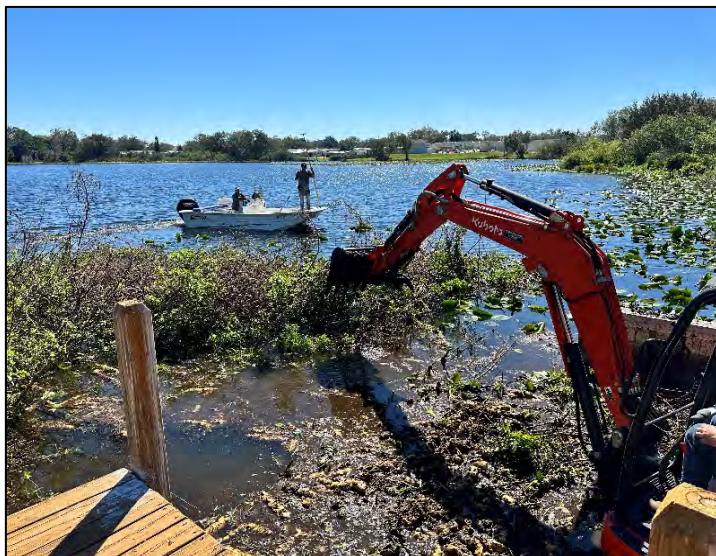
Figure 2-10. Photos of Lake Martha diesel spill remediation planting (top) and Lake Idyl tussock removal (bottom).

Another practice involves the reduction and removal of invasive plant species (Figure 2-10). Native plants have trouble competing with the extraordinary growth rates and lack of natural predators of exotic species, thus reducing diversity and wildlife habitat. Many invasive plants, like hydrilla and water hyacinth can clog up waterways, making navigation and recreational activities more difficult. Controlling terrestrial invasives, like Brazilian Peppertree, is also important for maintaining healthy ecosystems on City-owned properties. Controlling the introduction and spread of invasive plants is critical to preserving the health of our lakes and other natural resources. That said, early detection and rapid response planning is especially important to minimize the negative impacts of invasive removal efforts and herbicides.

fish and wildlife habitat in areas that have been heavily impacted by invasive species or other environmental factors (Figure 2-10). Finally, the City also looks for opportunities to expand critically important fish and wildlife habitat through the purchase and management of public properties. Many of the City's nature parks were purchased wetland parcels that have been improved to provide multiple recreational amenities and ecosystem services.

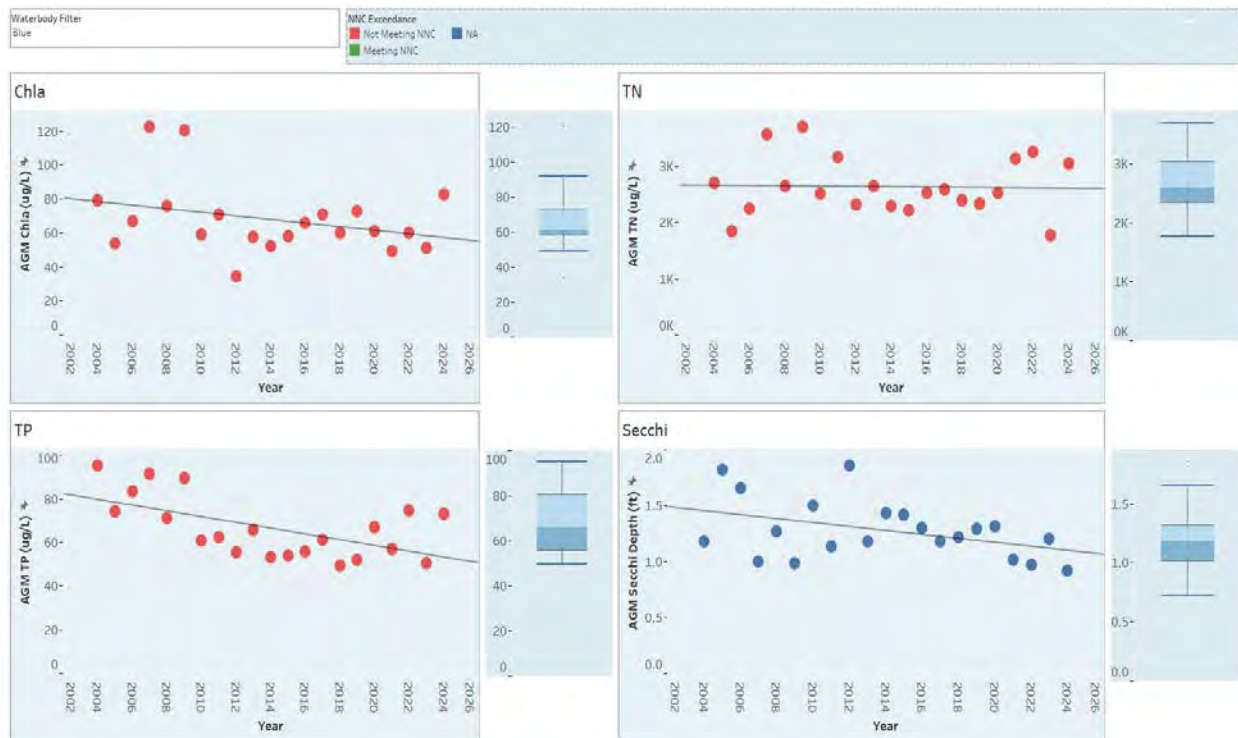
Long-term trend evaluation was conducted using linear regression analysis of annual Chl-a, TN, TP, and Secchi depth values from 2004 to 2024. Total phosphorus exhibited a statistically significant improving trend; Chl-a and TN exhibited non-significant improving trends; and Secchi depth exhibited a non-significant declining trend. Despite its impairments and high nutrient pollutant loads, Lake Blue is exhibiting marginal improvement in water quality. That said, it has a long way to go in order to start meeting the impairment thresholds. For example, the chlorophyll-a concentrations, which were roughly 50 ug/l, would need to be at or below 20 ug/l to meet the target.

Figure 3-7. Lake Blue AGM Chl-a, TN, TP, and Secchi depth values from 2004 to 2024. Data points colored in red depict NNC exceedances. Also detailed are trend lines and box & whisker plots that show relative variance.

period (Figure 3-7). This equates to an impairment criterion score of 0. In 2018, the FDEP established a total maximum daily load (TMDL) for Lake Blue. The TMDL stipulates a 66% reduction in TN and a 67% reduction in TP to meet NNC guidelines.

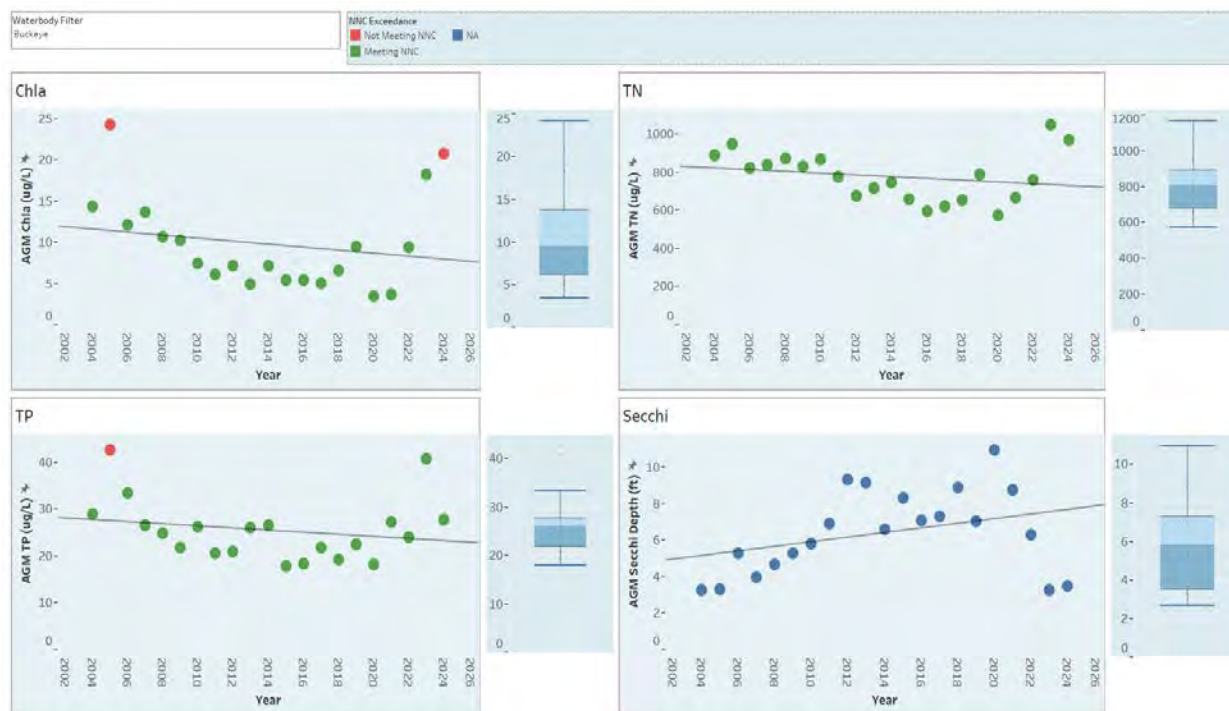
Long-term trend evaluation was conducted using linear regression analysis of AGM Chl-a, TN, TP, and Secchi depth values from 2004 to 2024. All four water quality parameters exhibited non-significant improving trends in 2024. In previous years, Lake Buckeye has shown significant improving trends. However, higher concentrations of Chl-a, TN, and TP coupled with lower Secchi depths indicate a recent shift toward poorer water quality. Again, this is a lake that will require close monitoring to ensure that water quality does not continue to decline.

Figure 3-15. Lake Buckeye AGM Chl-a, TN, TP, and Secchi depth values from 2004 to 2024. Data points colored in red depict NNC exceedances. Also detailed are trend lines and box & whisker plots that show relative variance.

To determine water quality impairment based on the Numeric Nutrient Criteria (NNC), Lake Buckeye is categorized as a clear, alkaline waterbody. Since 2000, there has only been one year in which Buckeye exceeded NNC thresholds in Chl-a and TP—2005 (Figure 3-15). However, Buckeye's Chl-a concentration did exceed the NNC impairment threshold in 2024 and TN also

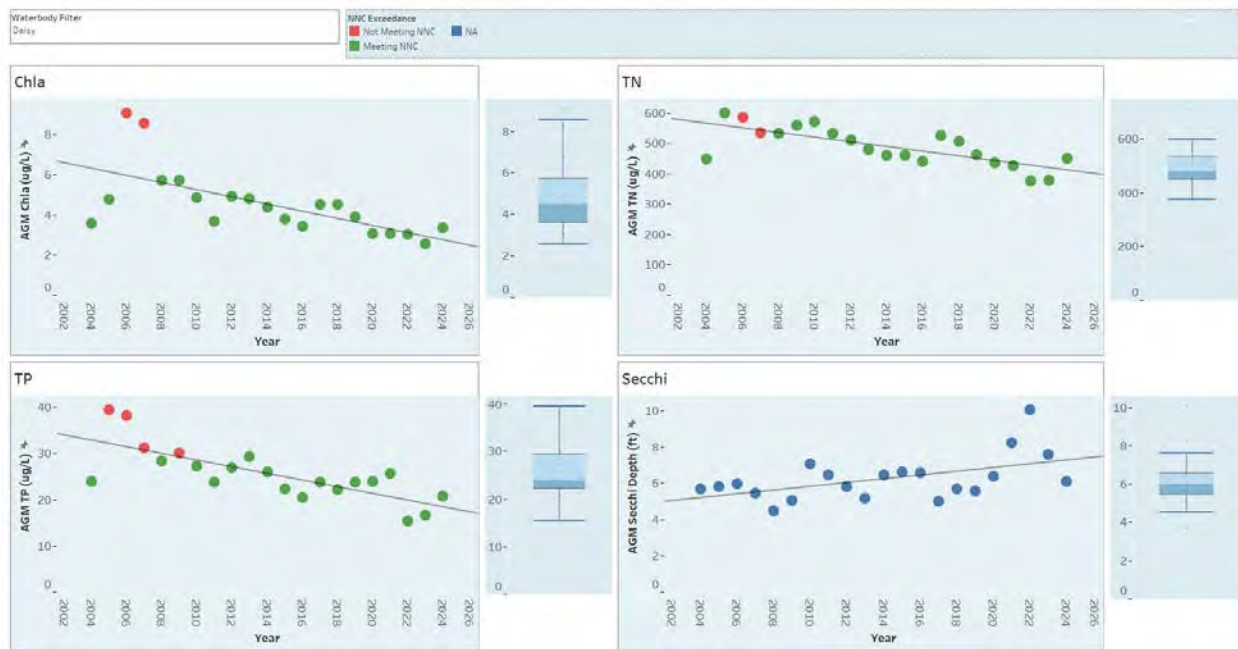
Figure 3-39. Lake Daisy AGM Chl-a, TN, TP, and Secchi depth values from 2004 to 2024. Data points colored in red depict NNC exceedances. Also detailed are trend lines and box & whisker plots that show relative variance.

To determine water quality impairment based on the Numeric Nutrient Criteria (NNC), Lake Daisy is categorized as a clear, low-alkalinity waterbody. Lake Daisy has not exhibited exceedances of any of its NNC parameters within the 7.5 year assessment period (Figure 3-39). The most recent exceedance occurred for TP in 2009. The lack of impairments earns Lake Daisy a score of 3.

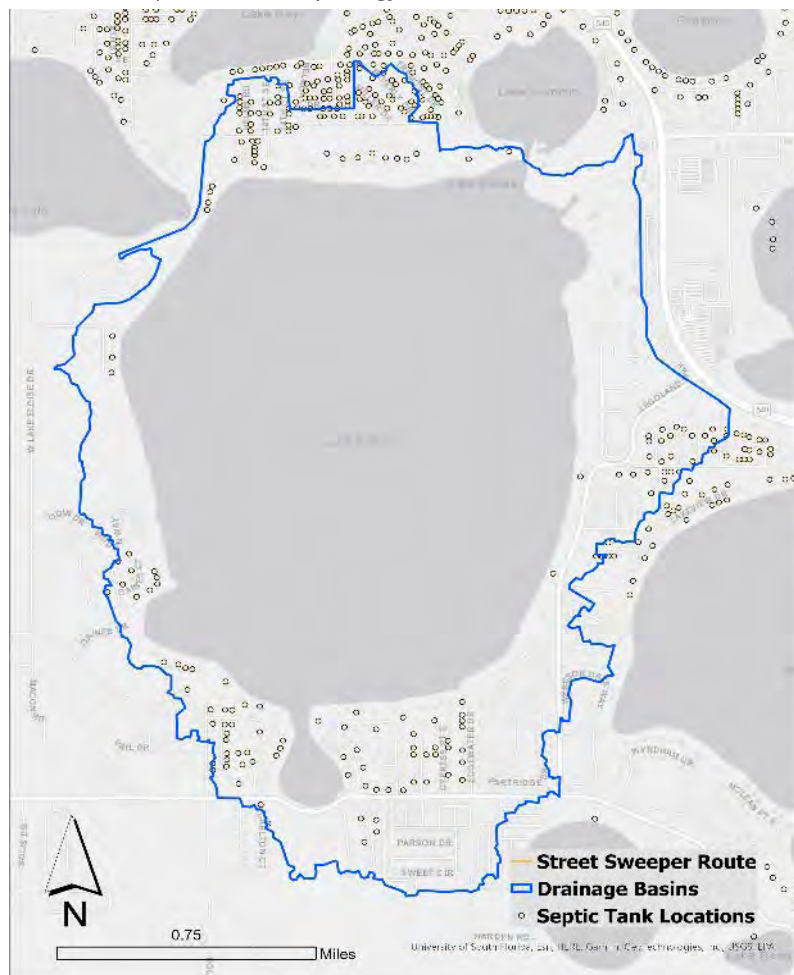
Stormwater is conveyed to this waterbody from a 1,981 acre drainage basin—of which the lake makes up the majority (Figure 3-61). The terrestrial areas of the basin are comprised mostly of residential land uses, with some agricultural in small quantities. These land uses contribute up to 3,875 lbs of TN and 665 lbs of TP to the lake annually. There are 186 septic systems within this basin—mostly congregated in the north and

Figure 3-61. Map of Lake Eloise's drainage basin and nearby septic systems.

south areas of the basin. There exist few City-owned roadways with stormwater infrastructure that drain to the lake. As a result, the City does not conduct street sweeping services in this basin.

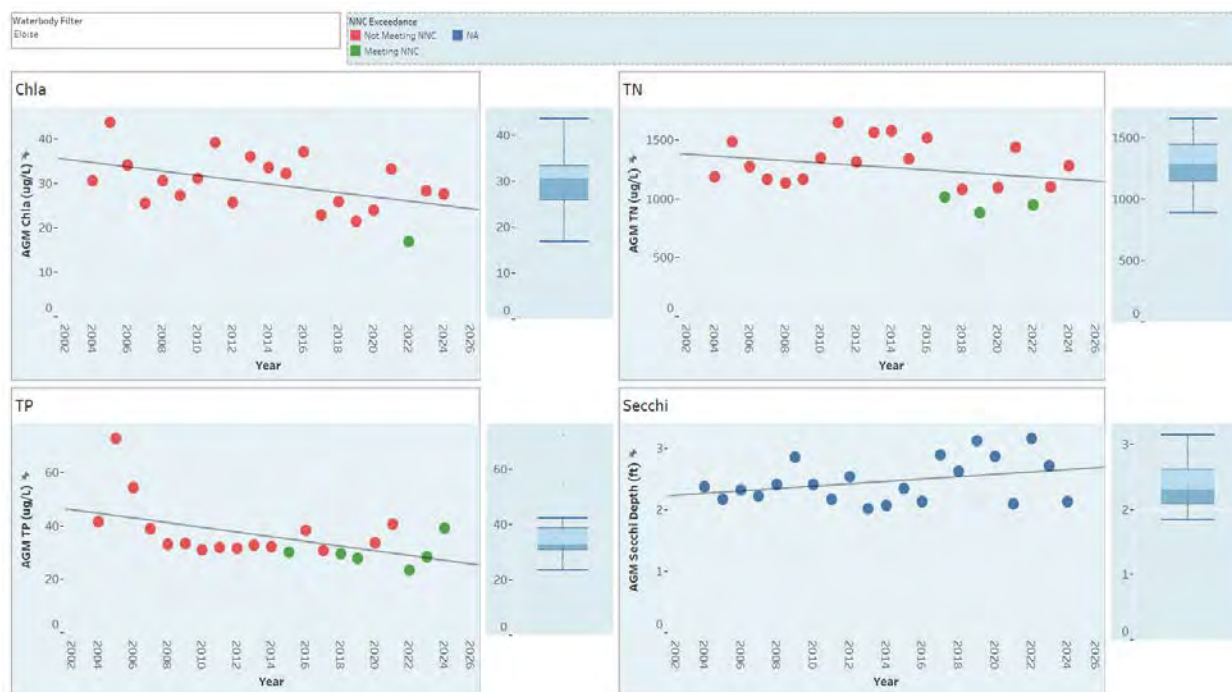
Figure 3-63. Lake Eloise AGM Chl-a, TN, TP, and Secchi depth values from 2004 to 2024. Data points colored in red depict NNC exceedances. Also detailed are trend lines and box & whisker plots that show relative abundance.

To determine water quality impairment based on the Numeric Nutrient Criteria (NNC), Lake Eloise is categorized as a clear, alkaline waterbody. Based on NNC exceedances most years during the assessment period, Lake Eloise is considered impaired for Chl-a, TN, and TP—earning it an impairment criterion score of 0 (Figure 3-63). In 2019, the FDEP established a total maximum daily load (TMDL) for Lake Eloise stipulating a 39% reduction in TN in order to meet NNC guidelines.

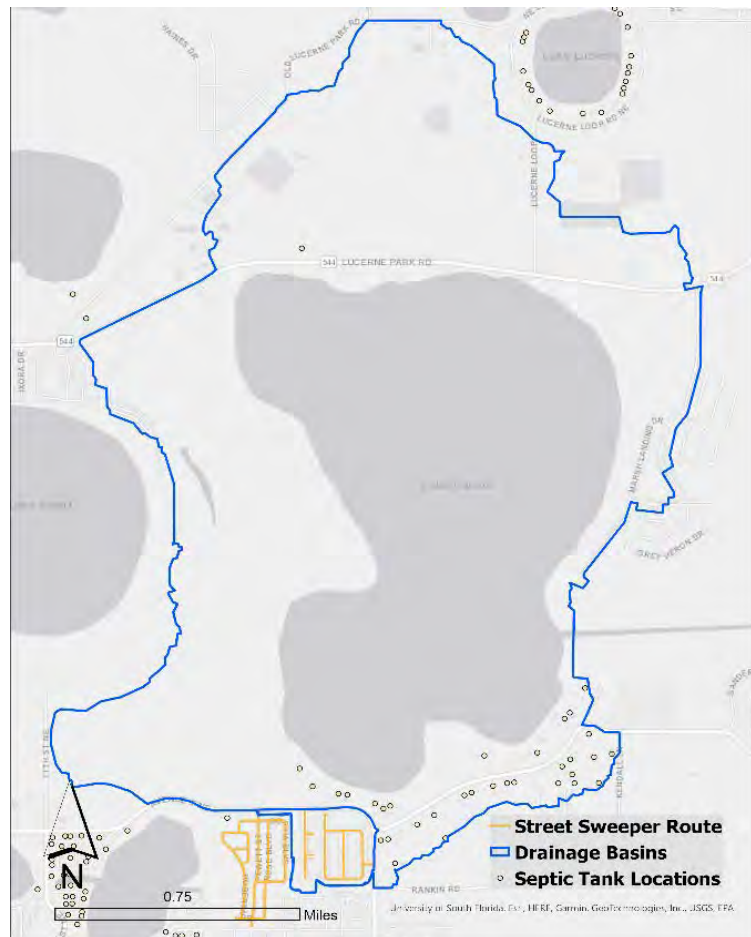
*Figure 3-69. Map of Lake Fannie's drainage basin, City street sweeping services, and nearby septic systems.*

Lake Fannie is a large, but shallow waterbody at 800 acres, with an average depth of 7.6 feet, and a maximum depth of only 10.75 feet (Figure 3-68). This makes it highly susceptible to sediment suspension via wind and wave action. Stormwater is conveyed to this waterbody from a 5,800 acre, mostly rural drainage basin (Figure 3-69). Though, the previously agricultural land uses are shifting more toward residential. These land uses contribute 4,133 lbs of TN and 717 lbs of TP to the lake annually. By area, however, these loads rank 35<sup>th</sup> compared to the other lakes in the region. There are 33 septic systems within this drainage basin. However, due to their low density, this isn't a major concern from a pollutant loading standpoint. There is also very little stormwater infrastructure present within the drainage basin—likely contributing to its relatively low pollutant loads.

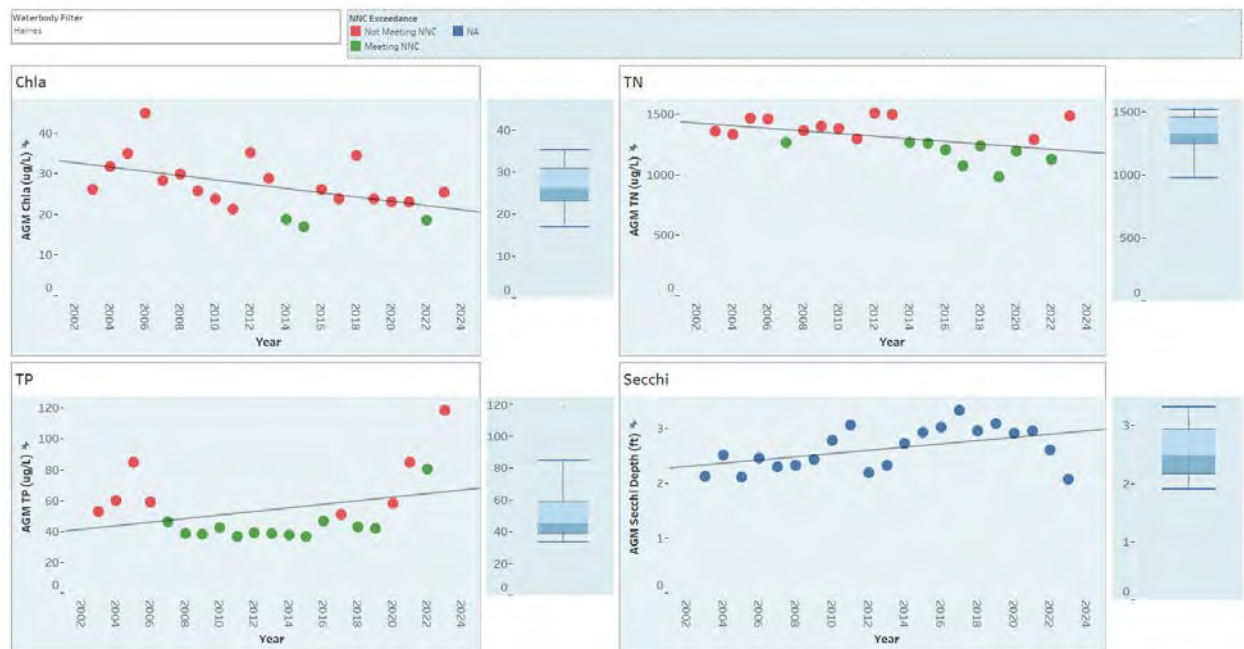
Figure 3-79. Lake Haines' AGM Chl-a, TN, TP, and Secchi depth values from 2004 to 2024. Data points colored in red depict NNC exceedances. Also detailed are trend lines and box & whisker plots that show relative variance.

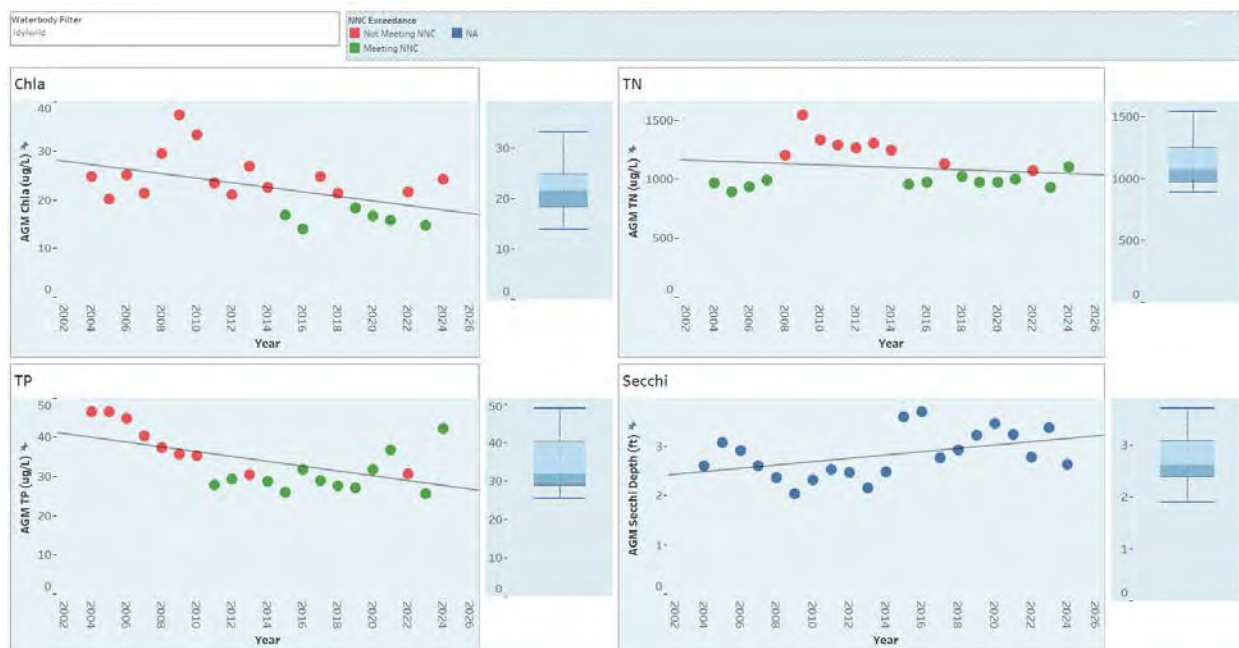
Long-term trend evaluation was conducted using linear regression analysis of AGM Chl-a, TN, TP, and Secchi depth values from 2004 to 2024. Based on the data, Chl-a, TP, and Secchi depth exhibit significant improving trends; which equate to trend criterion scores of 3. While also improving, the TN trend is not statistically significant; which results in a trend score of 2. With the Chl-a concentrations continuing to trend in a downward direction, there should be a point in the near future where Chl-a becomes unimpaired, thereby increasing its water quality scores. Considering Lake Idylwild's previous impairments, these trends highlight how much the lake has improved in the last two decades.

Figure 3-119. Lake Idylwild AGM Chl-a, TN, TP, and Secchi depth values from 2004 to 2024. Data points colored in red depict NNC exceedances. Also detailed are trend lines and box & whisker plots that show relative variance.

To determine water quality impairment based on the Numeric Nutrient Criteria (NNC), Lake Idylwild is categorized as a clear, alkaline waterbody. Due to consecutive NNC exceedances in 2017 and 2018, Lake Idylwild is considered impaired for Chl-a (Figure 3-119). This equates to an impairment criterion score of 2. Concentrations of Chl-a also exceeded the NNC threshold in 2022 and 2024. In 2019, the FDEP established a total maximum daily load for Lake Idylwild, stipulating a 31% reduction in TN to meeting NNC guidelines.

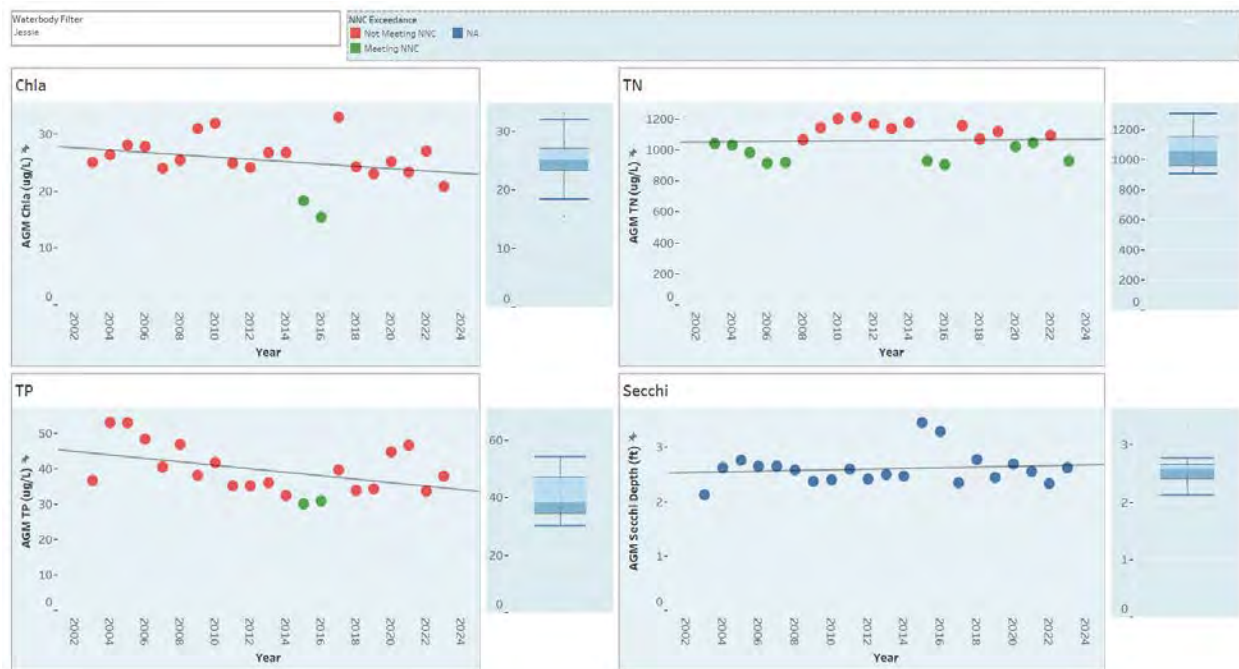
Long-term trend evaluation was conducted using linear regression analysis of AGM Chl-a, TN, TP, and Secchi depth values from 2004 to 2024. None of these parameters exhibited statistically significant trends. Whereas, Chl-a and TN earn a trend criteria score of 1 for their non-significant deteriorating trends and Secchi depth receives a criteria score of 2 for improving trend (Figure 3-127). Individual AGM values and trend statistics can be found in the appendix.

Figure 3-127. Lake Jessie AGM Chl-a, TN, TP, and Secchi depth values from 2004 to 2024. Data points colored in red depict NNC exceedances. Also detailed are trend lines and box & whisker plots that show relative variance.

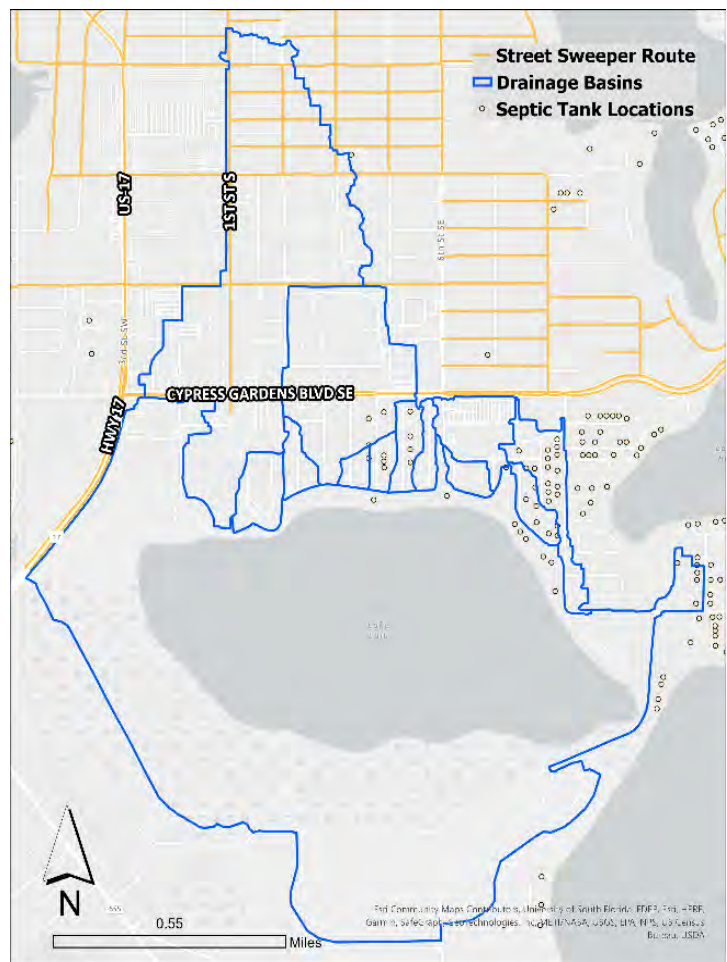
One of the larger waterbodies on the South Chain, Lake Lulu has a total area of 307 acres. While large, Lulu is one of the shallower lakes with a mean depth of 6.8 feet and a maximum depth of 10 feet (Figure 3-140). The shallowness of the lake makes it much more susceptible to sediment suspension via wind and wave action. Stormwater is conveyed to this waterbody from a 1,006 acre drainage basin comprised of 13 individual sub-basins (Figure 3-141). The primary land uses in this drainage area are commercial, wetlands and residential which contribute 2,791 lbs of TN and 483 lbs of TP to Lake Lulu annually. Though these loads rank on the low side compared with the other 36 lakes in the study area. There are 46 septic systems located within the County portion of the basin. This constitutes a moderate density which can have potential impacts on water quality. To combat stormwater pollutant loading, the City conducts 11.6 miles of street sweeping monthly for residential roads and twice monthly for larger roadways.

Figure 3-141. Map of Lake Lulu's drainage basin, City street sweeper routes, and nearby septic systems.

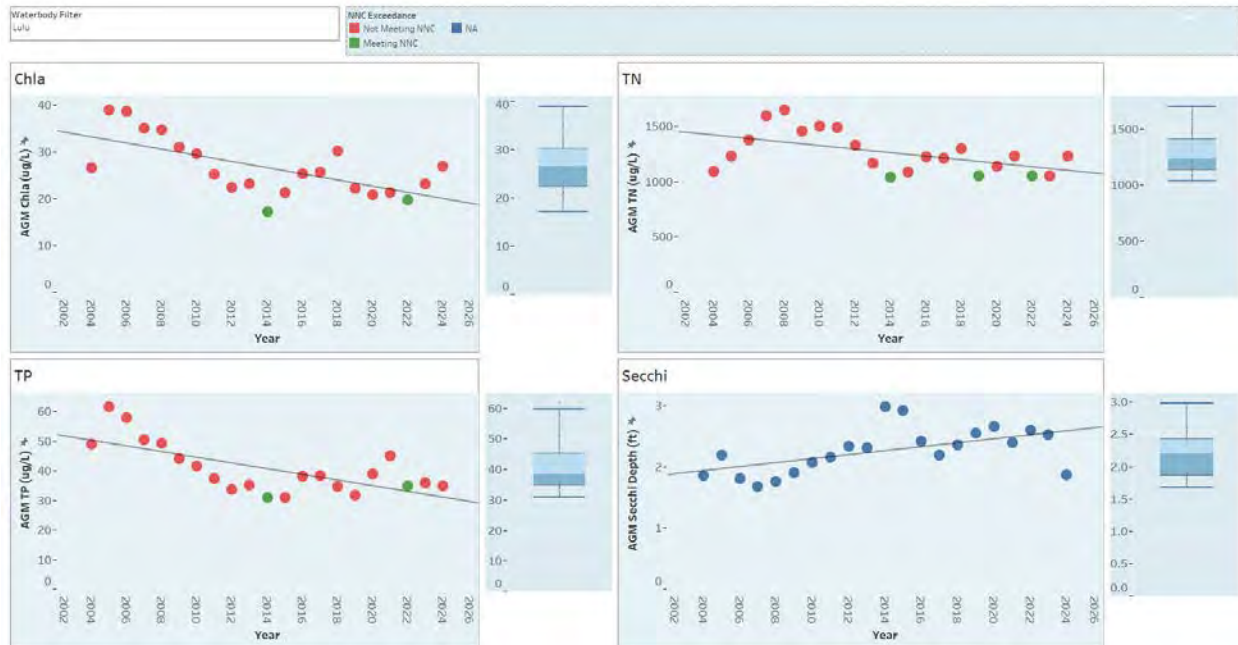
Figure 3-143. Lake Lulu AGM Chl-a, TN, TP, and Secchi depth values from 2004 to 2024. Data points colored in red depict NNC exceedances. Also detailed are trend lines and box & whisker plots that show relative variance.

Long-term trend evaluation was conducted using linear regression analysis of AGM Chl-a, TN, TP, and Secchi depth values from 2004 to 2024. Based on these data, all four of these parameters exhibit significant improving trends. While on the right track, it will still take some time for water quality values to consistently meet NNC guidelines for Lake Lulu to be considered unimpaired.

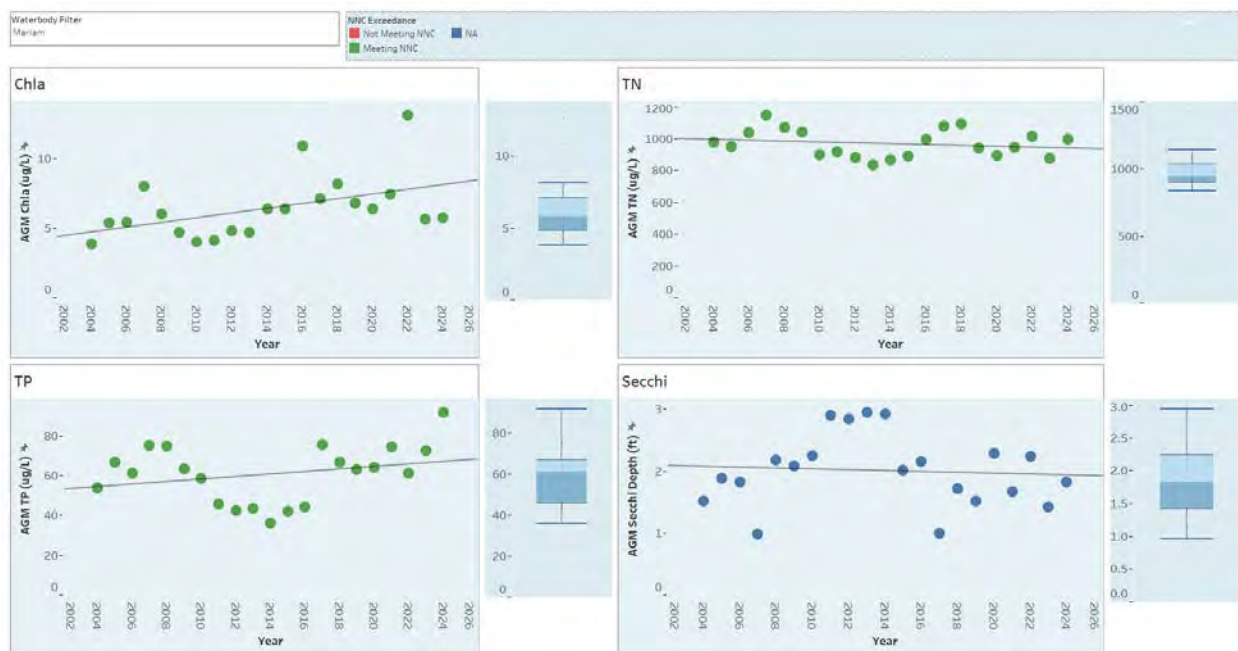
Figure 3-151. Lake Mariam AGM Chl-a, TN, TP, and Secchi depth values from 2004 to 2024. Data points colored in red depict NNC exceedances. Also detailed are trend lines and box & whisker plots that show relative variance.

To determine water quality impairment based on the Numeric Nutrient Criteria (NNC), Lake Mariam is categorized as a high-color waterbody; likely due to its large connected wetland that contributes tannins to the water column. Based on the water quality data, Lake Mariam exhibited no NNC exceedances during the assessment period (Figure 3-151). This equates to an impairment criterion score of 3.

Long-term trend evaluation was conducted using linear regression of AGM Chl-a, TN, TP, and Secchi depth values from 2004 to 2024. Based on these data, Chl-a exhibits a significant deteriorating trend, earning a score of 0. The remaining parameters exhibit non-significant trends; TP and Secchi in deteriorating directions and TN with an improving direction. The Chl-a trend remains the only concern as it could be highlighting potential impairment in the future. That said, the Chl-a concentrations are currently well below the impairment threshold.

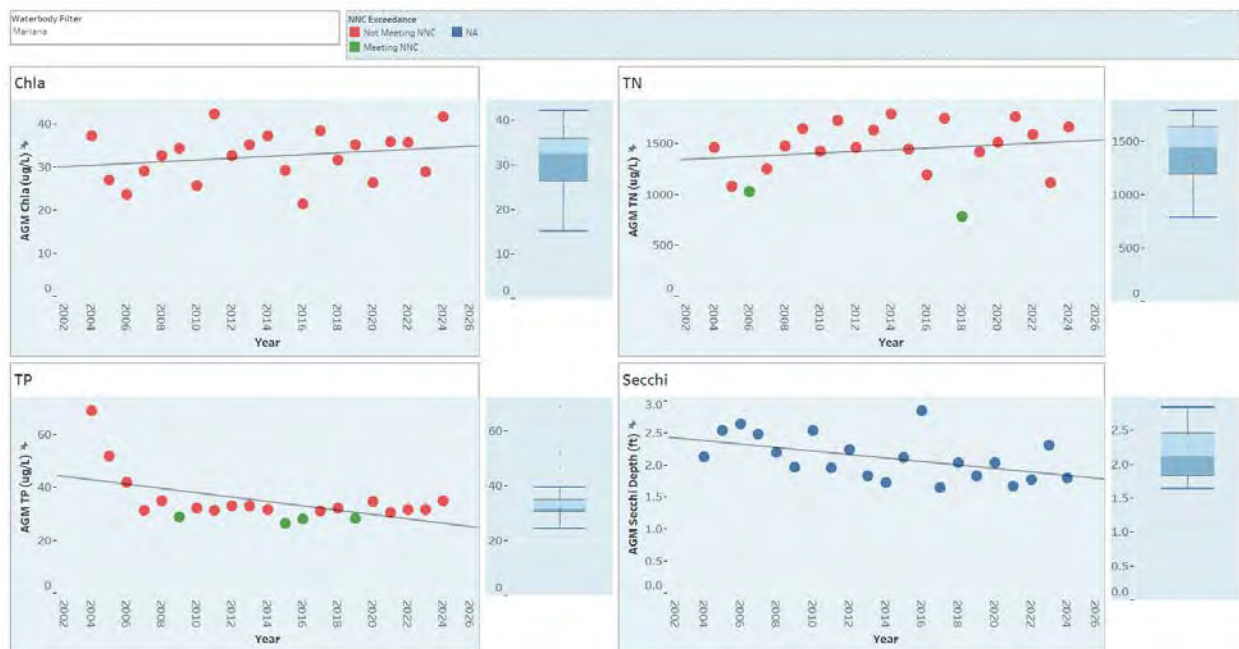
Figure 3-159. Lake Mariana AGM Chl-a, TN, TP, and Secchi depth values from 2004 to 2024. Data points colored in red depict NNC exceedances. Also detailed are trend lines and box & whisker plots showing relative variance.

Long-term trend evaluation was conducted using linear regression analysis of AGM Chl-a, TN, TP, and Secchi depth values from 2004 to 2024. According to the data, only Secchi depth exhibited a significant deteriorating trend. Chl-a and TN shifted in their trend statistics such that their deteriorating trends in 2022 are now non-significant—indicating some improvement. The TP concentrations, on the other hand, are trending significantly in a downward direction.

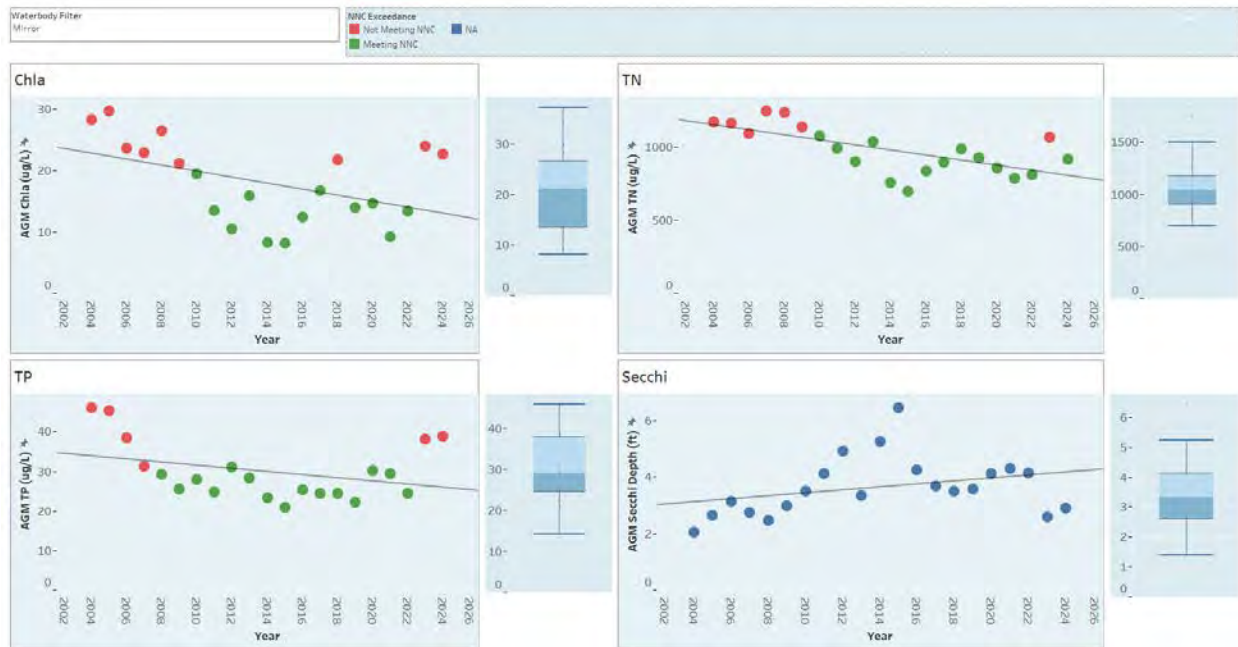
Figure 3-191. Lake Mirror AGM Chl-a, TN, TP, and Secchi depth values from 2004 to 2024. Data points colored in red depict NNC exceedances. Also detailed are trend lines and box & whisker plots showing relative variance.

Long-term trend evaluation was conducted using linear regression analysis of AGM Chl-a, TN, TP, and Secchi depth values from 2004 to 2024. Lake Mirror exhibited significant improving trends in Chl-a and TN, and non-significant improving trends in TP and Secchi depth. Despite the recent impairment classification, it is a good sign that Mirror's chlorophyll and nitrogen levels are still trending downward.

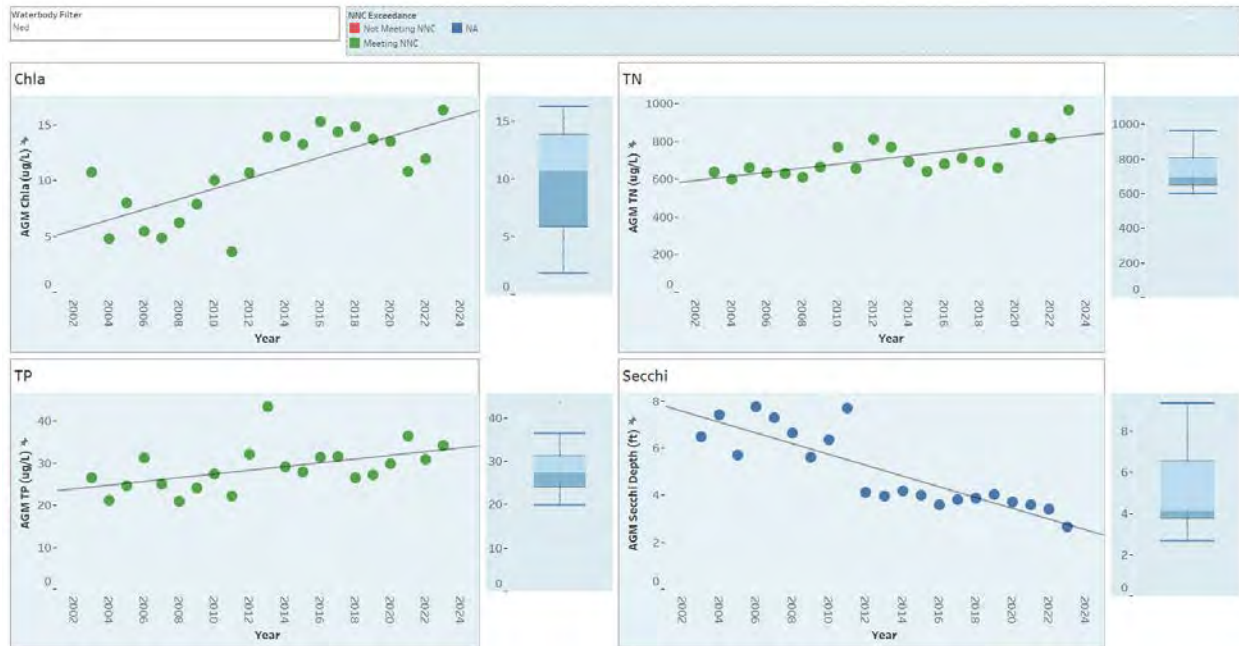
Figure 3-199. Lake Ned AGM Chl-a, TN, TP, and Secchi depth values from 2004 to 2024. Data points colored in red depict NNC exceedances. Also detailed are trend lines and box & whisker plots showing relative variance.

To determine water quality impairment based on the Numeric Nutrient Criteria (NNC), Lake Ned is categorized as a clear, alkaline waterbody. Due to a lack of exceedances in any of the NNC parameters during the assessment period, Lake Ned is considered un-impaired (Figure 3-199). This equates to an impairment criterion score of 3. Recently, concentrations of Chl-a, TN, and TP have been higher than normal; with Secchi depths at or below median levels—indicating water quality declines.

Long-term trend evaluation was conducted using linear regression analysis of AGM Chl-a, TN, TP, and Secchi depth values from 2004 to 2024. Chl-a, TN, and Secchi depth all exhibited

significant deteriorating trends. This equates to trend criteria scores of 0. While a deteriorating TP trend was present in 2023, this has shifted to a non-significant deteriorating trend in 2024. It is evident that Lake Ned's water quality is trending in a negative trajectory. Management efforts will be critical in order to prevent water quality impairment in the future.

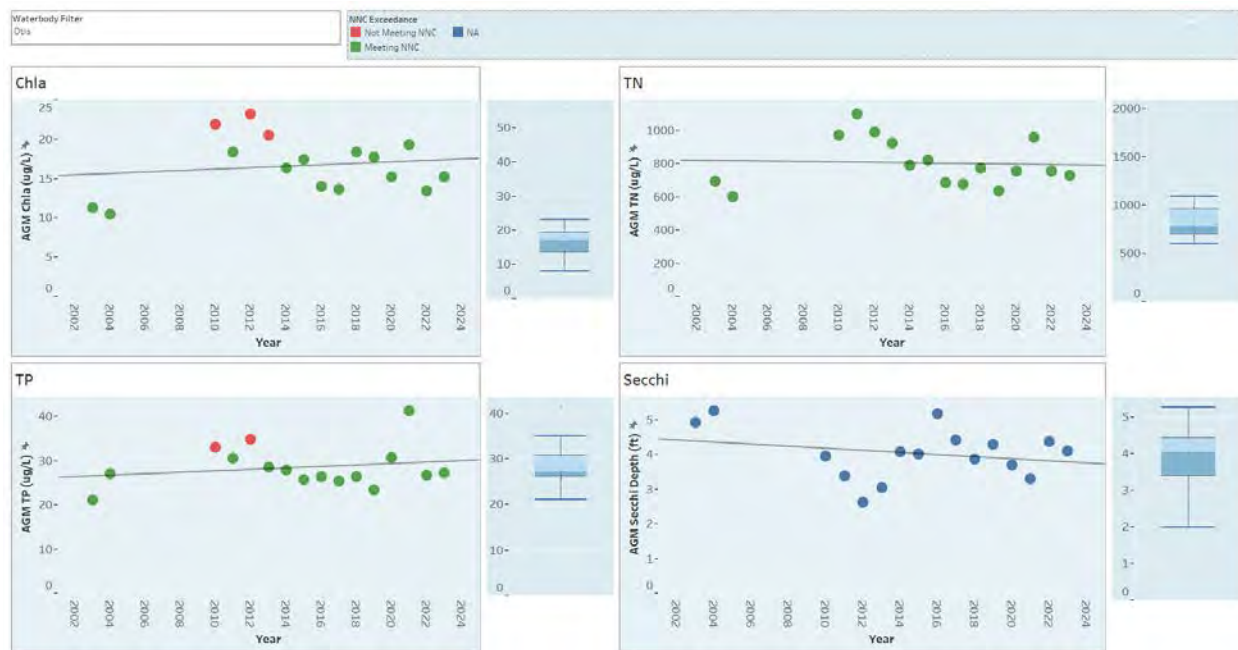
Figure 3-207. Lake Otis AGM Chl-a, TN, TP, and Secchi depth values from 2004 to 2024. Data points colored in red depict NNC exceedances. Also detailed are trend lines and box & whisker plots showing relative variance.

Long-term trend evaluation was conducted using linear regression analysis of AGM Chl-a, TN, TP, and Secchi depth values from 2004 to 2024. Lake Otis exhibits no statistically significant trends. However, TP and Secchi depth trends are in a deteriorating direction, while the Chl-a and TN trends are in an improving direction. Deteriorating trend directions earn scores of 1 while improving directions earn scores of 2.

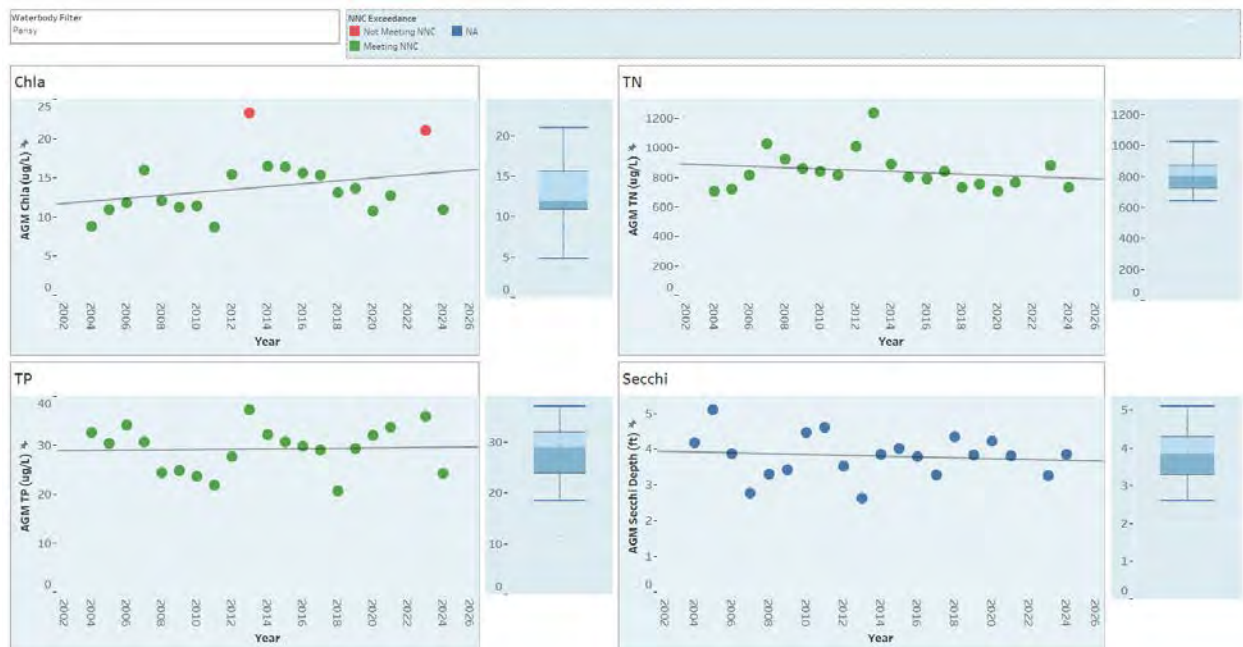
Figure 3-215. Lake Pansy AGM Chl-a, TN, TP, and Secchi depth values from 2004 to 2024. Data points colored in red depict NNC exceedances. Also detailed are trend lines and box & whisker plots that show relative variance.

To determine water quality impairment based on the Numeric Nutrient Criteria (NNC), Lake Pansy is categorized as a highly colored waterbody. Aside from a single NNC exceedance of Chl-a during 2023, Lake Pansy's water quality has met the NNC guidelines (Figure 3-215). Pansy's status is currently un-impaired which earns it an impairment criterion score of 3.

Long-term trend evaluation was conducted using linear regression analysis of AGM Chl-a, TN, TP, and Secchi depth values from 2004 to 2024. During this time frame, none of the NNC parameters exhibited a statistically significant trend. The trends for Chl-a, TP, and Secchi depth moved in a deteriorating direction, earning a trend criterion score of 1; whereas the TN trend moved in an improving direction, for a criterion score of 2. Considering the lack of impairments, these trends are not concerning as they don't indicate declining water quality.

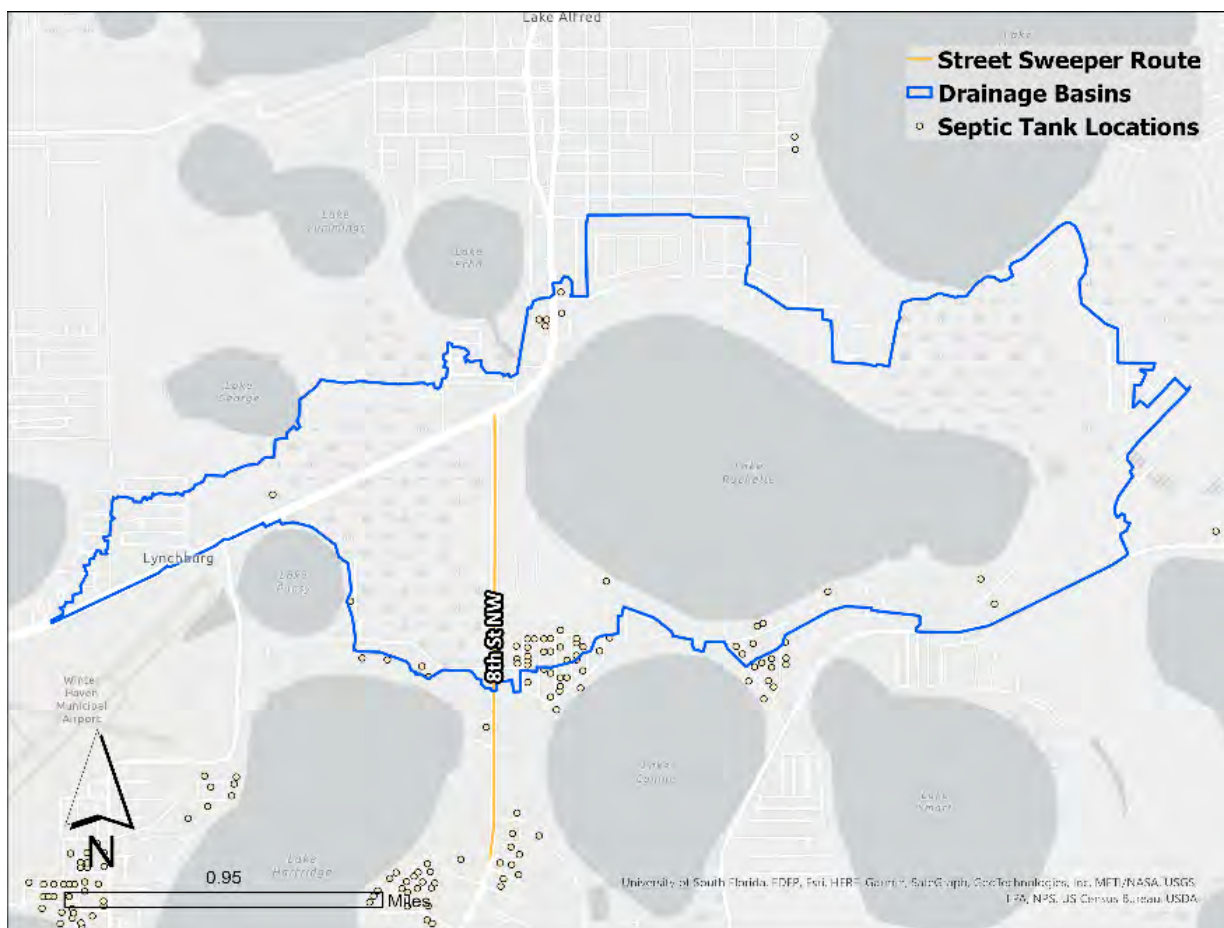
Figure 3-221. Map of Lake Rochelle's drainage basin, City street sweeper routes, and nearby septic systems.

Lake Rochelle is one of Winter Haven's larger waterbodies with a surface area of 560 acres. Rochelle is slightly deeper than the regional average with a mean depth of nearly 9 feet and a maximum depth of 20 feet (Figure 3-220). Despite the depth, the slope of the lake bed is relatively gradual—allowing for a large littoral zone to support a robust vegetation community. Stormwater is conveyed to this waterbody from a 1,670 acre, relatively rural drainage basin (Figure 3-221). Wetland, residential, agricultural, and commercial land uses comprise the drainage basin, contributing 3,002 lbs of TN and 522 lbs of TP to the lake annually. On a per acre basis, these are some of the lowest pollutant loading rates in the study area. There are over 40 septic systems within the basin. These constitute a relatively low density based on the number of systems per acre. To mitigate stormwater pollutant loading, the City conducts 4.4 miles of street sweeping twice monthly along US Highway 17.
