# Winter Haven Lakes Report

2024

**CITY OF WINTER HAVEN**  
**Public Works Department**  
**Natural Resources Division**

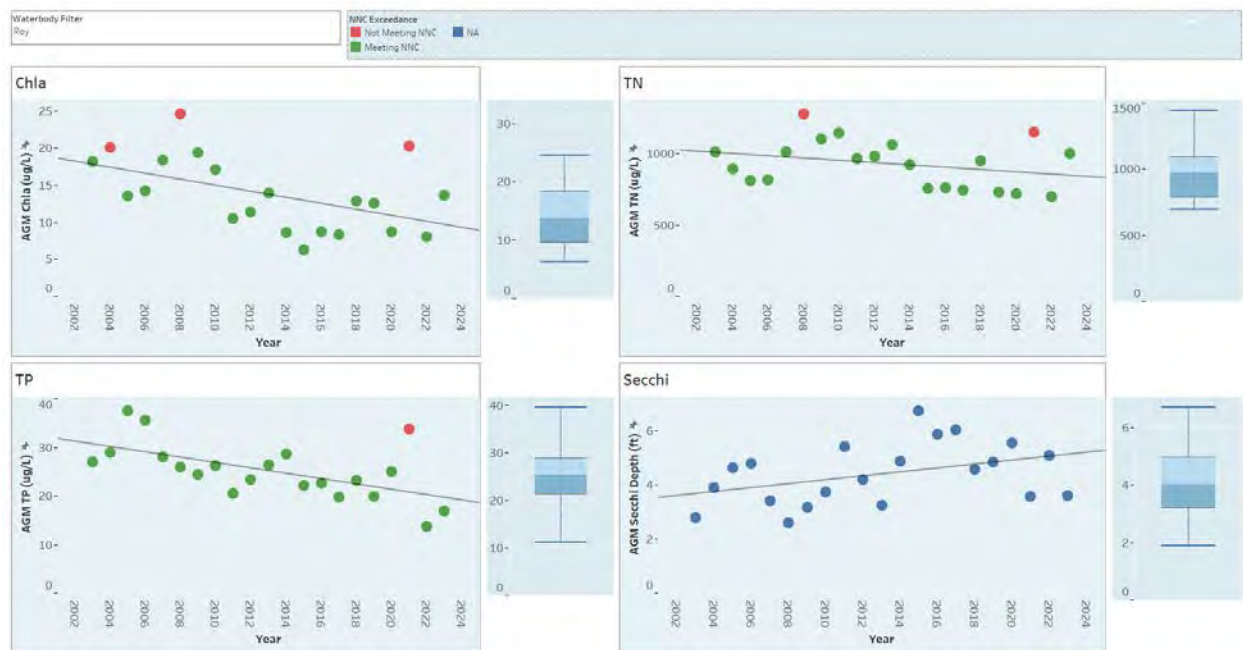
Figure 3-231. Lake Roy AGM Chl-a, TN, TP, and Secchi depth values from 2004 to 2024. Data points colored in red depict NNC exceedances. Also detailed are trend lines and box & whisker plots showing relative variance.

To determine water quality impairment based on the Numeric Nutrient Criteria (NNC), Lake Roy is categorized as a clear, alkaline waterbody. Aside from an outlier year during 2021, Lake Roy has not exhibited any NNC exceedances during the assessment period (Figure 3-231). As a result, Roy is considered un-impaired and earns an impairment criterion score of 3. Despite the high Chl-a and nutrient concentrations in 2021, Lake Roy has exhibited low Chl-a, TN, and TP concentrations in recent years.

Long-term trend evaluation was conducted using linear regression analysis of AGM Chl-a, TN, TP, and Secchi depth values from 2004 to 2024. During this period, Chl-a and TP exhibited significant improving trends. This equates to a trend criteria score of 3 for these parameters. Secchi depth and TN exhibited non-significant improving trends; for criterion scores of 2.

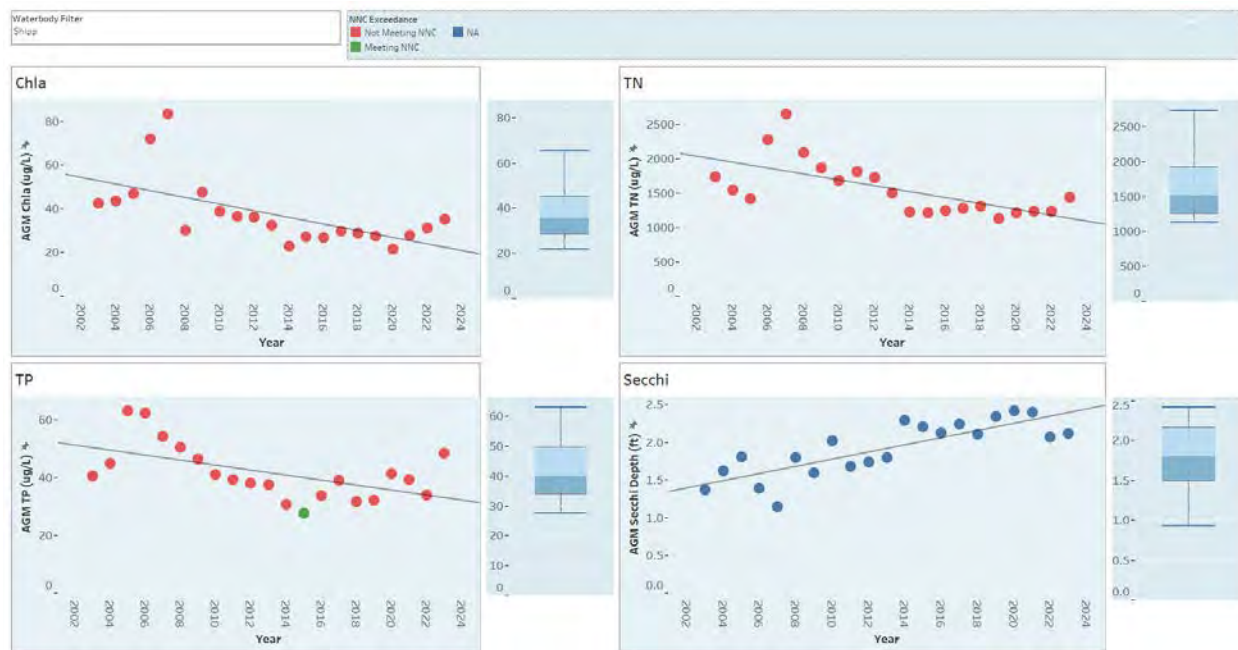
Figure 3-239. Lake Shipp AGM Chl-a, TN, TP, and Secchi depth values from 2004 to 2024. Data points colored in red depict NNC exceedances. Also detailed are trend lines and box & whisker plots that show relative variance.

To determine water quality impairment based on the Numeric Nutrient Criteria (NNC), Lake Shipp is categorized as a clear, alkaline waterbody. Due to consistent NNC exceedances during the assessment period, Lake Shipp is considered impaired for Chl-a, TN, and TP (Figure 3-239). This equates to an impairment criterion score of 0. In 2019, the FDEP established a total maximum daily load stipulating a 53% reduction in TN in order for Lake Shipp to meet NNC guidelines.

Long-term trend evaluation was conducted using linear regression analysis of AGM Chl-a, TN, TP, and Secchi depth values from 2004 to 2024. Each of Lake Shipp's water quality parameters exhibited significant improving trends during this period. This equates to trend criteria scores of 3 for Chl-a, TN, TP, and Secchi depth. It should be noted that despite the long-term trends, Chl-a, TP, and TN concentrations appear to have generally increased over the last four years.

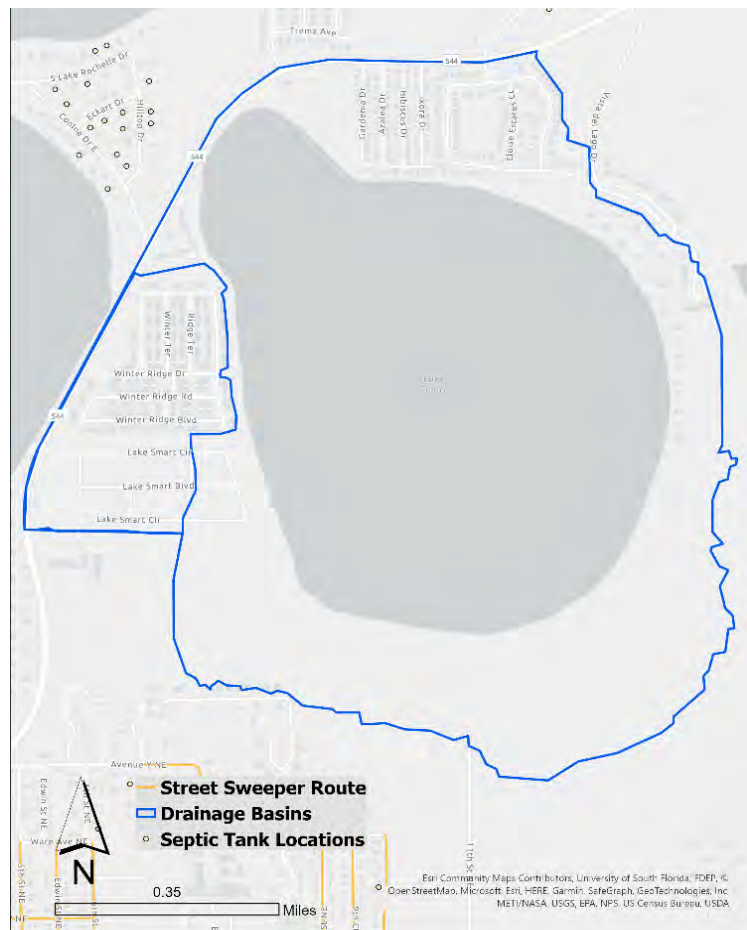
Figure 3-253. Map of Lake Smart's drainage basin and nearby septic systems.

As part of the North Chain of Lakes, Smart is connected to Lake Conine to the west via navigable canal and Lake Fannie to the east via a non-navigable canal. Excess water from the North Chain eventually drains via the SWFWMD-managed P-8 control structure at the south of Lake Hamilton and enters the Peace Creek. Over the period of record, surface levels in this section of the North Chain (Lakes Conine, Haines, Rochelle, and Smart) have fluctuated between 122 and 129.5 feet above sea level. The normal range fluctuates much less between 126.1 and 128.2 feet (Figure 3-254). During 2024, the North Chain reached a dry season low of 127.8 feet in June and a wet season peak of 130.3 feet in October. The October peak was a record high for this chain of lakes; exceeding the previous record experienced during the triple hurricane season of 2004. The surface level ended the year above the high end of the normal range, at 128.5 feet. Changes in Lake Smart's surface level are directly correlated with water clarity and indirectly correlated with Chl-a and TN (see appendix). This carries management implications as maintaining higher levels should result in water quality improvements.

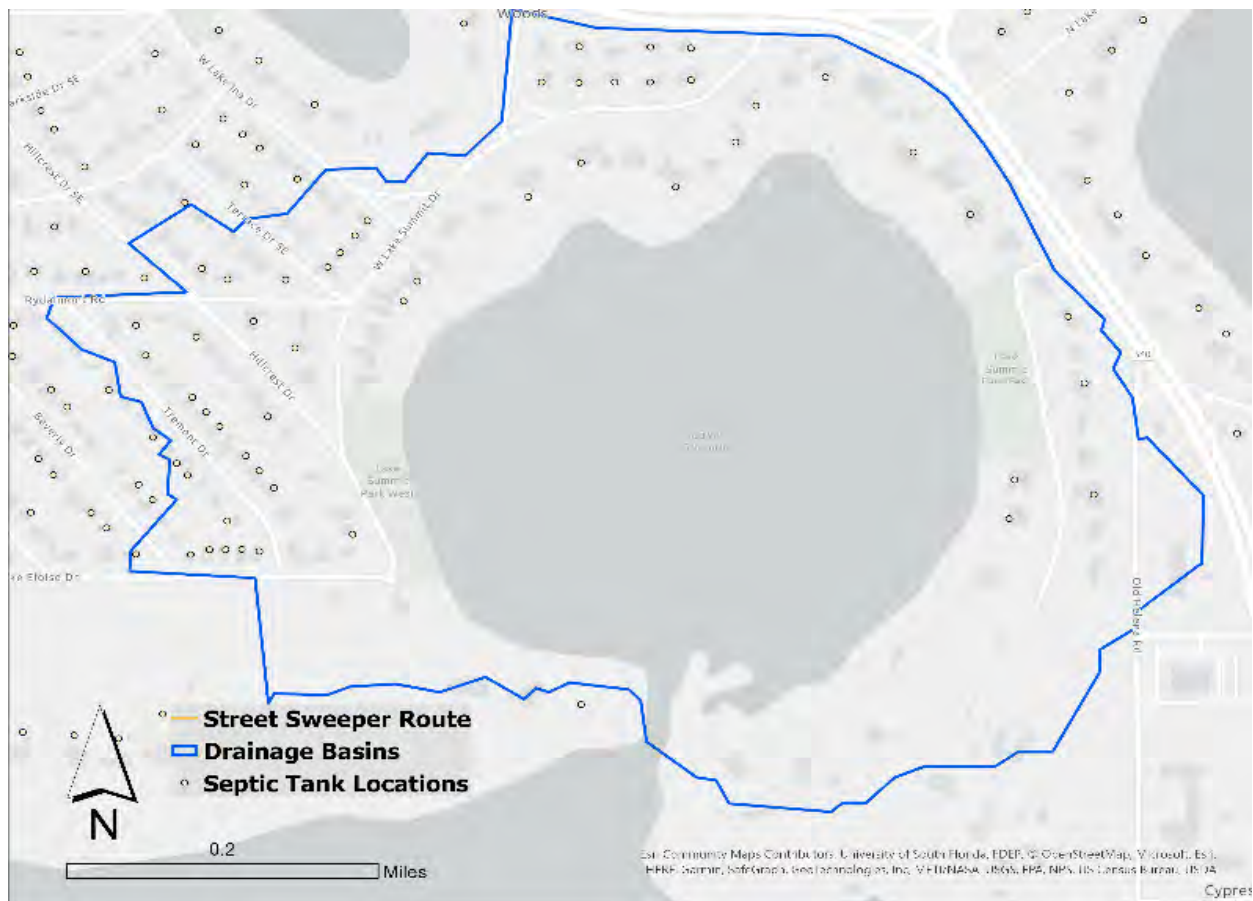
Figure 3-269. Map of Lake Summit's drainage basin and nearby septic systems.

Lake Summit is a small, but deep waterbody at 67 acres, an average depth of 10.7 feet, and a maximum depth of almost 30 feet (Figure 3-268). Summit's average depth is almost two feet deeper than the regional mean. Coupled with the small size of the lake, the lake bed has a steeper slope. While this would normally significantly limit the littoral zone, Lake Summit has very high water clarity which allows its aquatic plants to grow in deeper water than many other lakes in the study area. Stormwater is conveyed to this waterbody from a 166 acre drainage basin (Figure 3-269). The basin is dominated by residential land uses, contributing 513 lbs of TN and 83 lbs of TP to the lake annually. On a per acre basis, these pollutant loading rates are fairly low compared with other drainage basins in the study area. There are 52 septic systems present in the basin. This constitutes a moderate density that may contribute some pollutant loading through groundwater leaching. Due to the drainage basin being mostly outside of Winter Haven limits, the City does not conduct any street sweeping that benefits this lake.

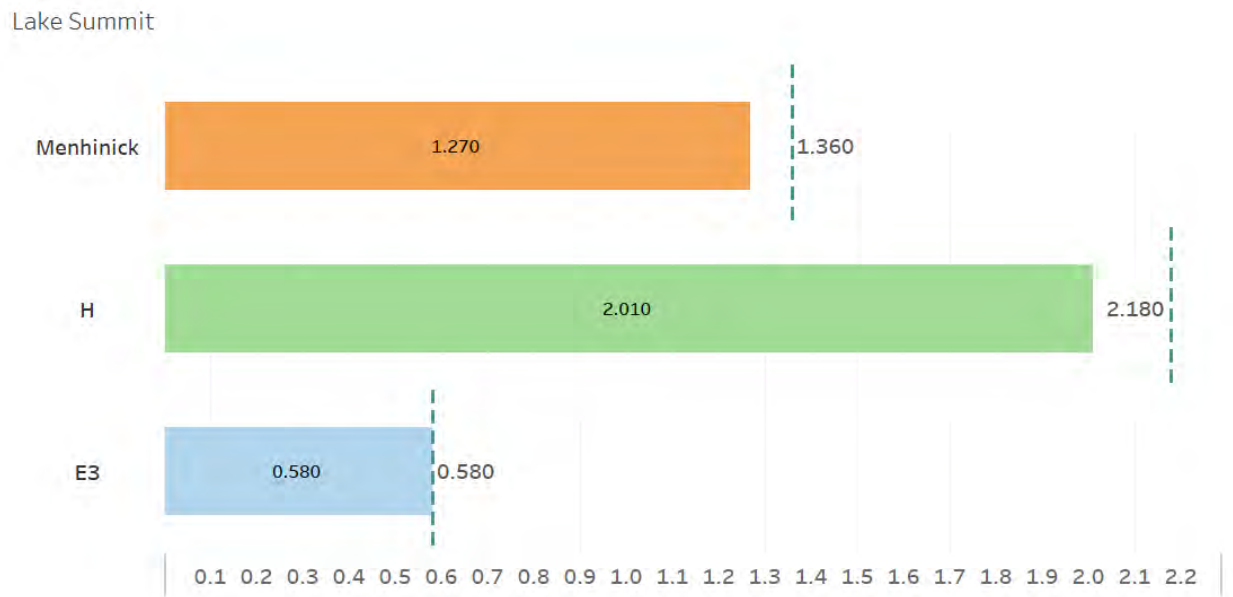
Figure 3-274. Chart depicting 2024 diversity indices for Lake Summit. Dashed lines represent median values.

This evaluation examines three diversity indices: species richness (Menhinick), species evenness (E3), and overall diversity (H). According to the 2024 species data, only Lake Summit's evenness index met or exceeded its median value (Figure 3-274). This equates to a diversity criterion score of 1. All three diversity indices underwent a decline from the previous year. The total number of unique species decreased from 15 to 12, and the distribution of these species was slightly less equitable in 2024. The invasive management efforts in 2023 and 2024 were the likely causes for these shifts in diversity.

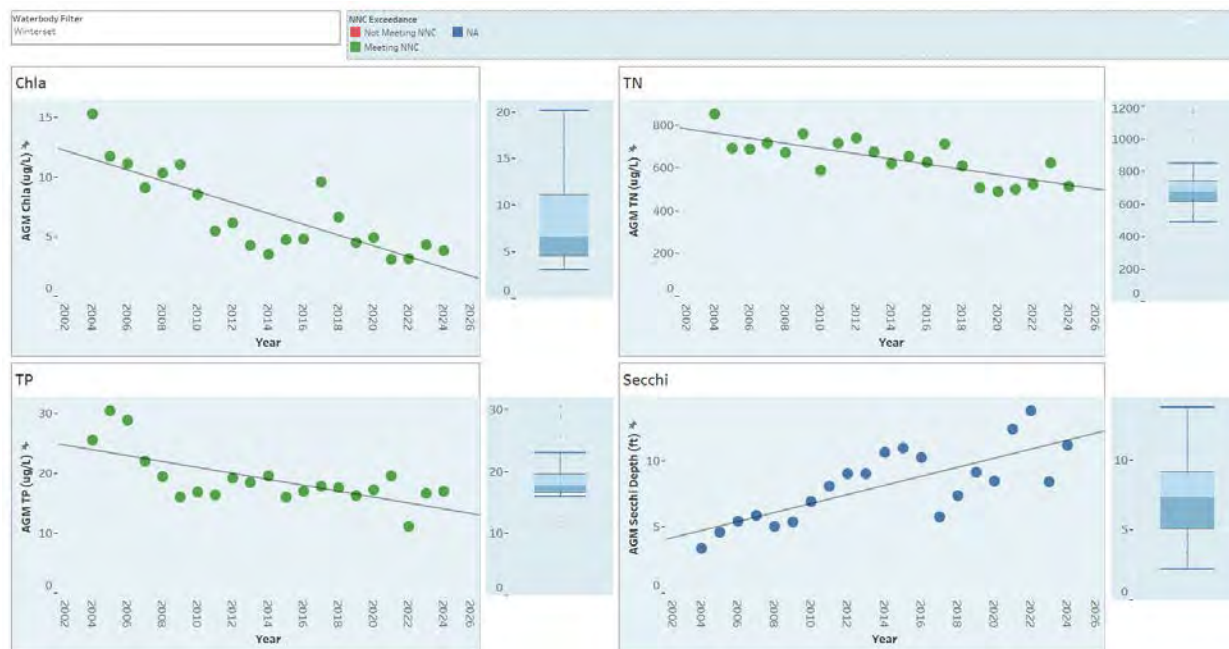
Figure 3-279. Lake Winterset AGM Chl-a, TN, TP, and Secchi depth values from 2004 to 2024. Data points colored in red depict NNC exceedances. Also detailed are trend lines and box & whisker plots that show relative variance.

Long-term trend evaluation was conducted using linear regression analysis of AGM Chl-a, TN, TP, and Secchi depth values from 2004 to 2024. During this period, all four of these parameters exhibited statistically significant improving trends. This equates to trend criteria scores of 3 for each of these. Lake Winterset likely has the best water quality in Winter Haven and will continue to be as long as the trends consistently maintain these improving directions.

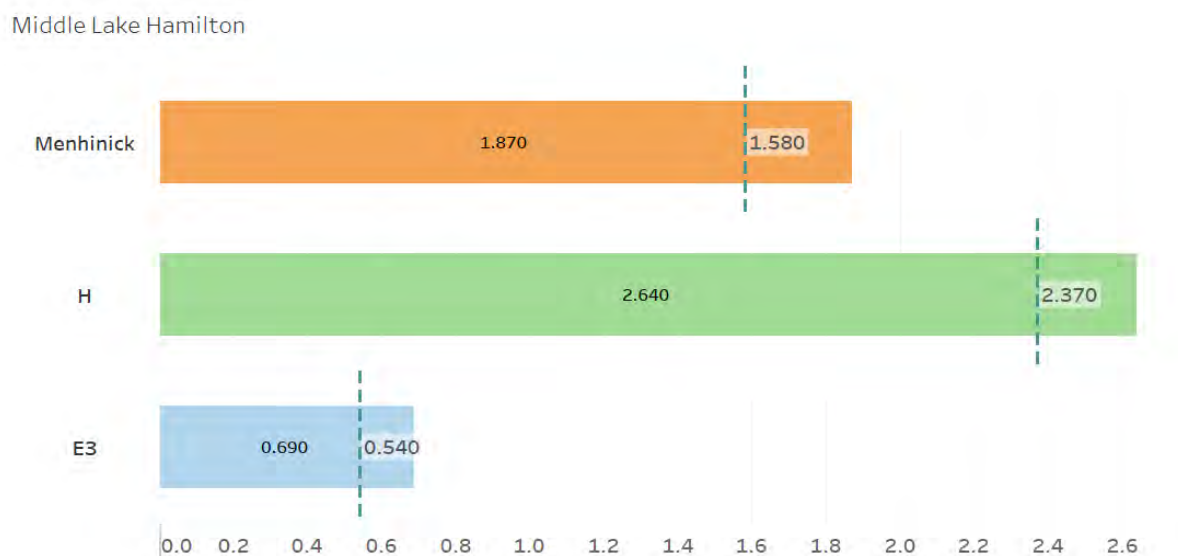
Figure 3-298. Chart depicting 2022 diversity indices for Middle Lake Hamilton. Dashed lines represent median values.

This evaluation examines three diversity indices: species richness (Menhinick), species evenness (E3), and overall diversity (H). According to 2024 species data, all three of Middle Hamilton's diversity indices exceeded their respective median values, earning a diversity criterion score of 3 (Figure 3-298). The actual number of unique species didn't change from the previous year, but the relative proportions of each were much more evenly distributed; increasing not just the evenness index, but the richness and overall diversity indices as well. Species diversity does not discriminate between natives and invasives, so these increases aren't necessarily a good outcome for the ecological health of the lake.
